Customer Complaint "Stopwatch Fogged Up" (Sport Chrono Package: M-no. 639/640/BLH): See Information (92/16)

Model Year: **As of 2012**

Model Line: **911 Carrera (991/992)**
Boxster/Cayman (981/982)

Subject: **Stopwatch (Sport Chrono clock)**

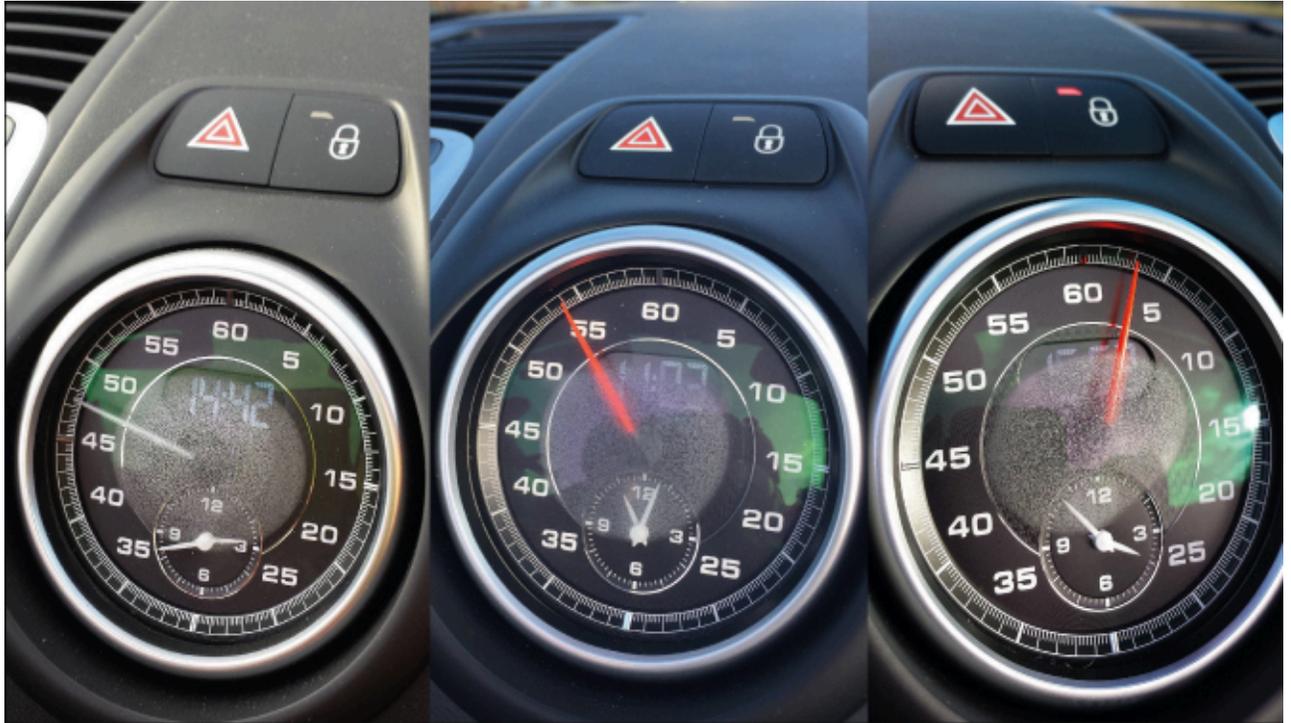
1.1 If the stopwatch is only slightly fogged up, i.e. with fine drops: Replacement of the stopwatch is **not** approved.

Example illustration of unapproved stopwatches

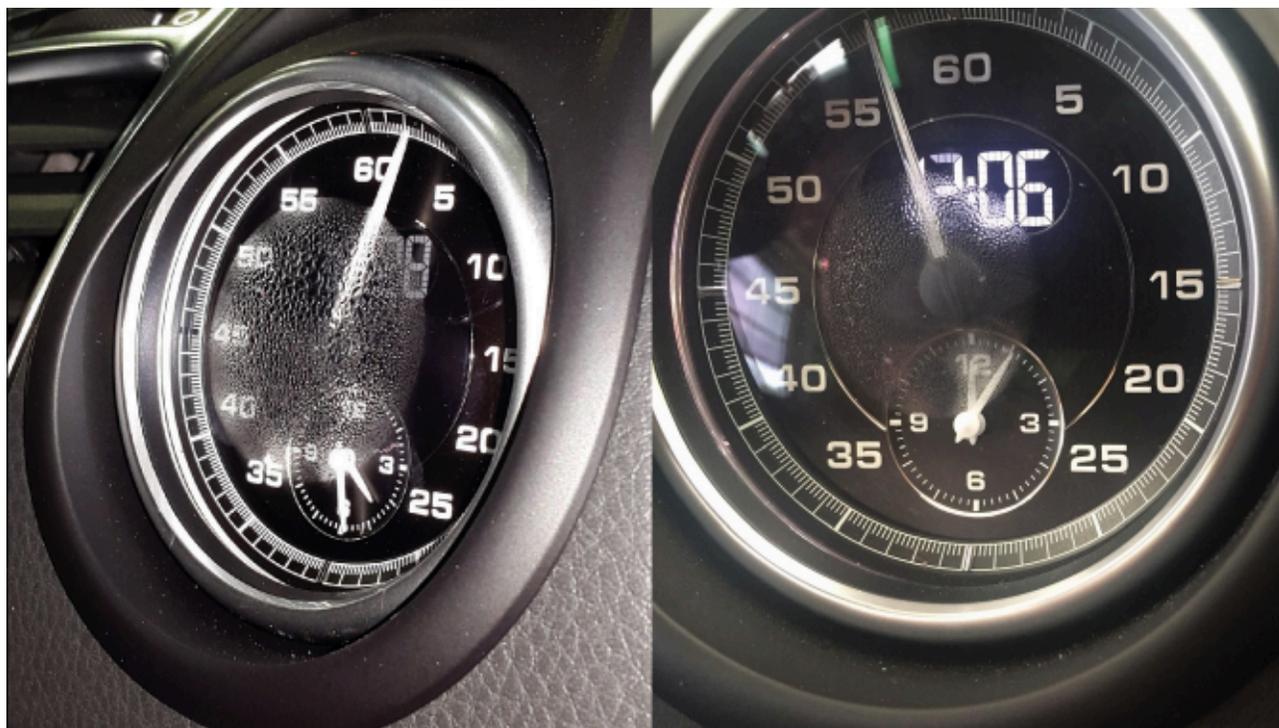
- 1.2 If the stopwatch is very fogged up, i.e. with bigger drops: Replacement of the stopwatch is **justified and approved**. ⇒ *Workshop Manual 'Removing and installing stopwatch'*.

Example illustration of approved stopwatches

The illustration provides a basis for assessment ⇒ *Example illustration of approved stopwatches*. **Please attach a photo of the condensation within the clock to the PQIS job.**

APOS	Labor operation	I No.
90225540	Replace stopwatch
