Surround Camera Intermittent Operation

Models	Model Year	Model Type	VIN Range	Vehicle-Specific Equipment
Cayenne	As of 2019 up to 2023	9YA, 9YB	N/A	KA6

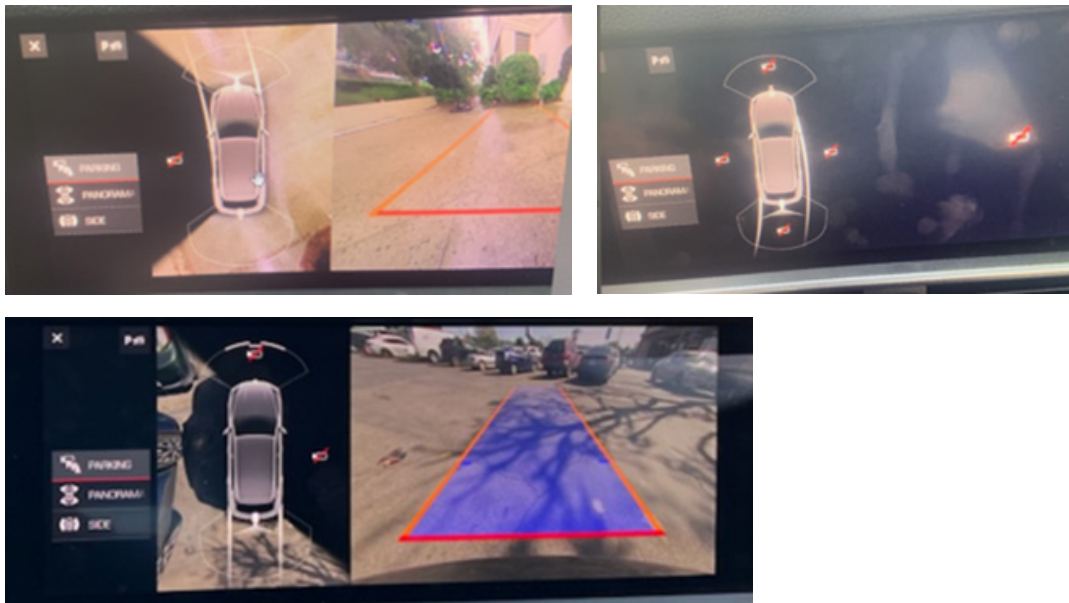
Customer complains of intermittent operation for one or multiple surround view cameras while appearing blank with a crossed-out camera icon for each failed camera.
