# Service Action

## Code: 69MJ

**Subject** Airbag Control Module

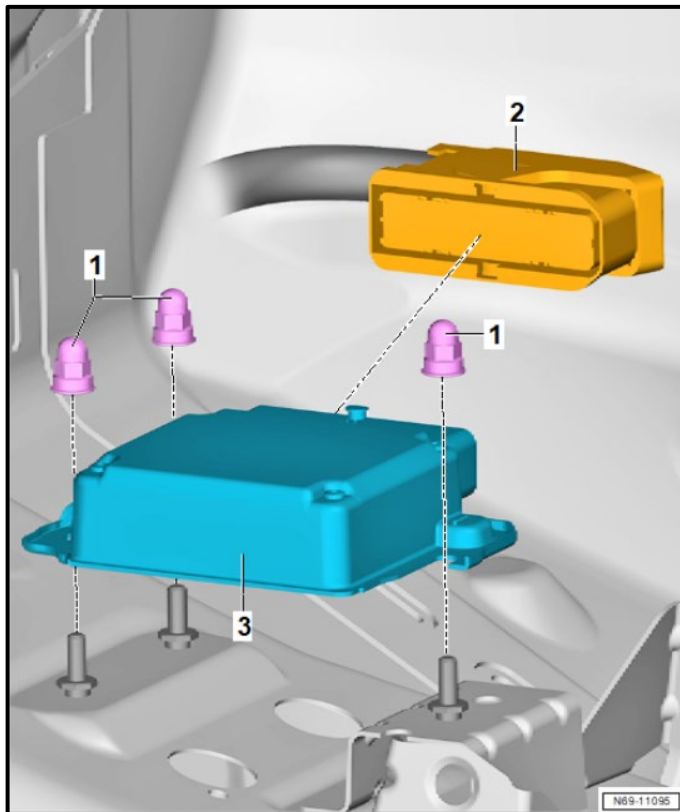
An incorrect EPROM component with lower bytes memory density may have been installed in some airbag control modules. This could cause the airbag indicator light on the instrument panel to come on. To address this issue, dealers will replace the airbag control module in the affected vehicles.

- Replace airbag control module.
