Condition

Applicable Vehicles					
Model(s)	Year	Eng. Code	Trans. Code	VIN Range From	VIN Range To
All	2021-2025	All	All	All	All

The lenses of the taillights are steamed up/damp from the inside with minor or major water droplet concentration.

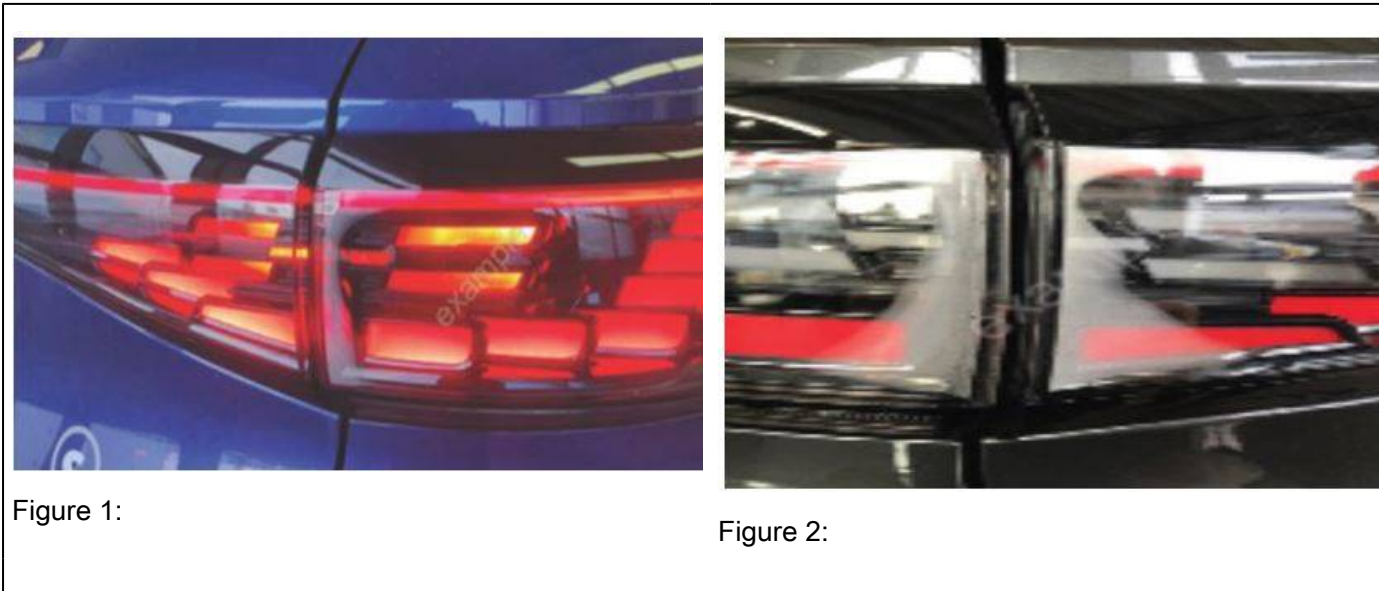
1. Example of taillight with slight condensation, no drips or water droplets.

1. Taillights: the condensation should systematically dry out after a change of the climate conditions.

This condition is normal, no replacement necessary.

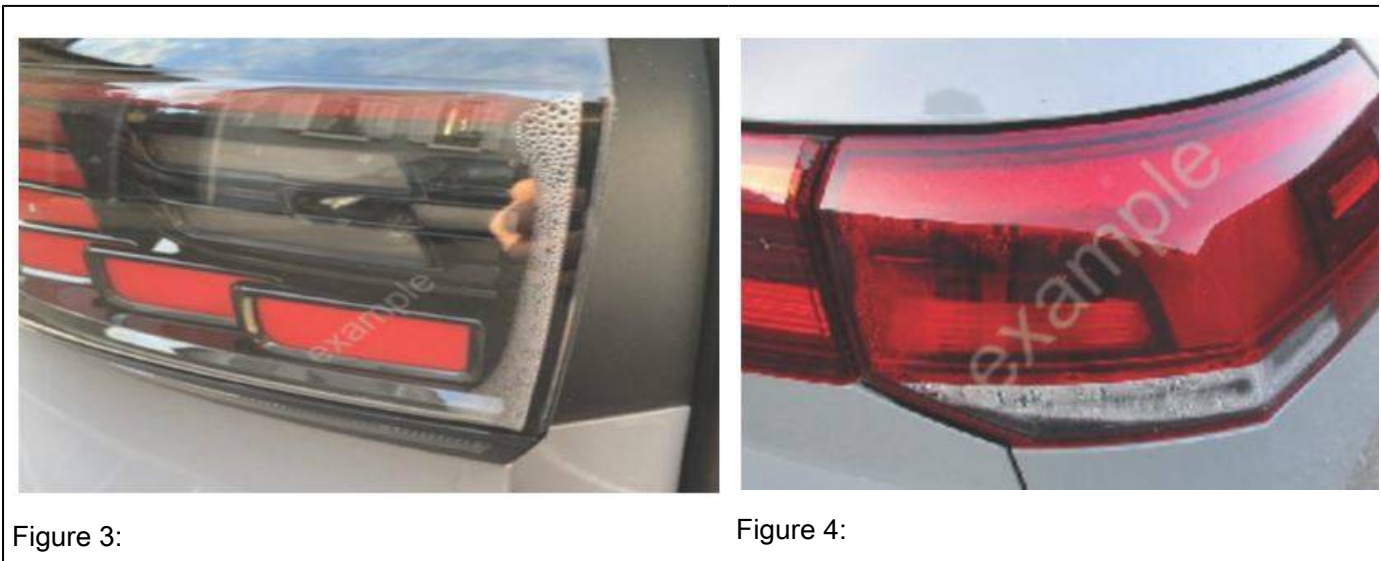
2. Examples of taillight condensation, with droplets or water dripping.

2. In case of an obvious water ingress check the taillight cluster for optical faults (seal fit, taillight housing cracks).

Upon replacing taillights all documentation and pictures showing the water ingress and/or optical faults must be uploaded to WISE for warranty reimbursement. See warranty section for more information on uploading information in WISE.
