**Technical Service Bulletin**

Transaction No.:  
**2074273/4**

91-24-05 - Car Net® 2.0 - Emergency Call Module and Communication Unit -J949-  
Vehicle is Offline (Not Connected)

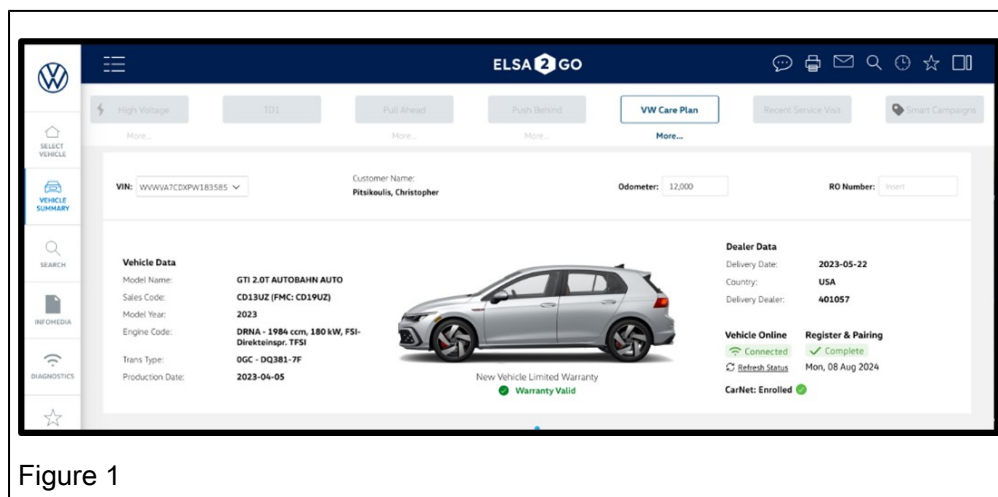
Figure 1

Once you take the vehicle out of transport mode, it may take up to 30 minutes for the system to come online. The green LED in the overhead console is an indicator that the vehicle has made a good connection; however, the definitive status can be found in Elsa2Go. On the figure below, verify that the vehicle is “**Connected**” and Register & Pairing is marked “**Complete**”. Any other status, in either of these spaces, indicates that the system is not operating correctly and requires intervention.

An incorrect status indicates that no connection was established. All vehicles equipped with myVW® need the status indicators in Elsa2Go to be as shown above; prior to being delivered to the customer.
