Technical Service Bulletin

Subject: FRONT DOOR INTERFERES WITH REAR DOOR GARNISH (5-DOOR HATCHBACK)	Bulletin No.: 09-028/25
	Last Issued : 07/28/2025

2019-2025 Mazda3 5-door HB (Japan built) with VINs lower than JM1BP*****766663 (produced before Sep. 27, 2024)

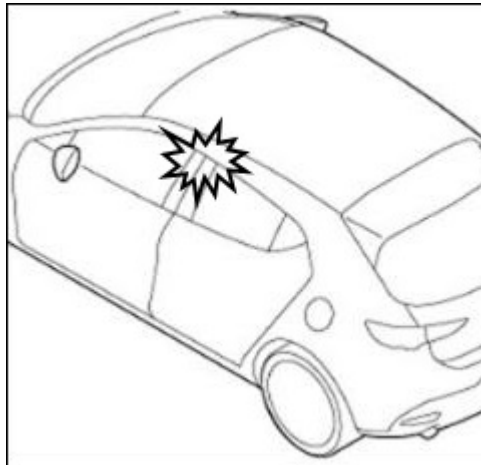
Some vehicles may exhibit that the glass run channel of the front door interferes with the rear door garnish.

Since the front door glass run channel is not fixed to the door strongly enough for the following situations, cycles of door operation may result in interference and lead to damage on the seal rubber at the rear door.

- When the front door glass is closed, the glass run channel may be forced to move to the B pillar side.
- In very hot climates, the glass run channel may expand to the B pillar side.

- Phase 1
 - Adhesive has been added between the front door glass run channel and the door panel.
- Phase 2
 - The shape of the front door glass run channel has been changed so as not to make contact with the rear garnish.
 - The shape of the clip at the rear side of the front door glass run channel has been changed for stronger fixing and the hole at the door sheet metal panel has been changed accordingly.

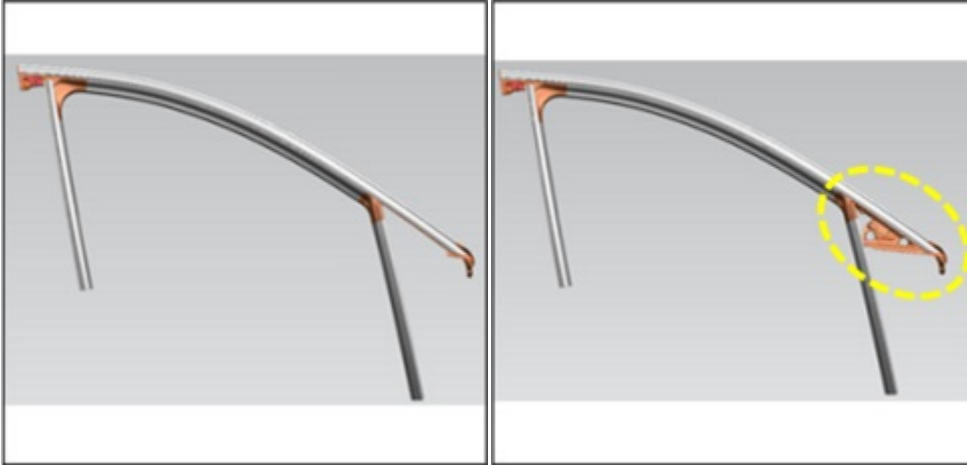
Front door glass run channel and sail garnish are integrally formed

- If the front door glass run channel obtained is BDMT-58/59-60ZJ or later level, remove and discard the sail garnish (1), which is originally installed on the vehicle according to the instructions on MGSS (SAIL GARNISH REMOVAL/INSTALLATION), before installing the front door glass run channel.

Discard
(1) Sail garnish
(BCJH-58-621)
