## Failure of One or More Surround View Cameras in the PCM Central Display

Bulletin #: 2517

Part ID: 9102

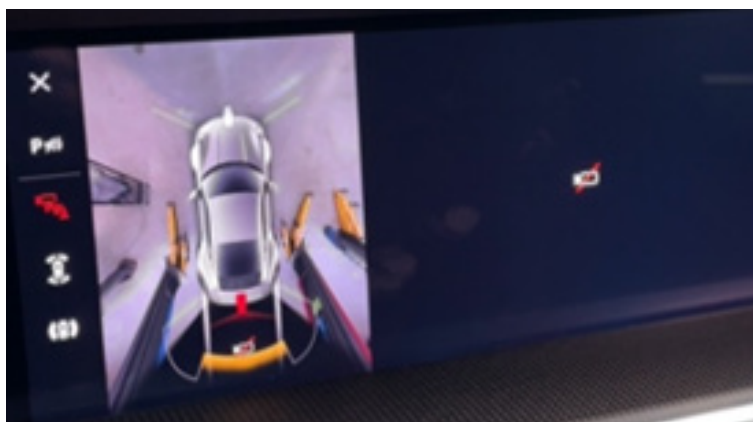
Figure 1

The customer complains about a sporadic, partial, or complete failure of the Surround View in the PCM Central Display. In addition, one or more of the fault memory entries listed below are stored in the control unit for assistance systems.

The condition can be triggered by implausible communication breaks or interruptions between the camera heads and the control unit for assistance systems.

**Update the Assistance System control unit H11 to software version 0511 using PIWIS Tester v43.500.011 (or higher).**

1. Check plug of the relevant video lines for tightness, damage and moisture entry/corrosion traces and
2. Check video lines for damage, crushing and voltage-free installation. If necessary, adjust line routing or replace if damaged.
