<b>Subject:</b>  EXTERIOR LIGHT WARNING WITH DTC B10A3:86	<b>Service Alert No.:</b> SA-034/25
	<b>Last Issued :</b> 07/30/2025

2024-2025 MX-5

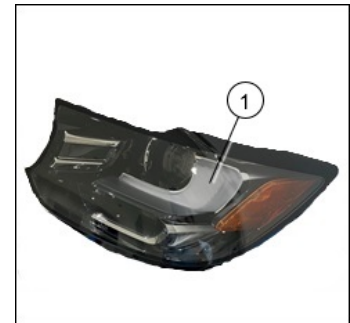
Exterior light warning light

Some vehicles equipped with the Adaptive Front lighting System (AFS) may exhibit the exterior light warning light/exterior light warning indication on while driving or when the ignition is turned on and DTC B10A3:86 (Error signal received from swivel actuator (LH)) is stored in memory.

This may be caused by the AFS Control Module detecting a false headlight malfunction. There are 2 causes, both of which will be resolved by software changes expected sometime in the 3rd quarter of 2025.

- The swivel sticks briefly (milliseconds) during spirited driving.
- The position sensor loses continuity for a very brief period (milliseconds) as the headlight swivels back and forth during normal driving.
