HYUNDAI
Technical Service Bulletin

GROUP	NUMBER
ENGINE MECHANICAL	25-EM-008H
DATE	MODEL(S)
JULY 2025	SANTA FE (NC)

SUBJECT: ENGINE NOISE INSPECTION & REPLACEMENT
(WARRANTY EXTENSION TXX8)

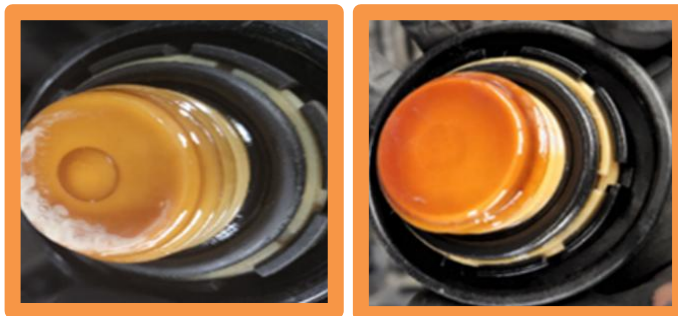
PASS

The oil cap condition will be used to determine if the rear bank rocker cover removal is needed.

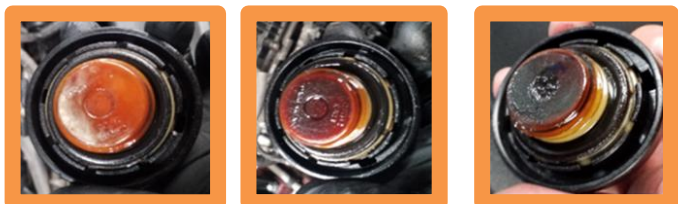
NO PASS

If the oil cap is in the **NO PASS** region, remove the rear bank rocker cover and upload the images of the valvetrain and inside the rear bank rocker cover to STUI with a sticky note with the date of repair.

- Do **NOT** remove the front bank rocker assembly.
 - Submit PA for engine replacement.

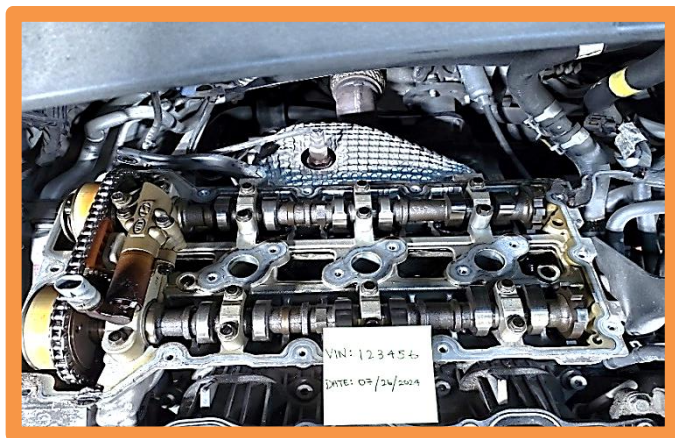
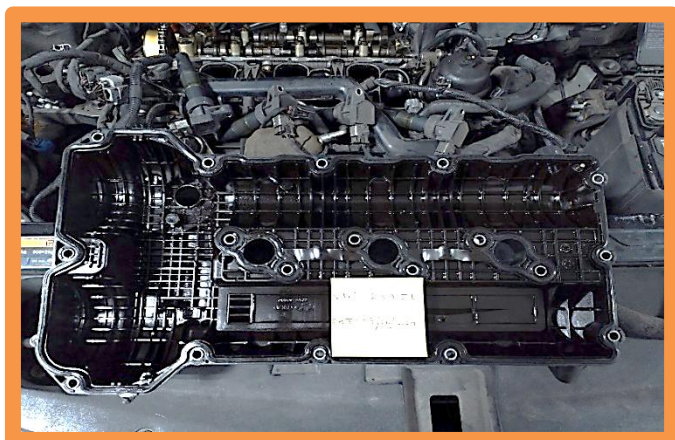
Ensure the photo is clear and focused, and matches the examples shown to the right when submitting valvetrain images via STUI.

Do **NOT** remove the front bank LH rocker cover for valvetrain images. This can disturb the high-pressure fuel system and line. Claims may be subject to chargeback if the front bank rocker cover is removed.

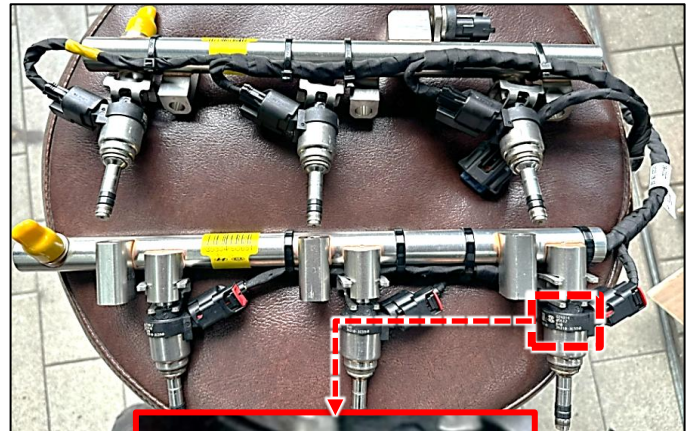
Select the appropriate tip seal according to the existing fuel injector part number.
Use of the incorrect tip seal may result in a critical fuel leak.

4. During the replacement, install the applicable injector tip seals based on the marking on each injector. Since both seals are included in the kit, use the table below to match the applicable part.

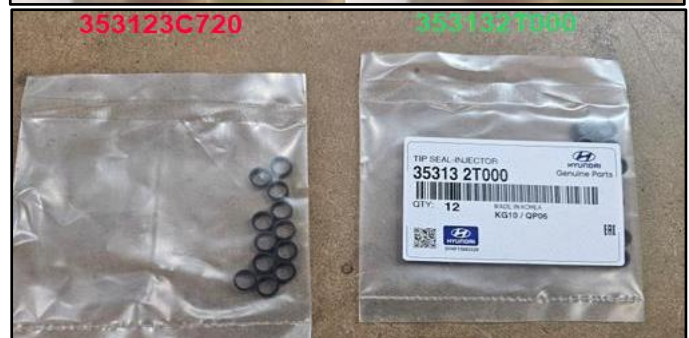
P/N: 353132T000 is labeled.
P/N: 353123C720 is **NOT** labeled.

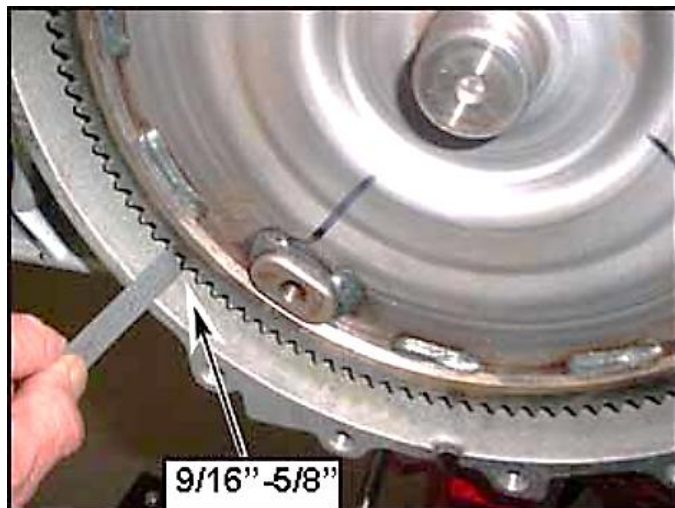
If the torque converter is **NOT** fully seated, the oil pump may be damaged during reinstallation.

8. If the torque converter moved out of position, gently push and rotate it back in until it is seated **5/16 inch – 9/16 inch (8-14 mm)** into the transaxle.
