Technical Service Bulletin

931D UPDATE

Software Update for High-Voltage Battery Diagnostic Software – (NVLW)

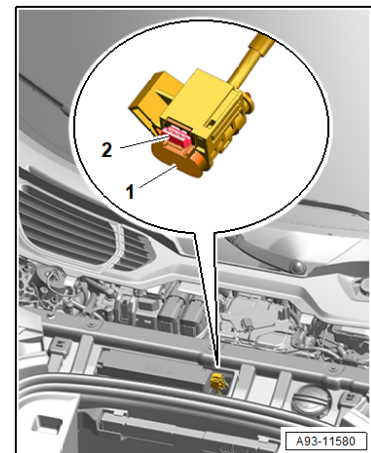
- Open the hood.
- Disconnect the High-Voltage System Maintenance Connector - TW -.
- Ensure the hood remains open during the flash.

- Use operating mode, FLASH.
- Select “SVM – Code Input”.
- Enter SVM code **93SWA799** and follow the on-screen prompts.
- Reconnect High-Voltage System Maintenance Connector - TW -.
- When exiting the FLASH program, ensure the diagnostic log is sent to GFF Paperless.
