Technical Service Bulletin

Audi Q4

Transaction No.: **2074899/4**

93 Q4 power transmission: clacking noises during load changes/when changing direction (e.g. maneuvering/driving away)

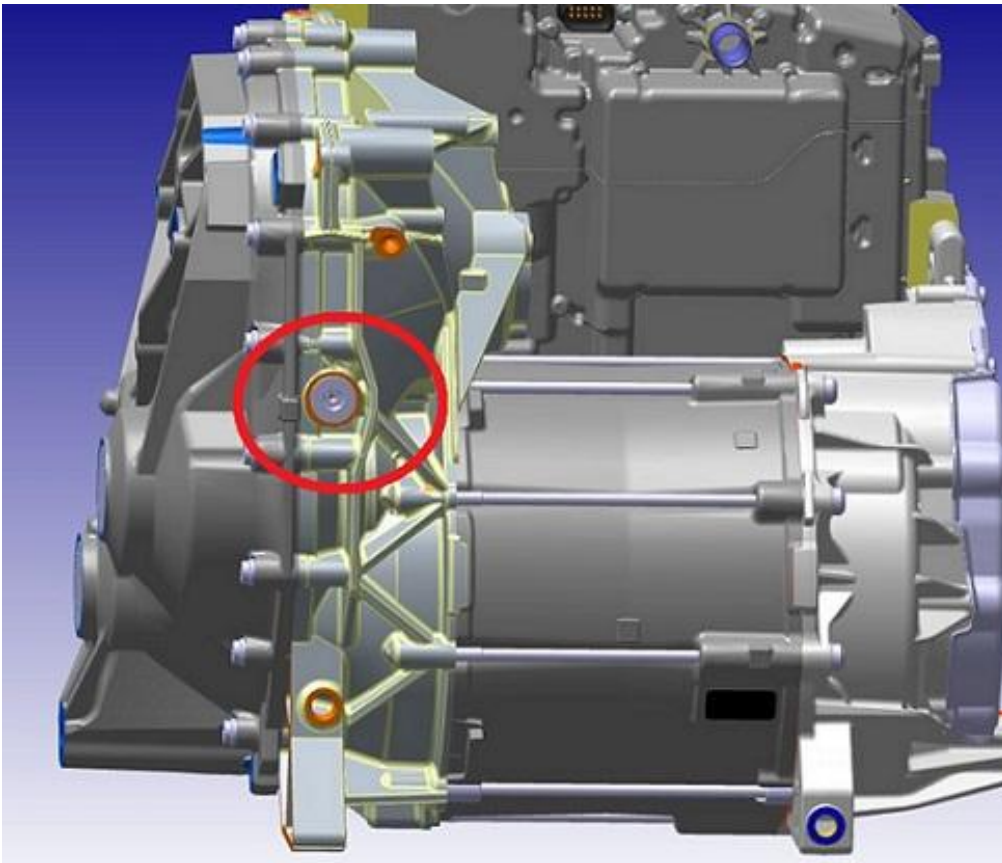
Figure 1. Filler cap for gear oil.

- Remove the gearbox as described in the ELSA Repair manual.
- Attach the gearbox to the engine and gearbox support -VAS6095A- as described in the ELSA Repair manual.
- Drain the gear oil via the filler cap (refer to Figure 1, red oval).

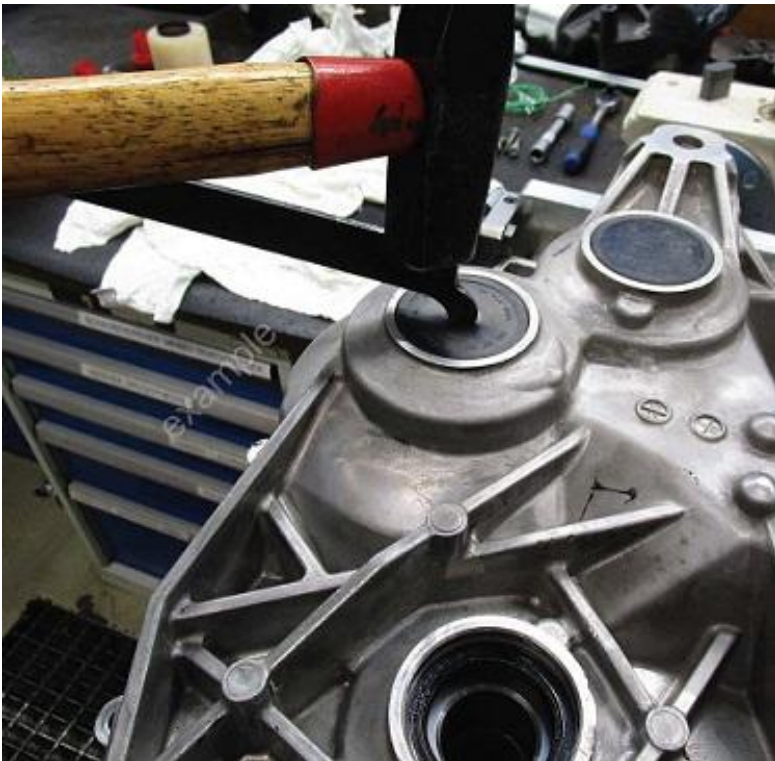
Figure 2. Removing the filler cap with the extractor lever -VW681- (example).

- Remove the center filler cap using the extractor lever -VW681- (refer to Figure 2).

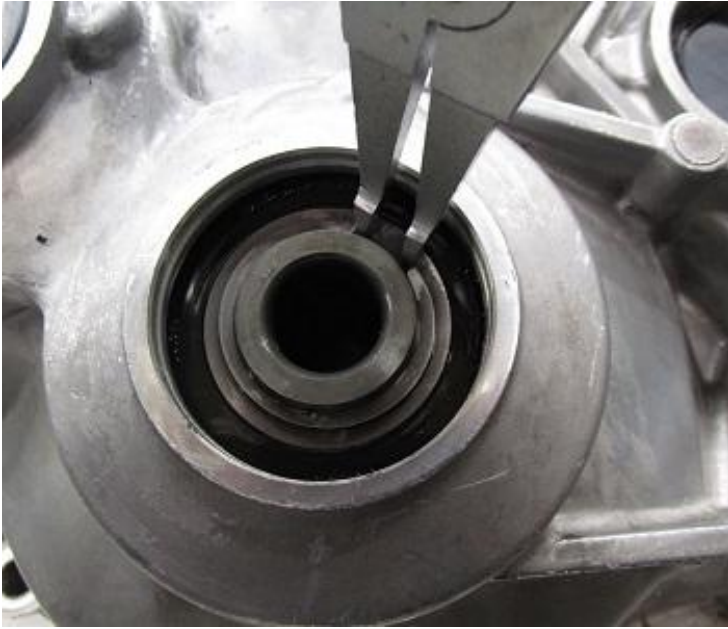
Figure 3. Removing the retaining ring for the inner ring of the intermediate shaft (example).

- Remove the retaining ring for the inner ring of the intermediate shaft (refer to Figure 3). The retaining ring must not be damaged and will need to be used again during the repair procedure.

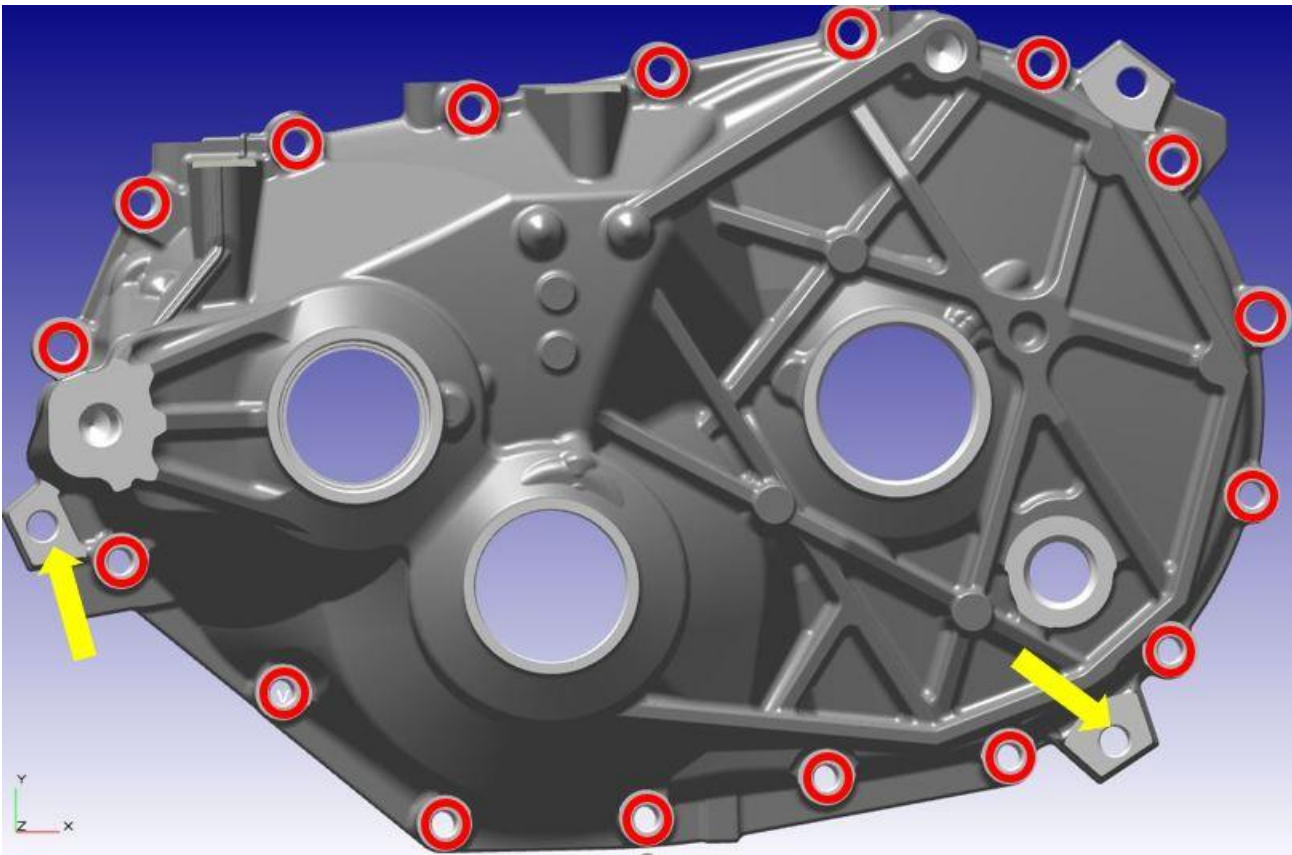
Figure 4. Positions of the housing bolts (red circles), and positions of contact points (yellow arrows).

- Remove 17 housing bolts (refer to Figure 4, red circles).

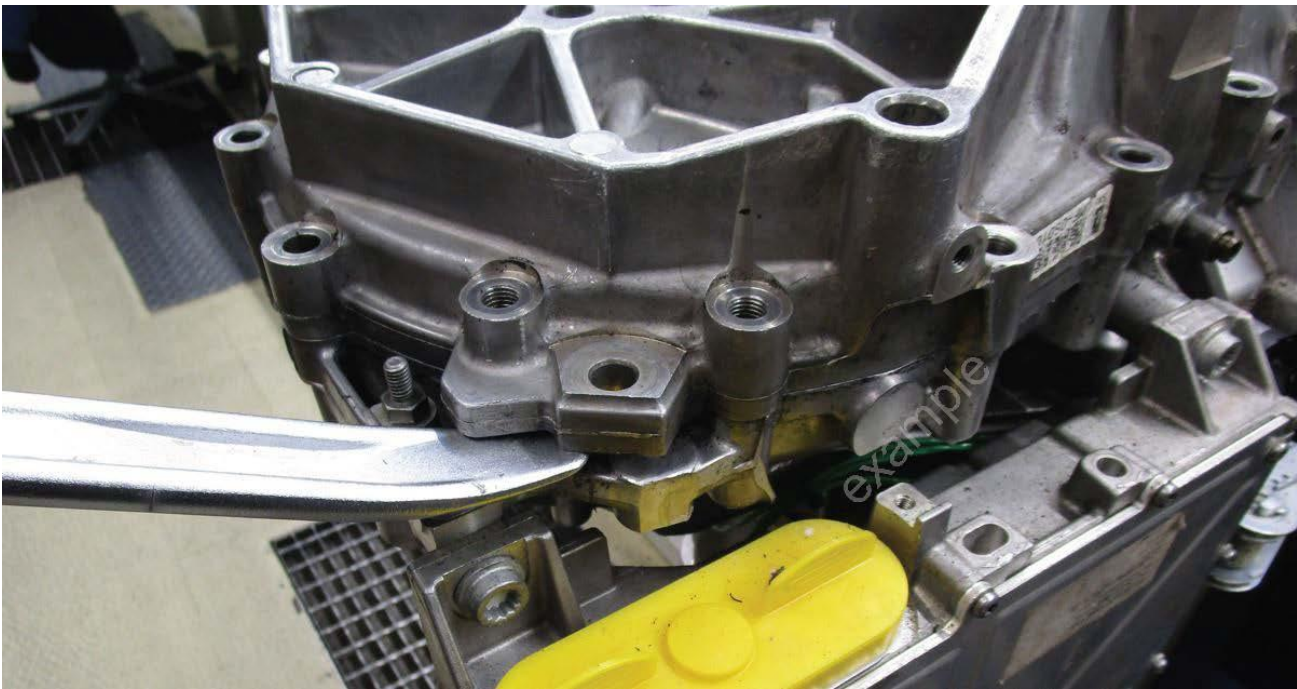
Figure 5. Separating sections of the gearbox housing from each other using the assembly lever.

- Apply a commercially available assembly lever under the contact points (refer to Figure 4 (yellow arrows), Figure 5 and Figure 6), carefully separate the two sections of the gearbox housing from each other and detach

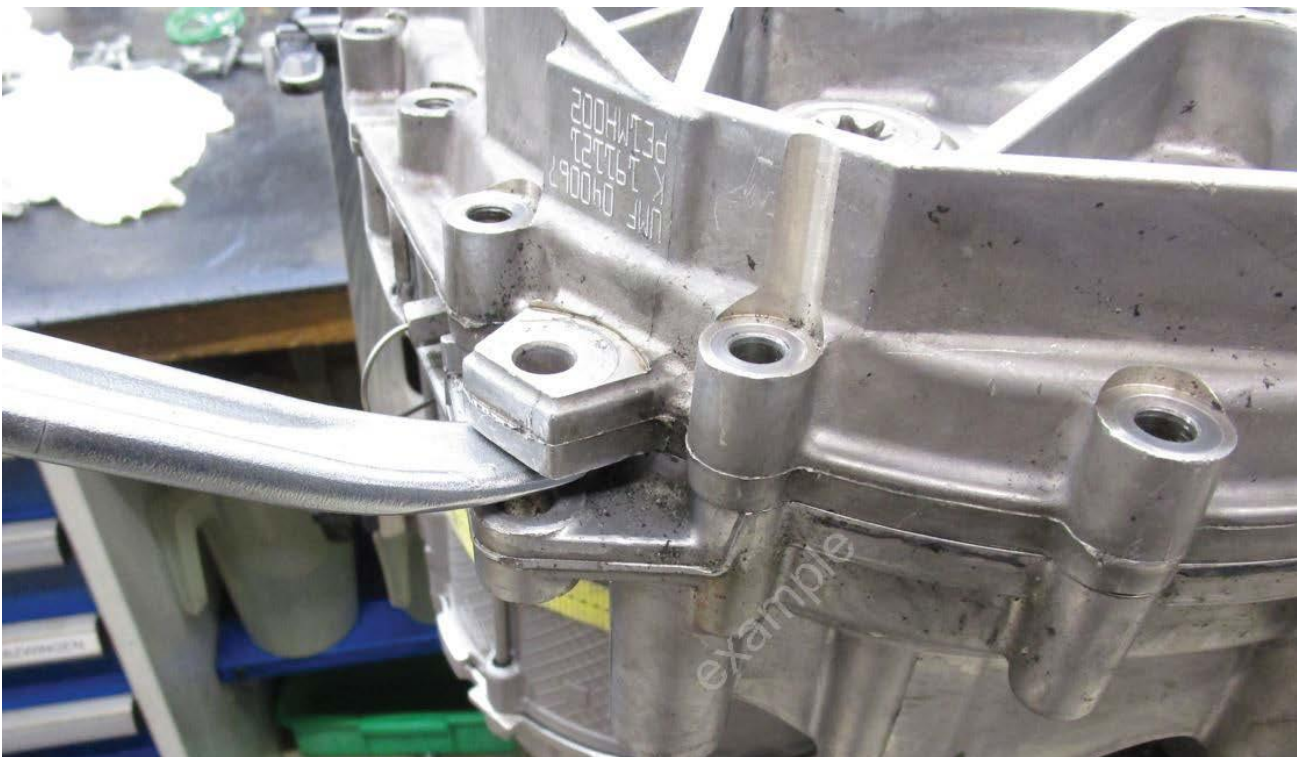
Figure 6. Separating sections of the gearbox housing from each other using the assembly lever.

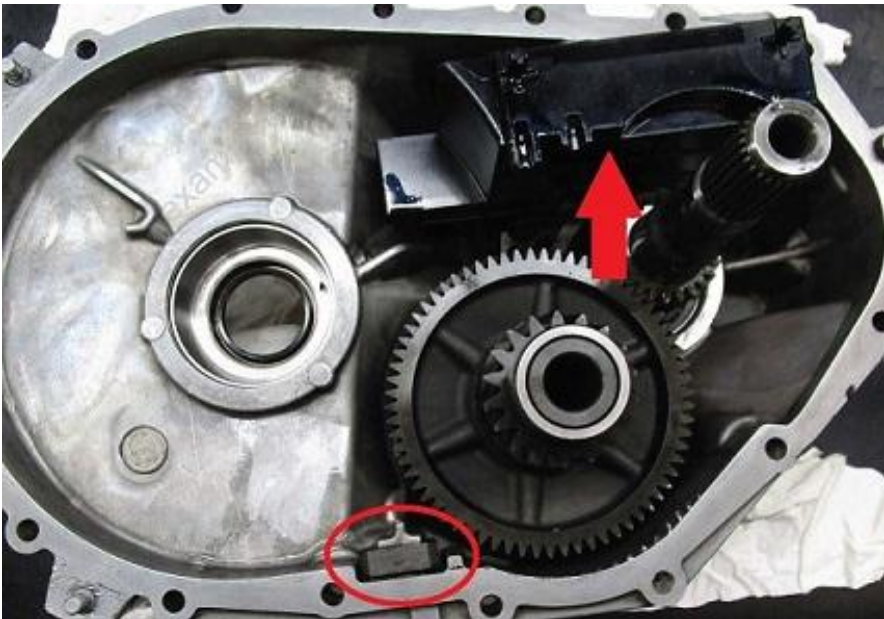
Figure 7. Positions of oil the reservoir and the magnet in the gearbox housing.

- Remove the oil reservoir (refer to Figure 7, red arrow) from the gearbox housing.
- Remove the magnet (refer to Figure 7, red oval) from the gearbox housing.

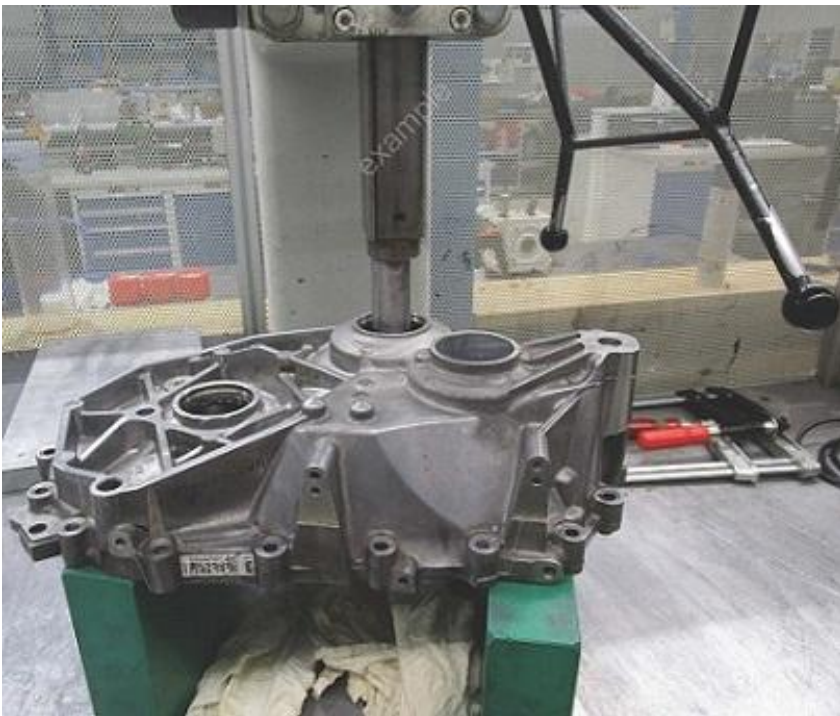
Figure 8. Pressing out the intermediate shaft (example).

- Press the intermediate shaft out using the removing and installing tool -VW459/2- (refer to Figure 8).

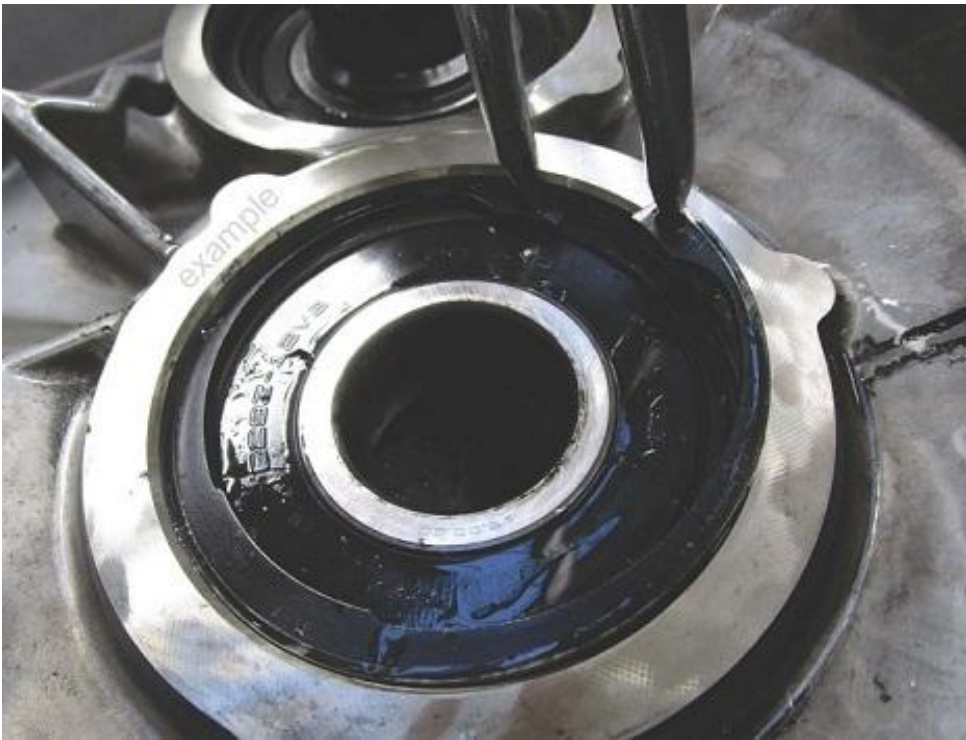
Figure 9. Removing the retaining ring (example).

- Remove the retaining ring for the outer ring (refer to Figure 9) of the bearing for the intermediate shaft. The retaining ring must not be damaged and will need to be used again during the repair procedure.

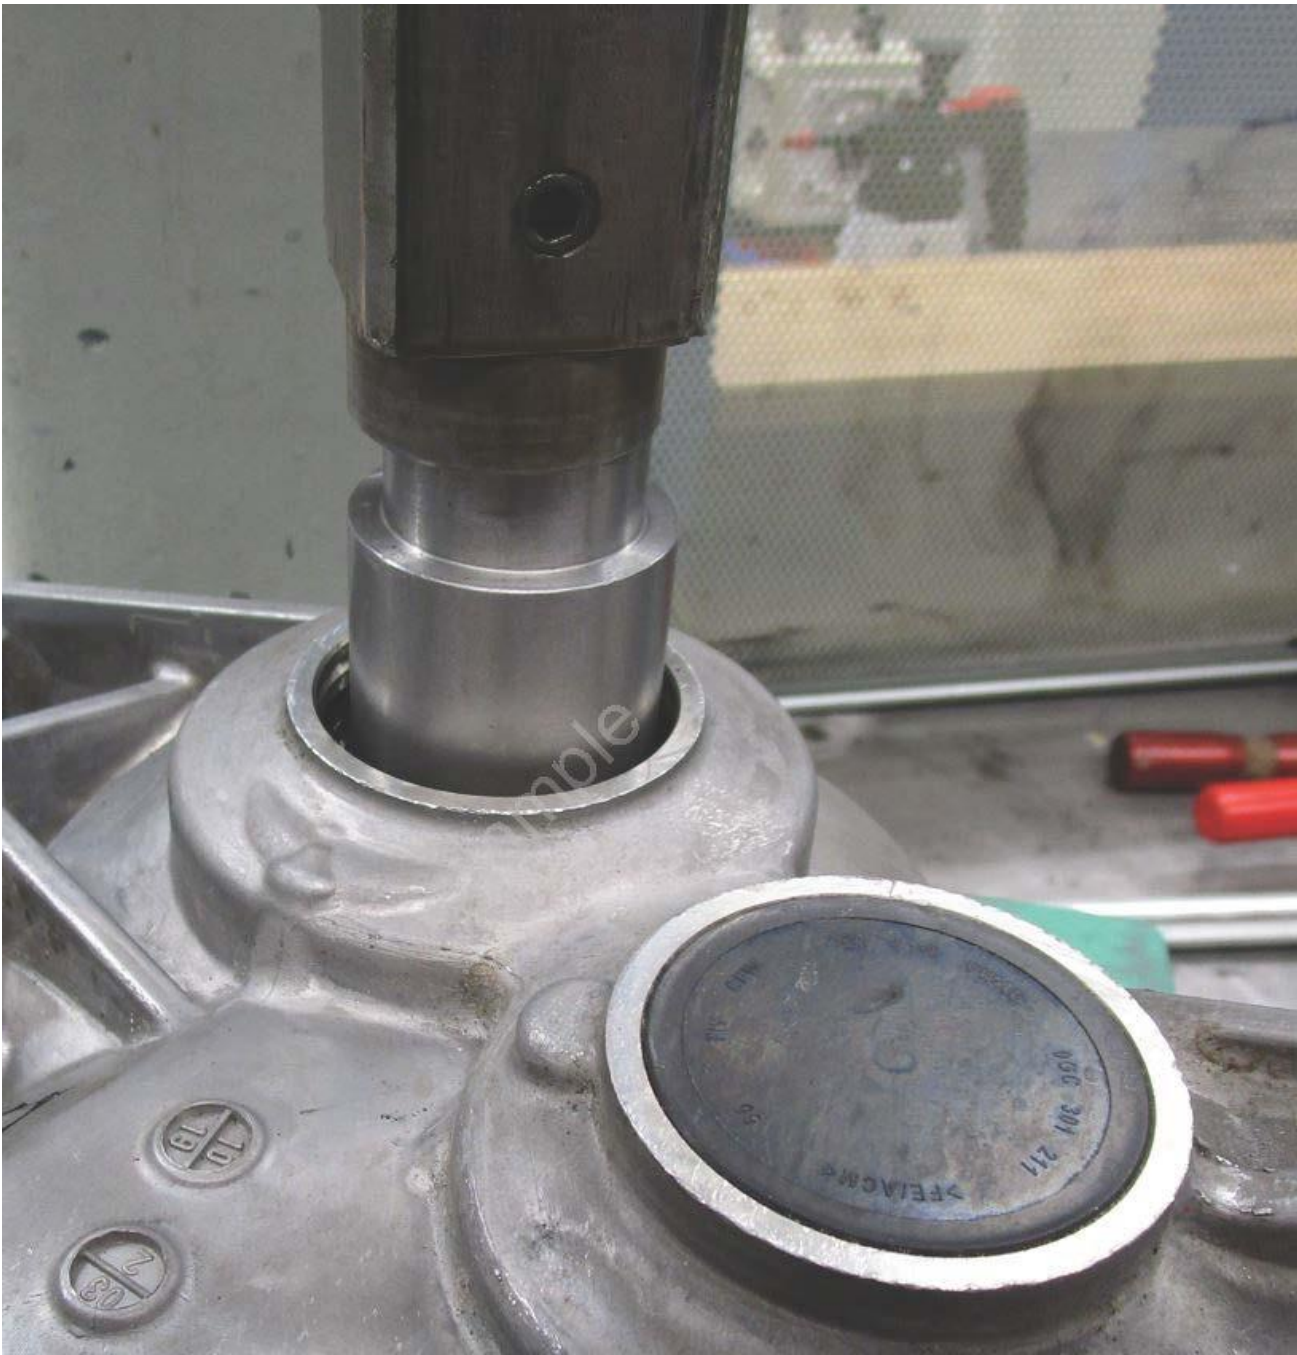
Figure 10. Pressing out the bearing for the intermediate shaft (example).

- Press the bearing for the intermediate shaft out, using the removing and installing tool -VW459/2- (refer to Figure 10).

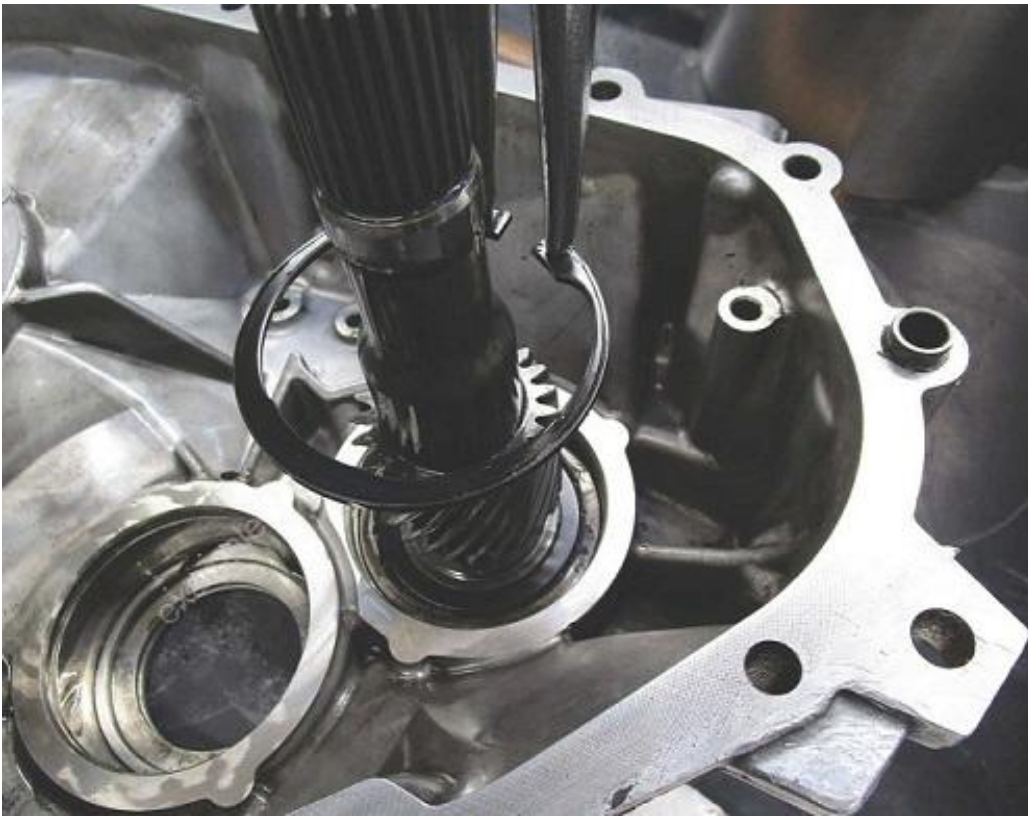
Figure 11. Removing the outer retaining ring for the drive shaft (example).

- Remove the outer retaining ring for the drive shaft (refer to Figure 11).

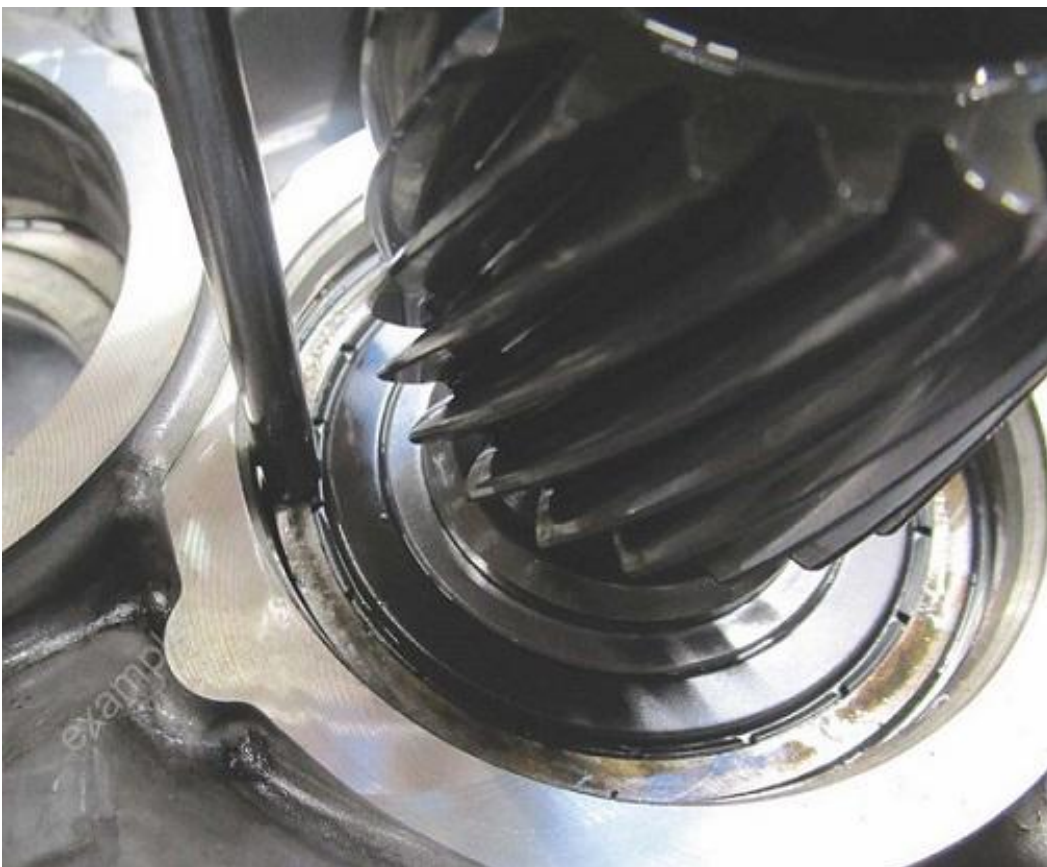
Figure 12. Driving the bearing for the drive shaft in deeper (example).

- Carefully drive the bearing for the drive shaft deeper into the gearbox housing using a commercially available drift and hammer at the outer ring of the bearing (refer to Figure 12).

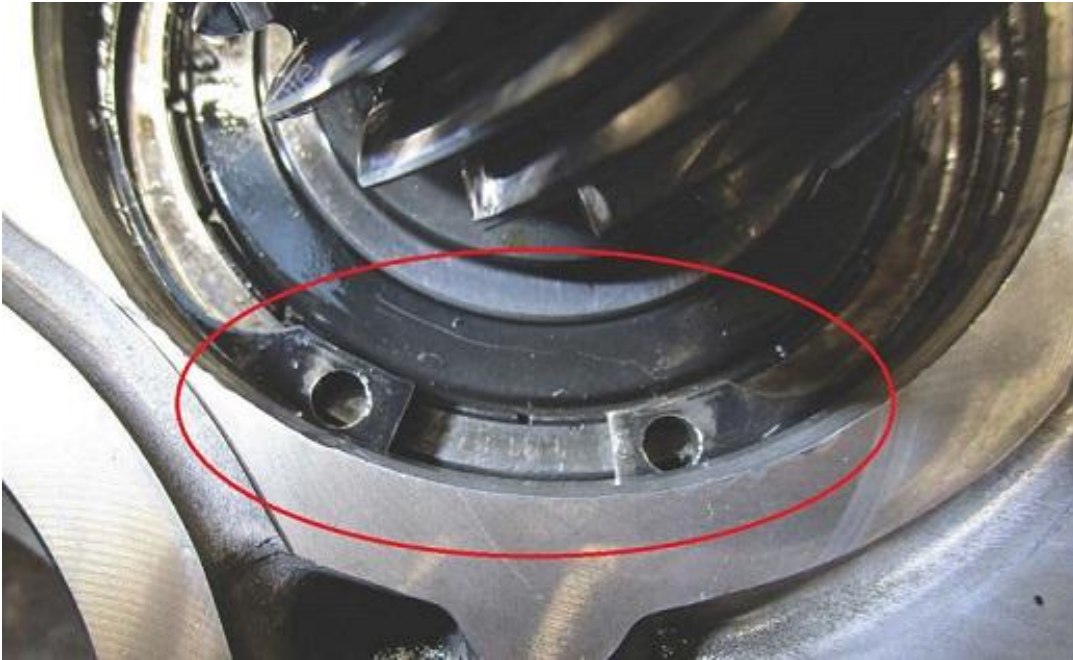
Figure 13. *The retaining ring has snapped fully into the groove (example).*

- Install the new retaining ring (with the maximum thickness/strength as described in parts information) as follows:
 - Install the new retaining ring (starting with the maximum thickness/strength). If the retaining ring does not fit in the groove, try to insert the next thinnest retaining ring.
 - Continue in this way as necessary until a retaining ring of the correct size can be installed.

The new retaining ring must snap fully into the groove (refer to Figure 13, red oval).

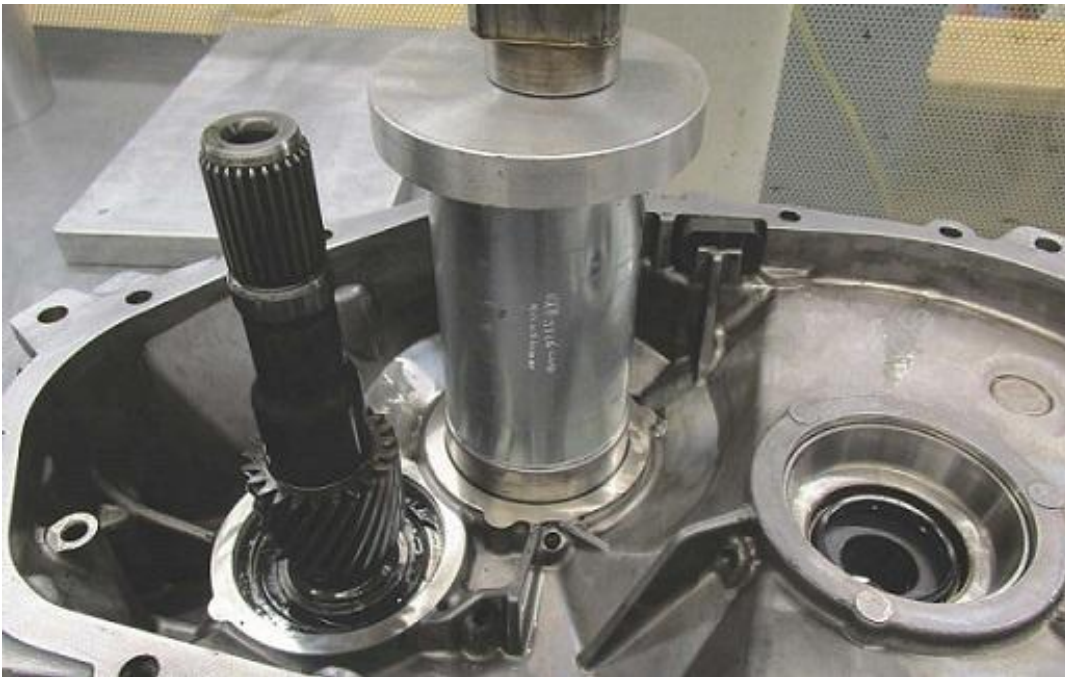
Figure 14. Pressing in the new bearing for the intermediate shaft with tube -3146-.

- Press the new bearing for the intermediate shaft (as described in parts information) into the gearbox housing with tube -3146- (refer to Figure 14).

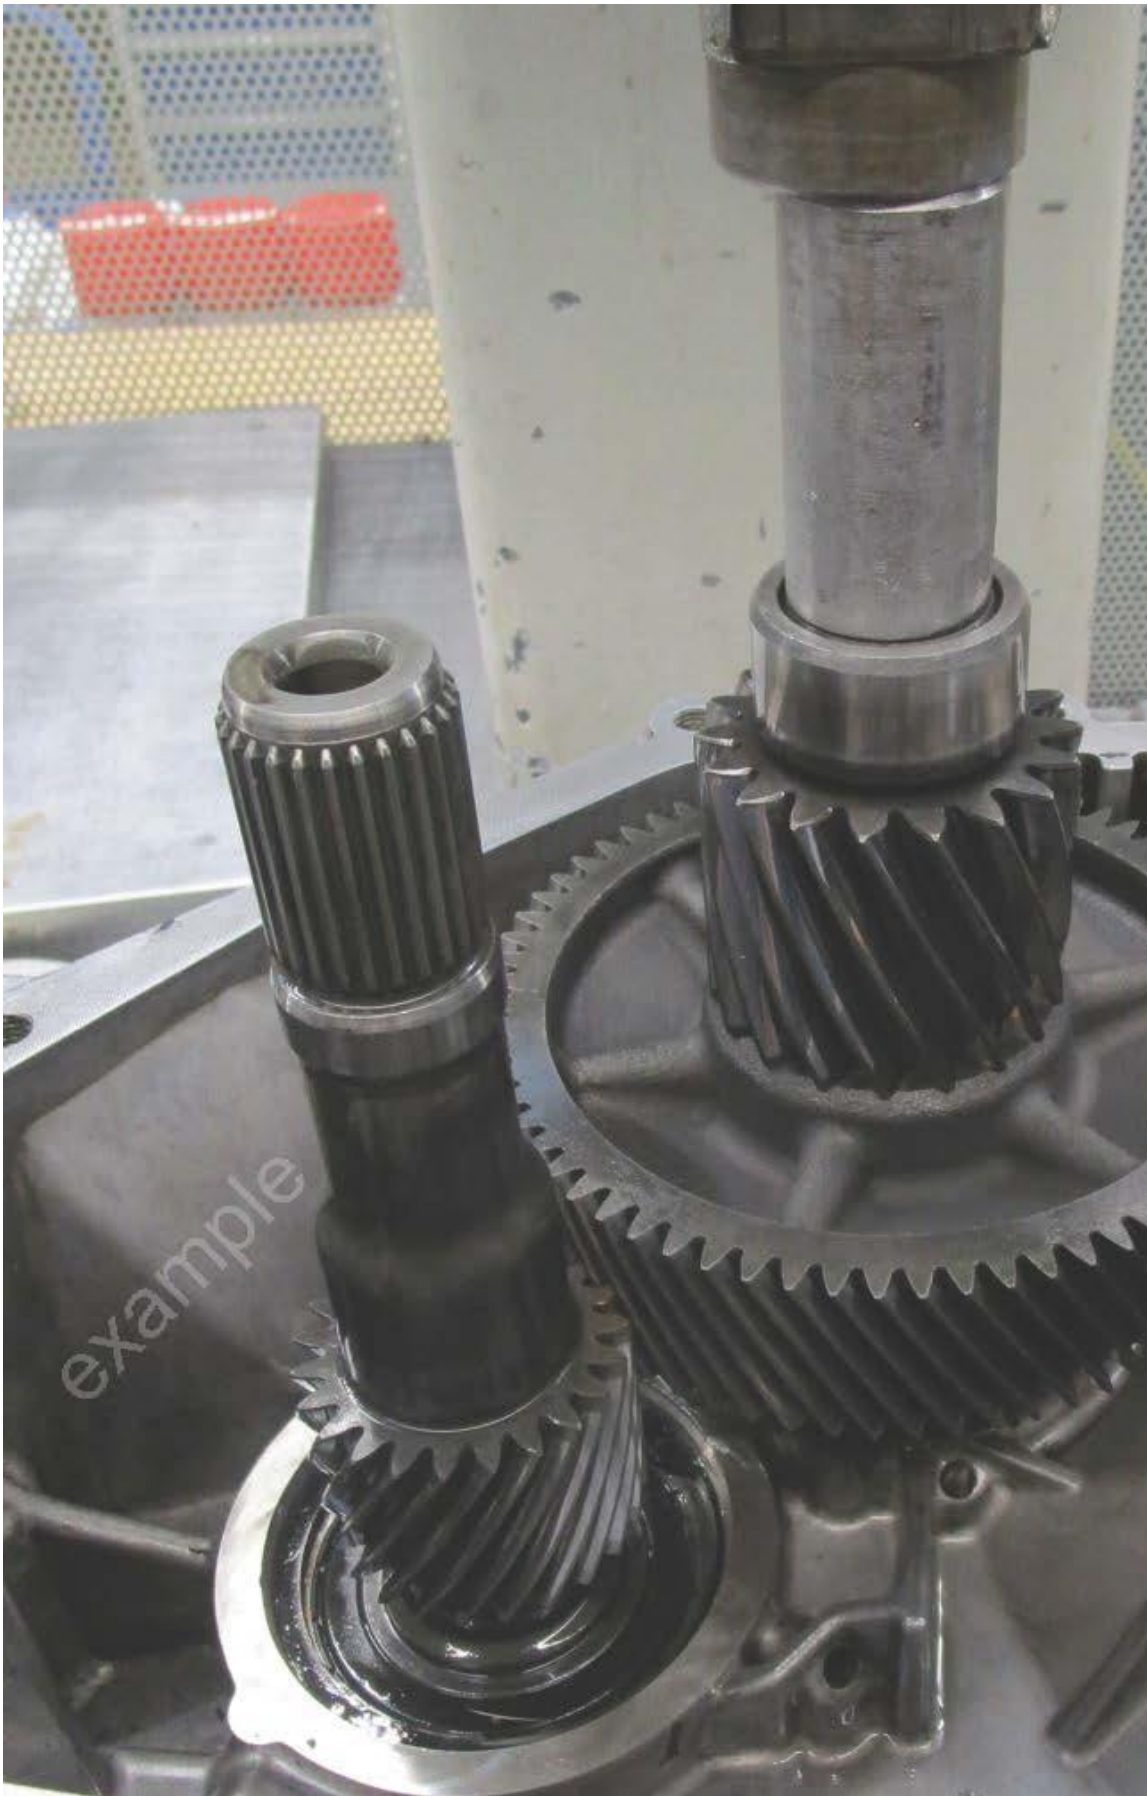
Figure 15. Pressing in the intermediate shaft with the removing and installing tool - VW459/2- (example).

- Re-install the retaining ring for the outer ring of the bearing for the intermediate shaft.
- Press the intermediate shaft in using the removing and installing tool -VW459/2- (refer to Figure 15); at the same time, support the inner ring with the thrust piece -VW454- (refer to Figure 16).

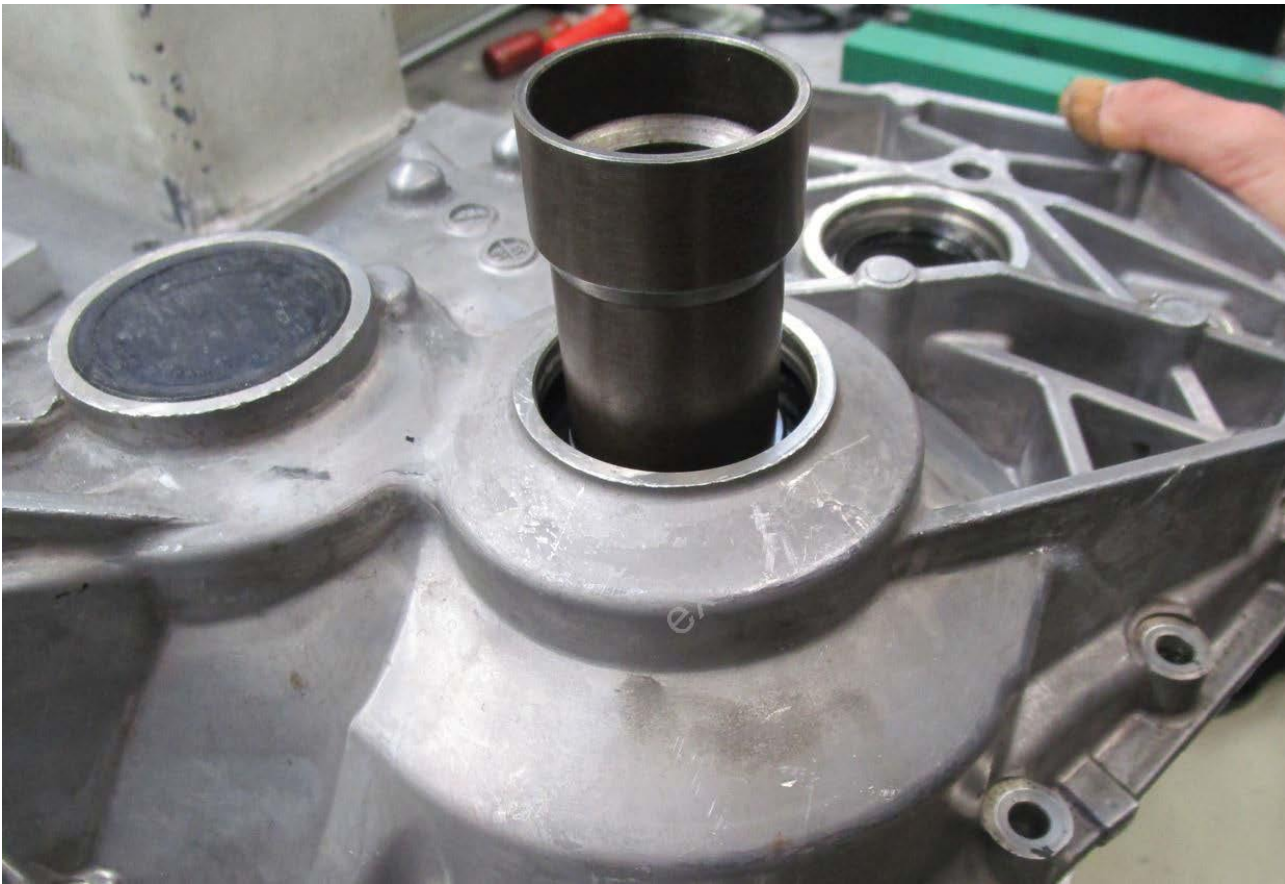
Figure 16. Supporting the inner ring with the thrust piece -VW454- (example).

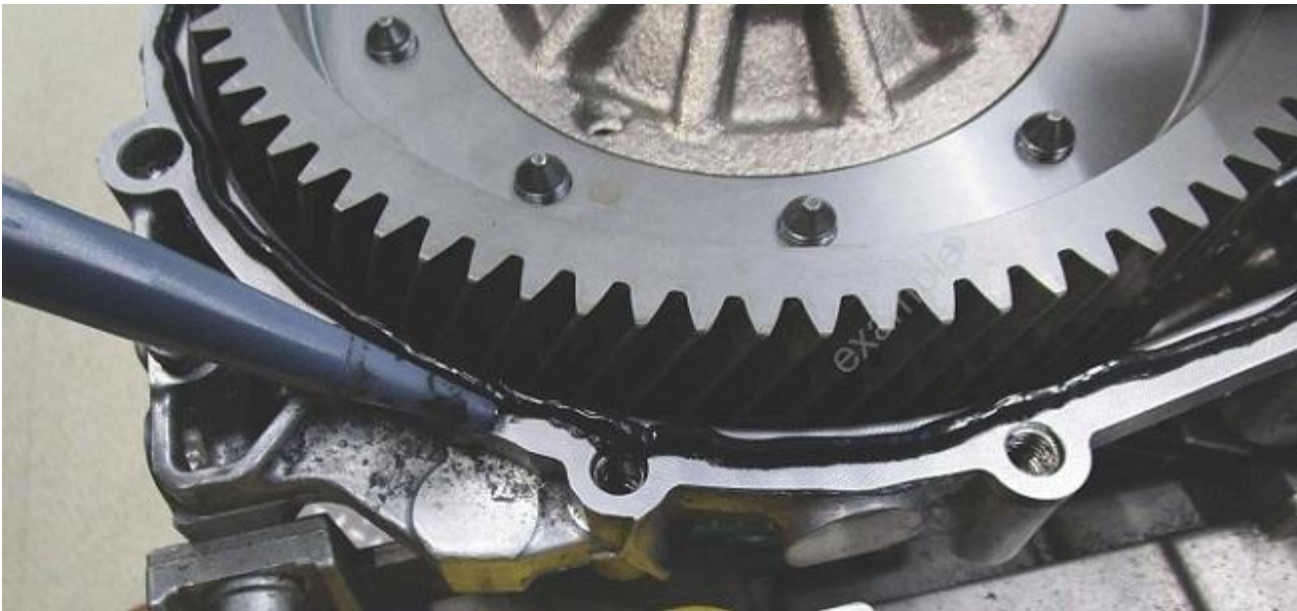
Figure 17. Applying silicone sealant all around the sealing surface of the intermediate housing (example).

- Allow flash-off time of 10 minutes for the sealing surfaces.
- Apply silicone sealant (part number: D 176 501 A1) all around the sealing surface of the intermediate housing (refer to Figure 17).

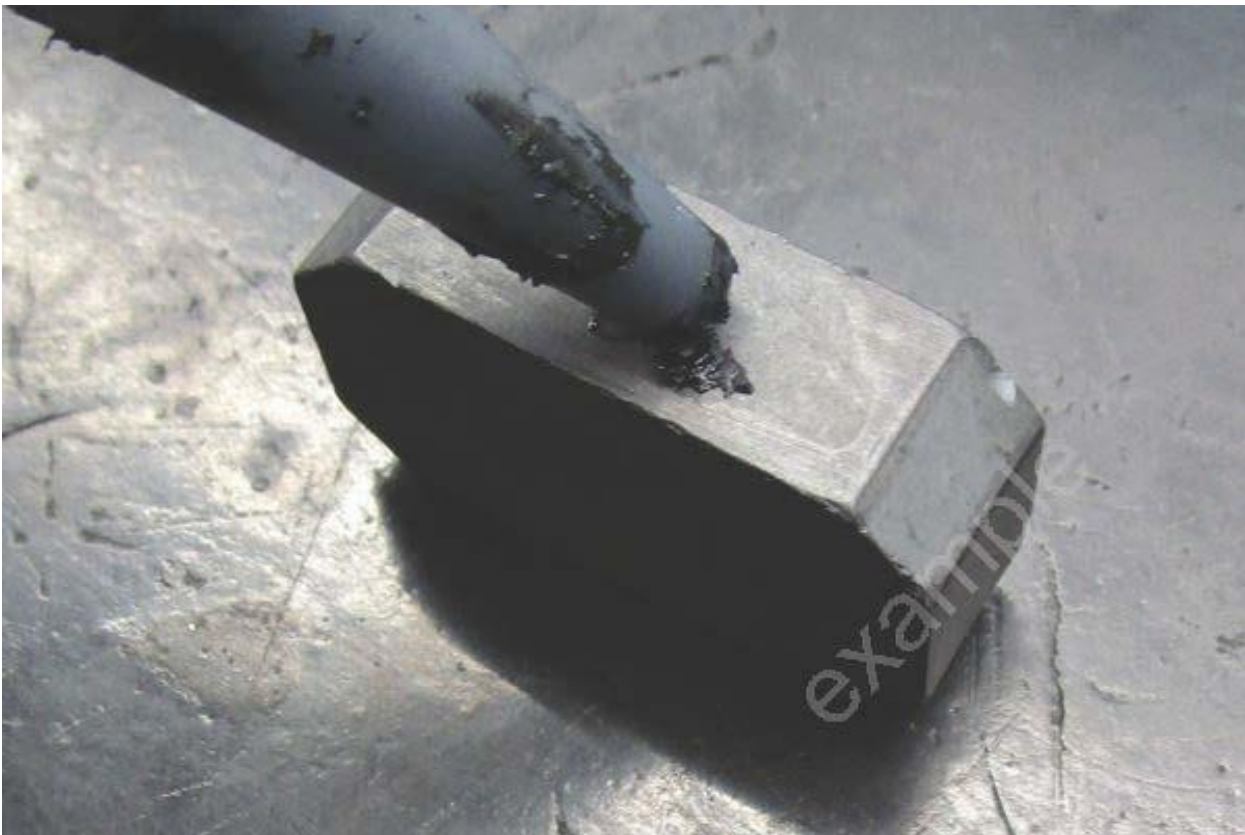
Figure 18. Magnet with silicone sealant (example).

- Bond the previously removed magnet (refer to Figure 18) into the gearbox housing using silicone sealant (part number: D 176 501 A1).

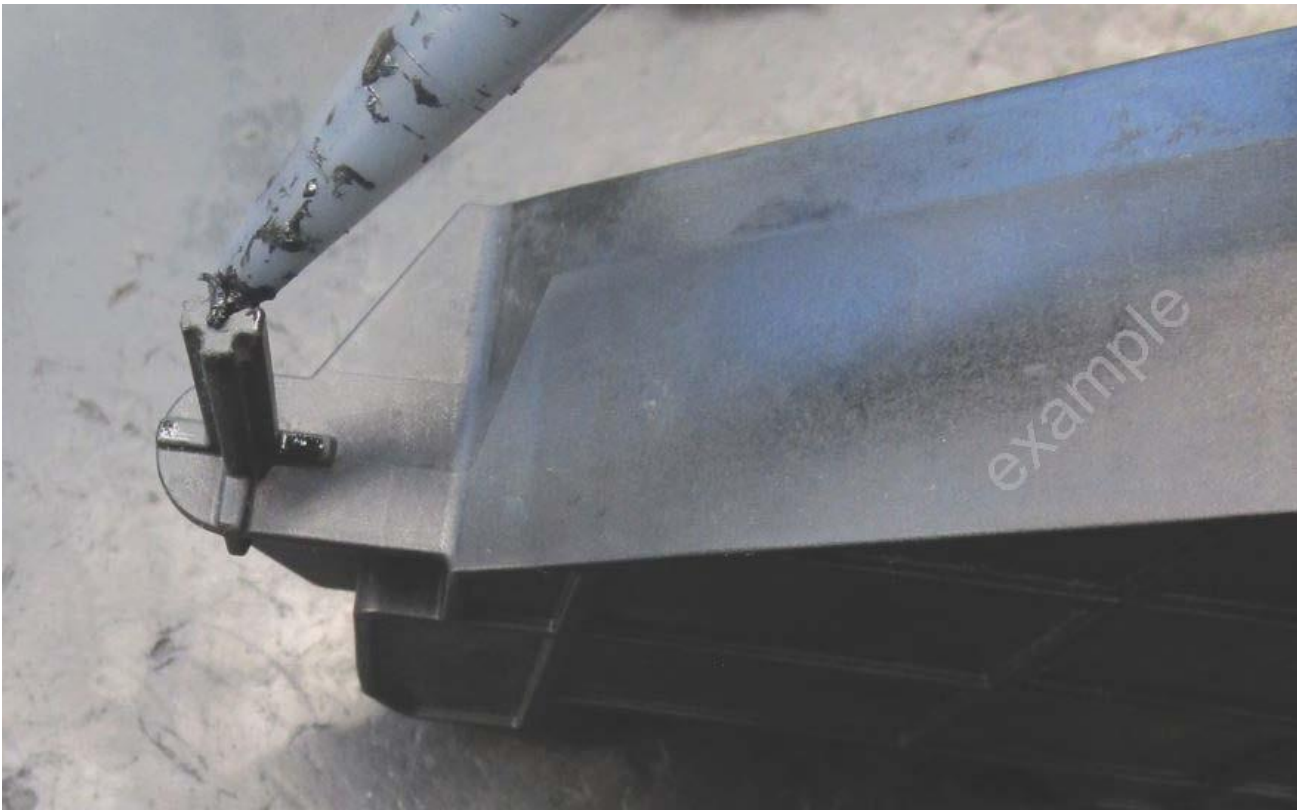
Figure 19. *Lightly applying silicone sealant to the attachment point (example).*

- Lightly apply silicone sealant (part number: D 176 501 A1) to the previously removed oil reservoir at 3 attachment points (refer to Figures 19 and 20).

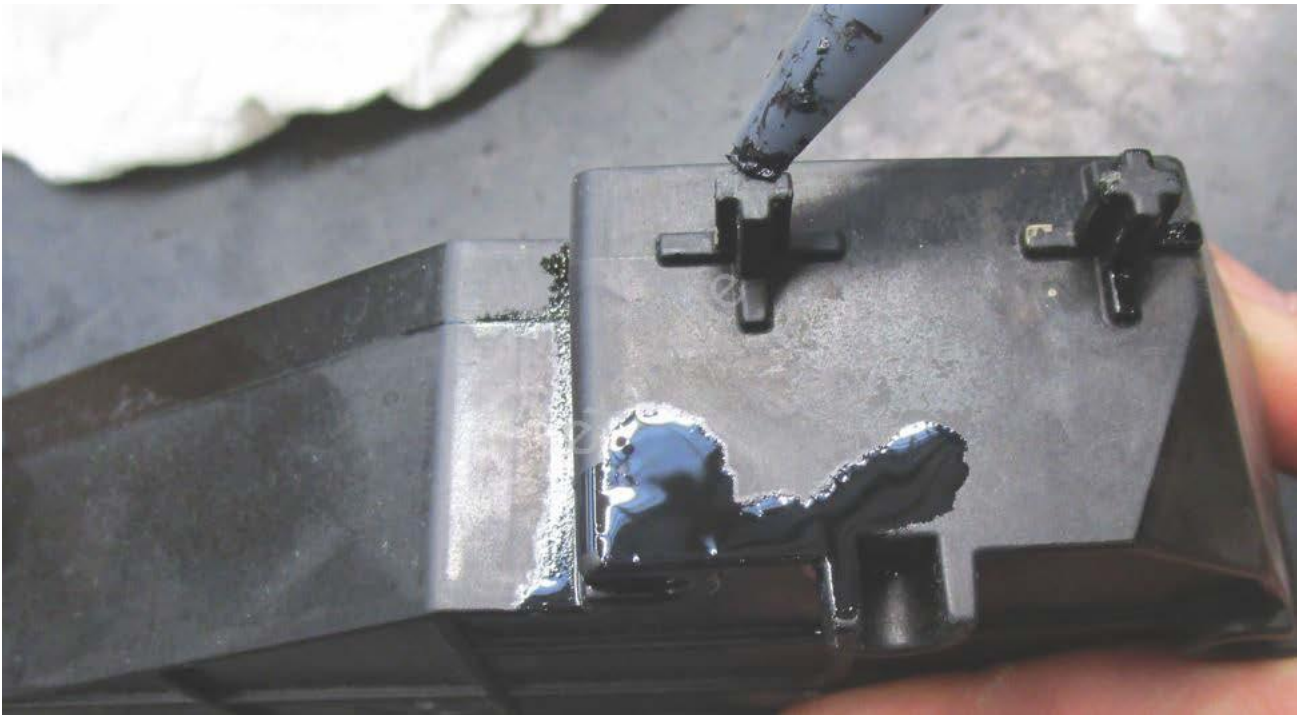
Figure 20. *Lightly applying silicone sealant to the attachment point (example).*

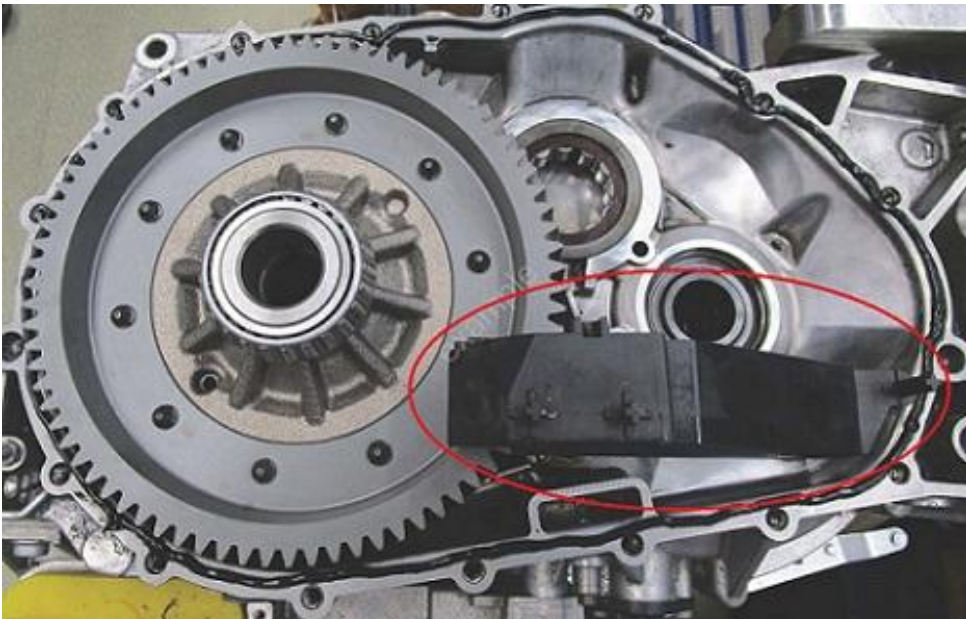
Figure 21. Oil reservoir fitted in the intermediate housing.

- Fit the oil reservoir (refer to Figure 21, red oval) in the intermediate housing.

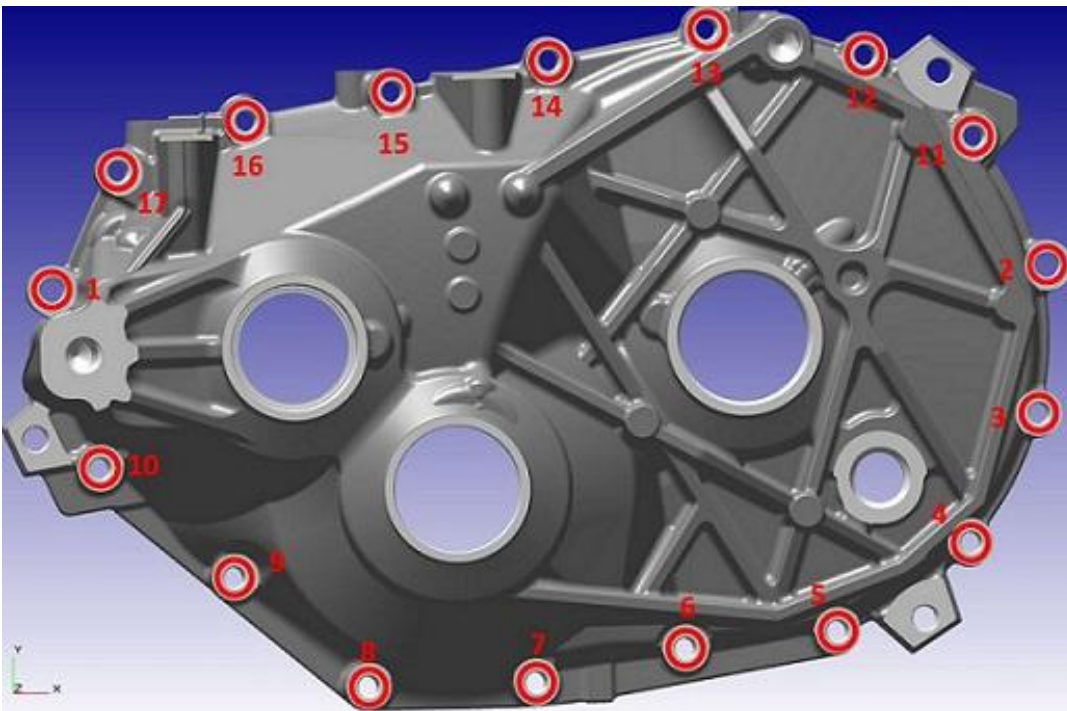
Figure 22. Installing the multi-point socket head bolts; tightening torque 20 Nm + 90°.

- Place the gearbox housing on the intermediate housing.
- Install the gearbox housing by screwing in the new multi-point socket head bolts in the sequence 1 to 17 (refer to Figure 22); **tightening torque: 20 Nm + 90°**.
