## Technical Service Bulletin

| <b>Topic</b> | 93 Q6 e-tron: charging cable is shown as being connected; U01E400 |
| <b>Brand</b> | Audi |
| <b>Transaction No.</b> | 2077962/2 |

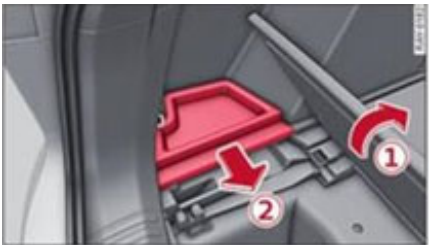
**Figure 1:** Fuse carrier installation location: luggage compartment on left, open cover.

Remove fuse F39 (activation of charging flap and charging socket no.1) or F43 (activation of charging flap and charging socket no.2) for at least 10 seconds. The fuse is located in the luggage compartment (see following images).

Reinsert the fuse in its position.

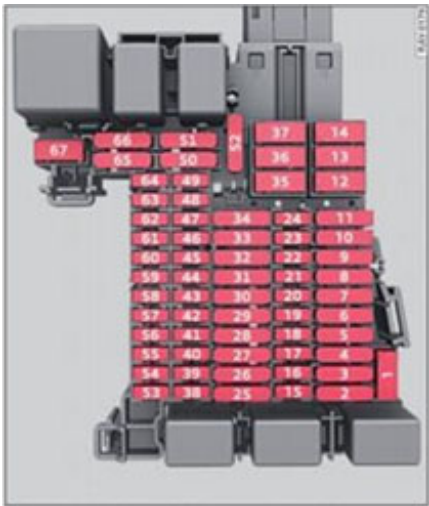
**Figure 2:** Fuse carrier.
