Technical Service Bulletin

Topic	91 MIB3 restarts by itself or fails
Market area	United States 444 Volkswagen of America, Inc. (6444)
Brand	Audi
Transaction No.	2078437/1
Level	EH
Status	Released for publishing
Release date	Jul 1, 2025

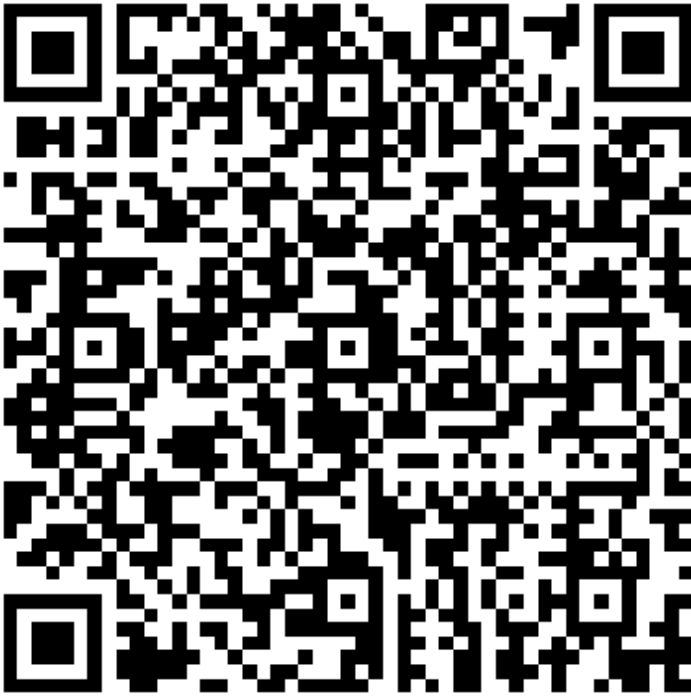
IMPORTANT: For the new software update program, the following SVM code must be entered exactly, including commas and without spaces (recommendation: scan QR code with hand-held scanner or copy and paste the SVM code chain).

FLIGHTON0075MLB,TGU1MDMVB,CL35A001MLBNAR,ZGDOIP,CL35A002MLBNAR,CL35A003MLBNAR,FLIGHTOFF0075MLB
