Technical Service Bulletin

Topic	63 Connection between bumper cover and wing above headlight has come loose
Market area	United States 444 Volkswagen of America, Inc. (6444)
Brand	Audi
Transaction No.	2078653/1
Level	EH
Status	Released for publishing
Release date	Jul 21, 2025

Audi A6 e-tron

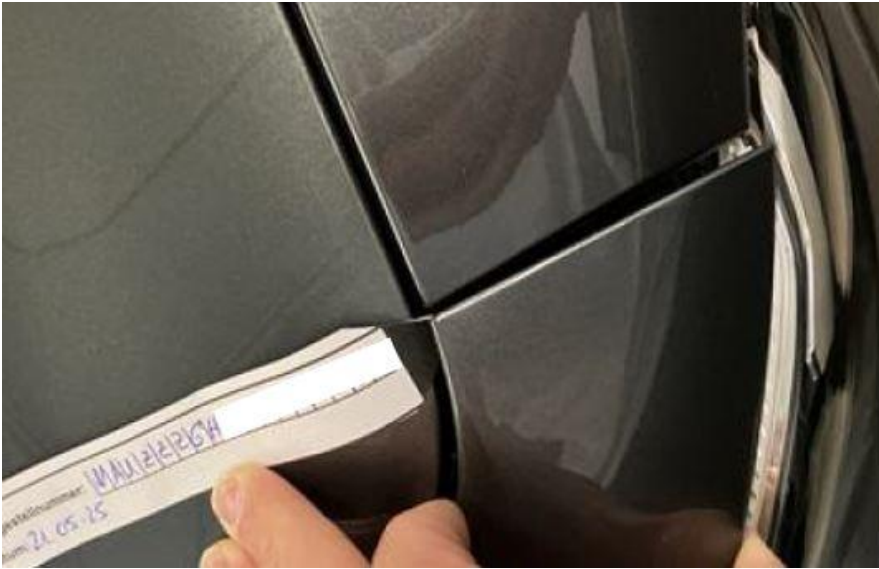
- The bumper cover protrudes past the wing. The front bumper has come loose at the connection to the wing above the headlight (Figure 1).

Figure 1. Example of the bumper cover protruding past the wing.

- The connecting clip that secures the front bumper cover to the wing above the headlight is not engaged correctly.

A securing strip is used to connect the bumper cover to the wing above the headlight. If this strip is not fully engaged in the bumper cover, the bumper cover may come loose from the wing.

Replace the securing strip on the affected side.

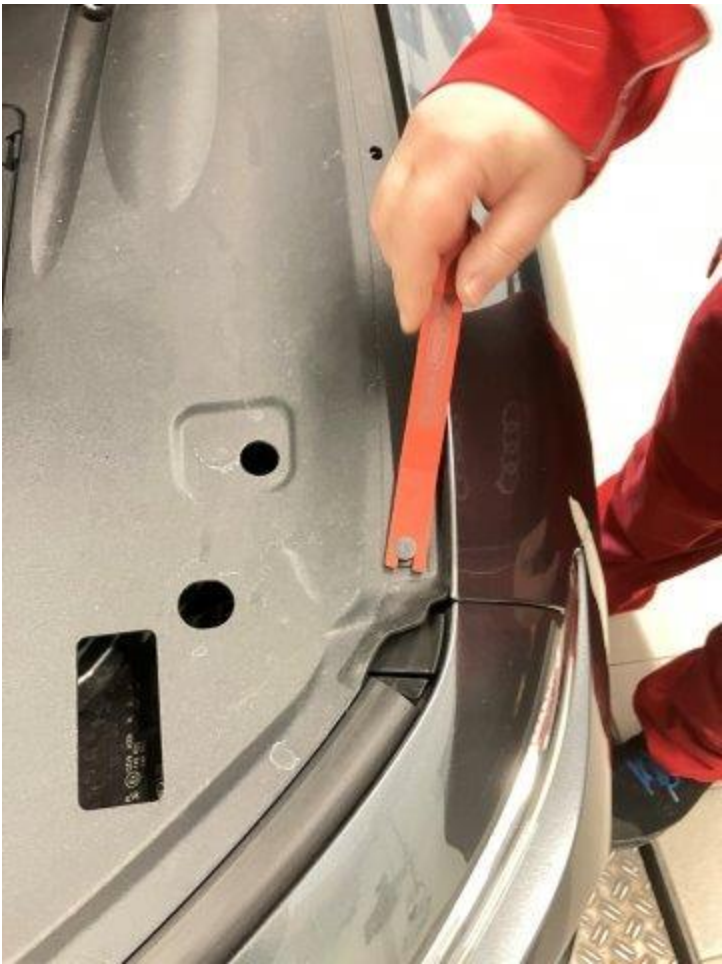
Figure 2. *Loosening the inner trim.*

To do this, loosen the trim at the front (refer to figure 2).

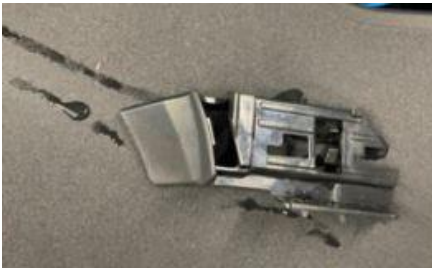
Figure 3. *New securing strip.*

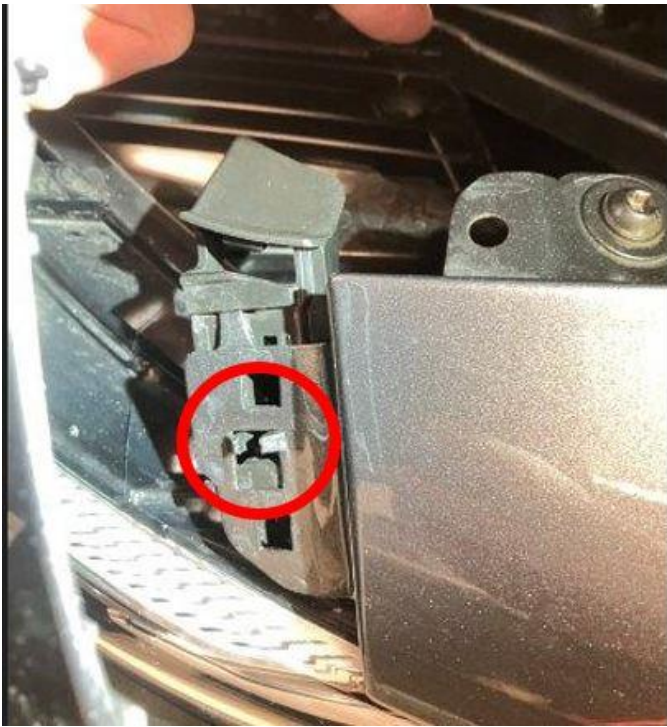
Figure 4. Image shows the clipped-in securing strip.

When attaching the new securing strip, ensure that it is fully clipped onto the wing.

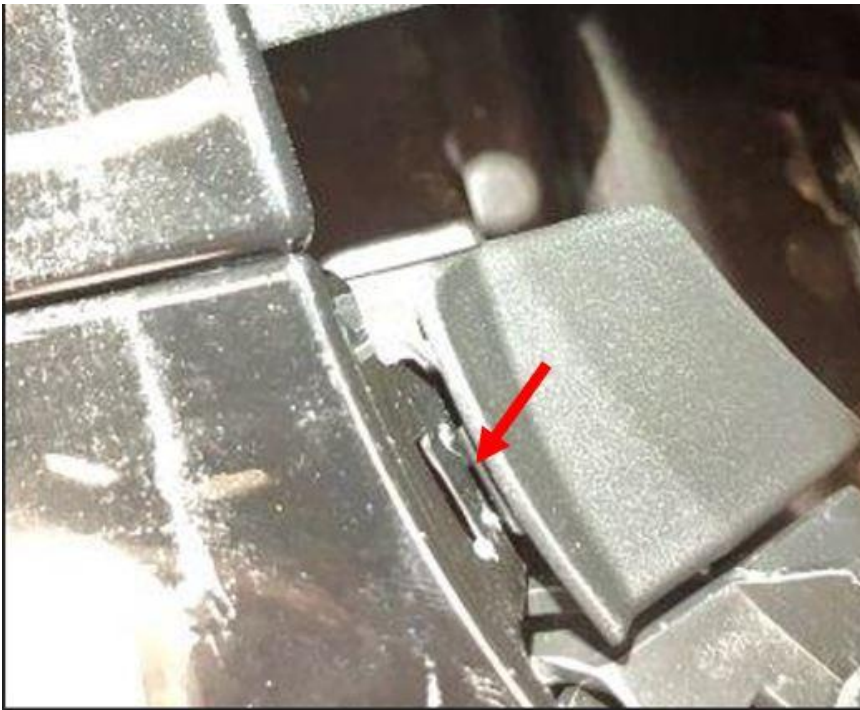
Figure 5. Image shows the area where the securing strip is clipped to the bumper cover.

Press the bumper cover onto the wing bracket and engage the securing strip. Ensure that the securing strip is fully clipped into the bumper cover.

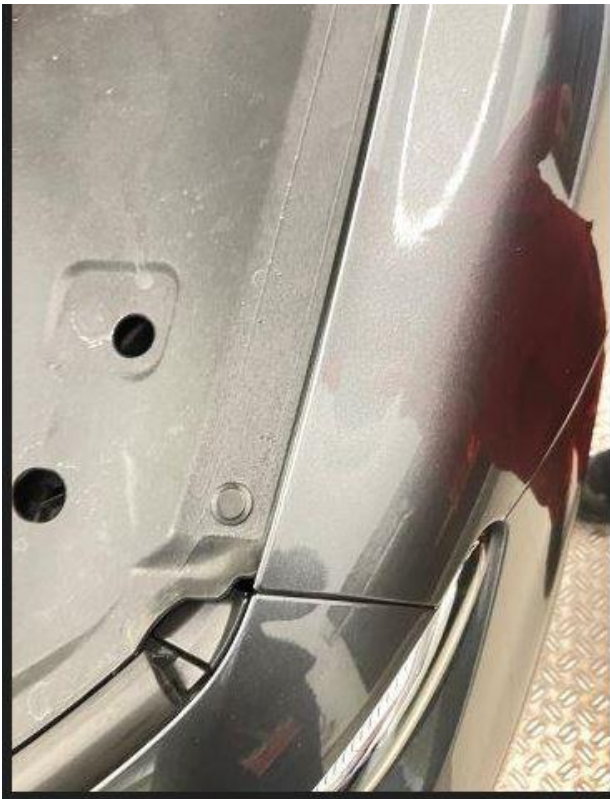
Figure 6. Image shows the area after the measure has been performed.

Fit the trim at the front.
