Technical Service Bulletin

Transaction No.: **2078803/1**

96 Driver assist systems: side assist issues warnings for no reason - A5

Release date: Jul 31, 2025

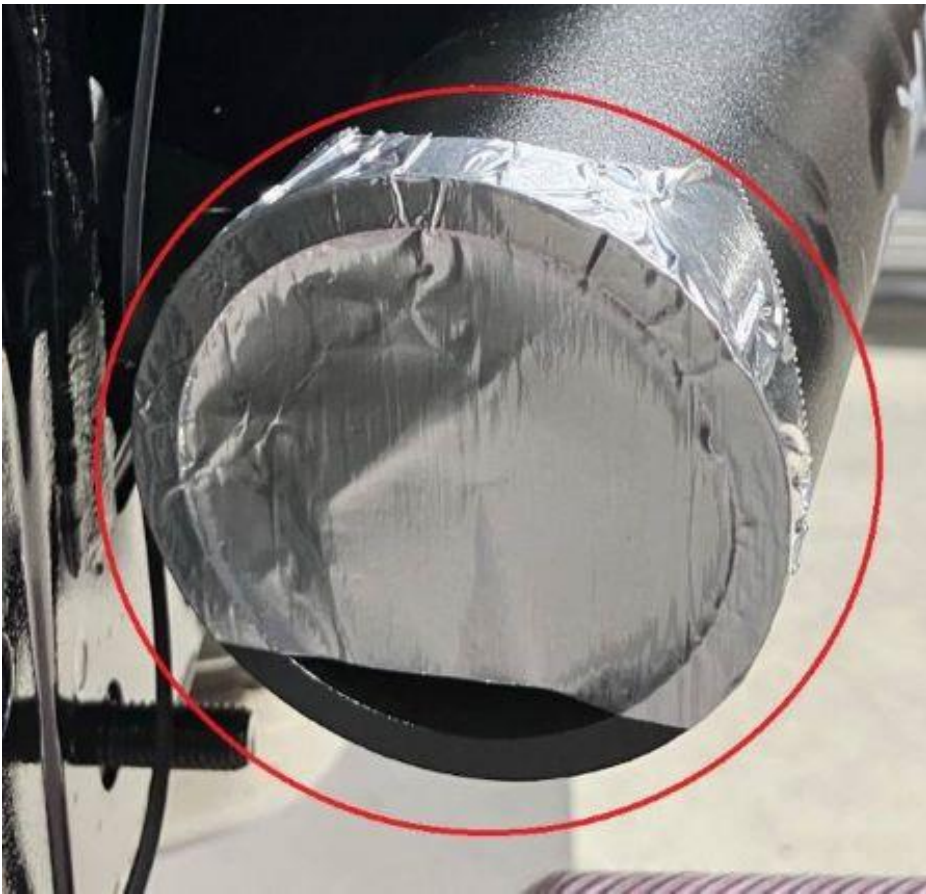
Reflections in the bumper carrier.

Figure 1. Left side of vehicle with towing bracket, bumper carrier opening sealed off with aluminum adhesive tape.

Close off the openings on both sides of the bumper carrier. Please use aluminum adhesive tape to do this.

When attaching the aluminum adhesive tape, please ensure that there is a small drainage opening at the bottom so that water can drain.

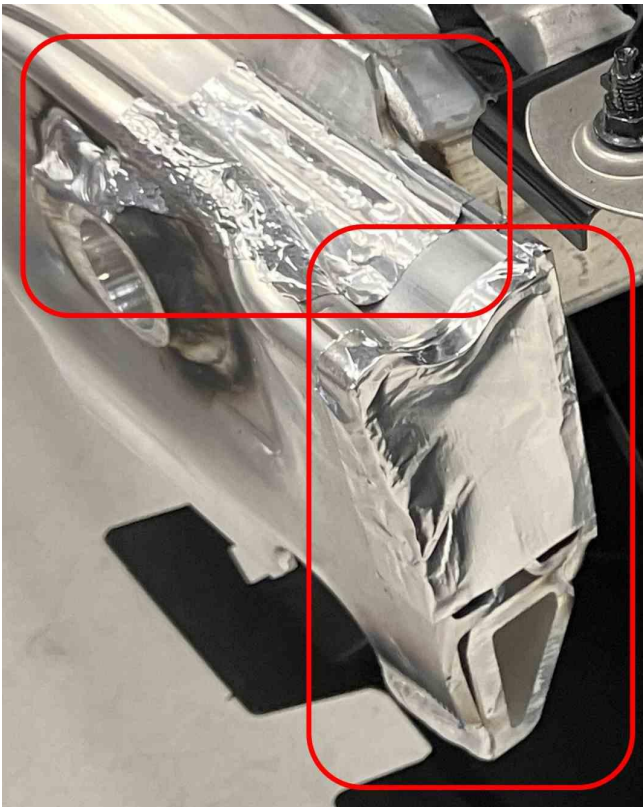
Figure 2. Right side of vehicle without towing bracket, bumper carrier opening (on the side and top) sealed off with aluminum adhesive tape.

For the version without a towing bracket, please also seal off the openings on the top of the bumper carrier (see figures 2 and 3).

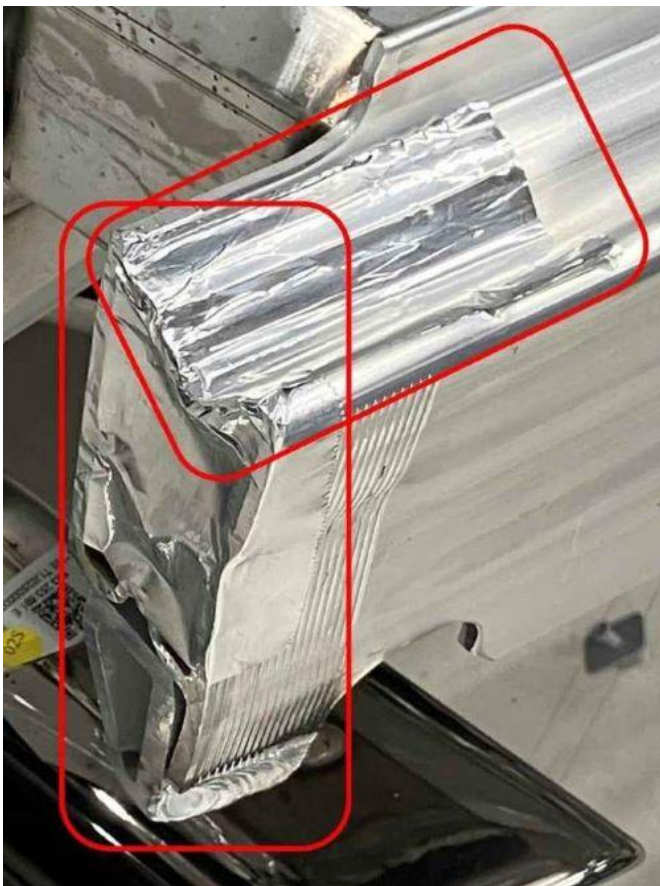
Figure 3. Left side of vehicle without towing bracket, bumper carrier openings (on the side and top) sealed off with aluminum adhesive tape.
