INSTRUCTION TO SERVICE

ITS-61325		JUNE 2, 2025
SECTION:	600-CUSTOMER OPTIONS	
SUBJECT:	Flashing Brigade 360 Camera ECU using SD card	
ISSUE:	Brigade 360 Camera Generation 3 system does not have the correct MCI updates for the toggle switch operation.	
SUMMARY:	<ul style="list-style-type: none">- Locate the Brigade 360 ECU.- Load the configuration onto an SD Card.- Connect the Calibration Tool to the ECU.- Insert the SD Card into the Calibration Tool.- Wait for the system to finish updating.- Remove the SD Card.- Validate no defects on 360 view.

ITS-61325

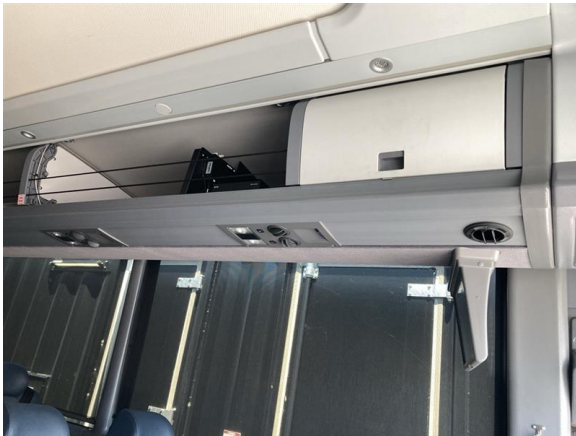
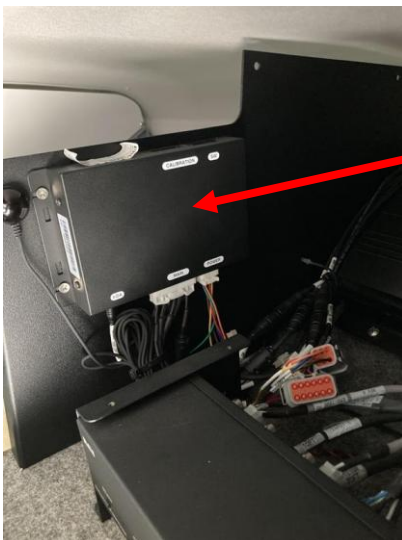
Brigade 360 Camera ECU

2. In the Street-Side Parcel rack, locate the black divider panel by the REI amplifier. This should be where the 360 camera ECU is located.

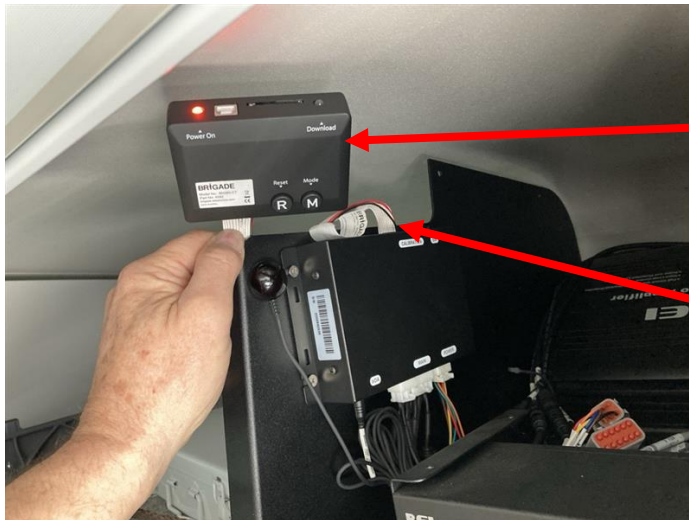
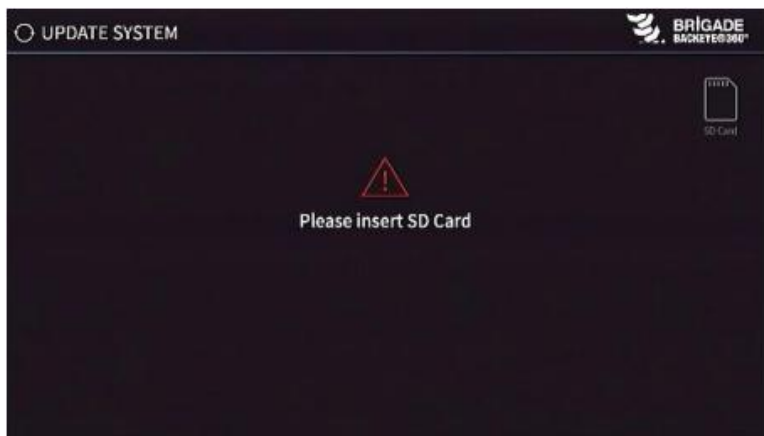
Plug the calibration tool in here

3. Insert the Calibration Tool into the BN360-300-ECU and apply power to the system. The "UPDATE SYSTEM" screen should be displayed on the Instrument Panel prompting the user to insert an SD card.

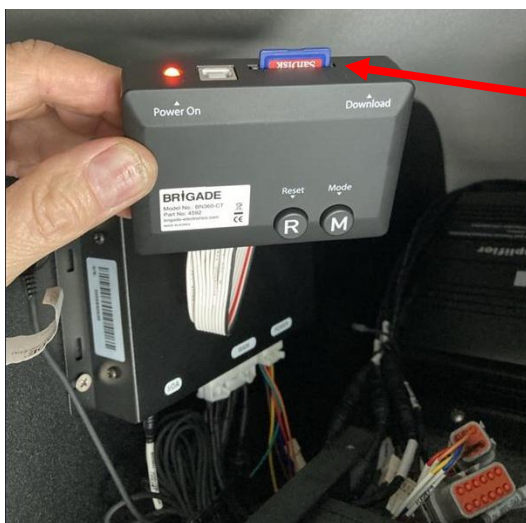
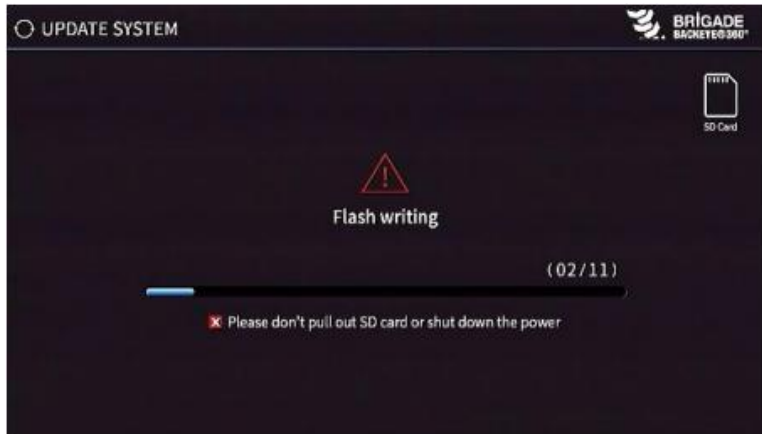
Insert the SD Card here

4. Insert the SD Card, the system will automatically begin the update process.

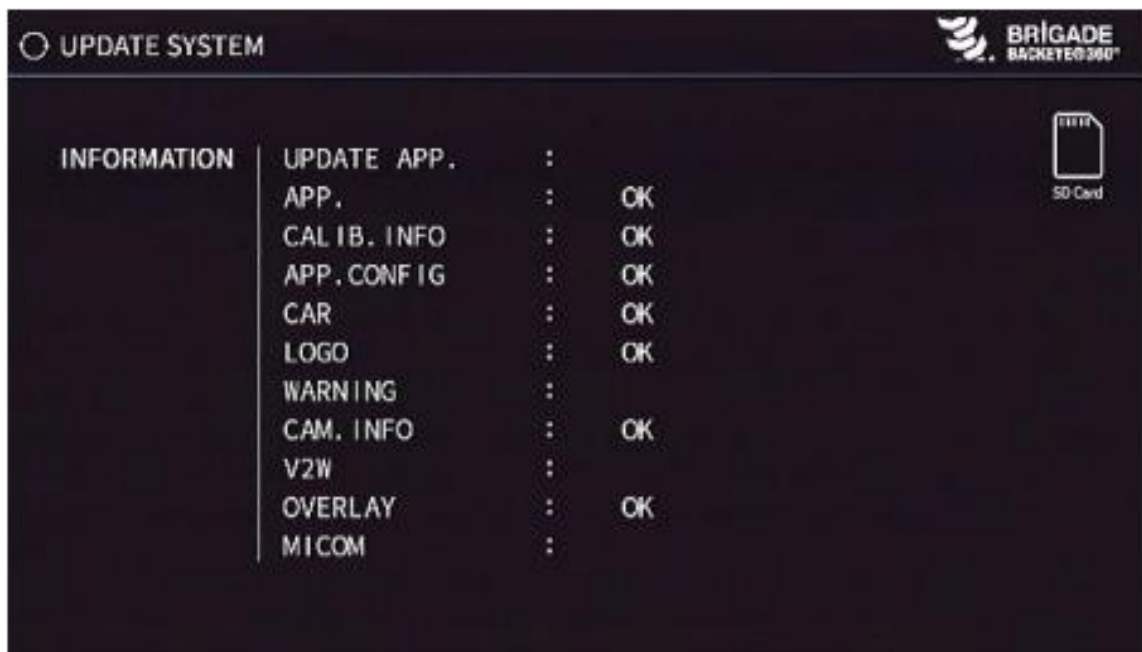
All items that have been updated will be displayed as “OK”. Some items such as “WARNING”, “LOGO” AND “MICOM” and “V2M” may not change so these will be blank.

5. Once the upload has been completed the following screen should show.

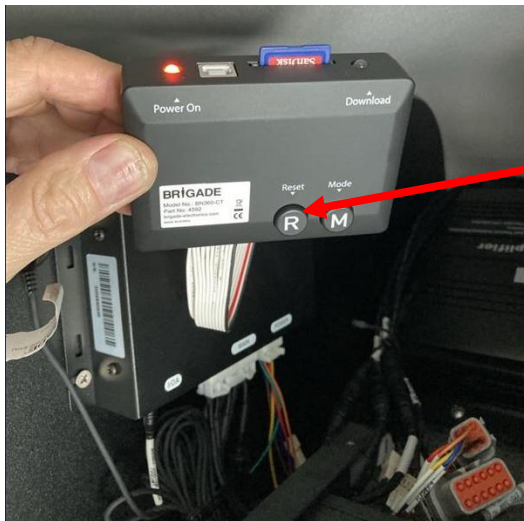
This is the "Reset" button.

6. Updating the ECU firmware is a two-stage process that requires a second upload to ensure all files are correctly updated. When the “INFORMATION” screen shows, do not eject the SD Card, press the “Reset” button on the Calibration Tool to repeat the calibration upload and wait for the update to complete a second time.

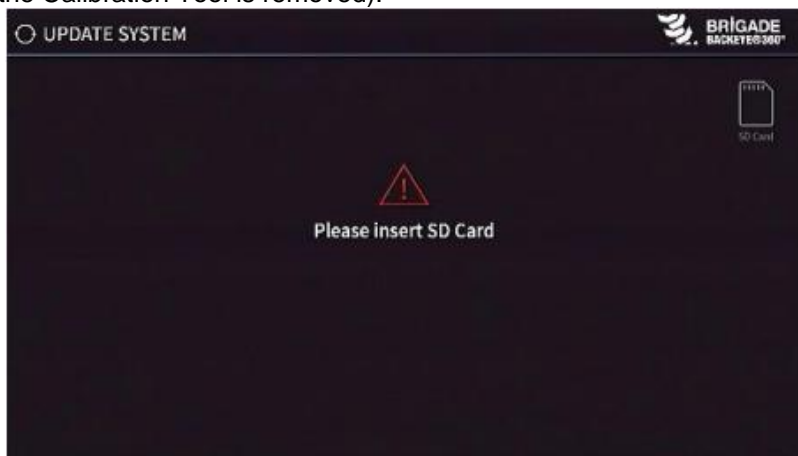
The system will automatically restart.

When the "INFORMATION" screen is displayed for a second time, eject the SD Card and wait for the "Please Insert SD Card" screen to appear before removing the Calibration Tool (the system can be left powered while the Calibration Tool is removed).
