**Technical Service Bulletin (TSB)**  
**Partial Rear Window Molding Detachment**

<b>REFERENCE:</b>	<b>TSB:</b> 23-024-25 REV. A <b>GROUP:</b> 23 - Body	<b>Date:</b>	August 1, 2028	<b>REVISION:</b>	23-024-25
<b>VEHICLES AFFECTED:</b>	<b>2024 (FG) FIAT 500e</b> This bulletin applies to vehicles built on or after January 15, 2024 (MDH 0115XX) and on or before September 03, 2024 (MDH 0903XX).			<b>MARKET APPLICABILITY:</b> <input checked="" type="checkbox"/> NA <input checked="" type="checkbox"/> MEA <input checked="" type="checkbox"/> SA <input type="checkbox"/> IAP <input checked="" type="checkbox"/> EE <input type="checkbox"/> CH  <b>NOTE:</b> This bulletin applies to the North America, South America, Middle East and Africa and Enlarged Europe markets.	
<b>CUSTOMER SYMPTOM:</b>	<b>Customers may experience the following:</b> <ul style="list-style-type: none"> <li>Noise/vibration from rear side window while driving.</li> </ul>				
<b>CAUSE:</b>	Rear window trim not fully sealed to the body at assembly

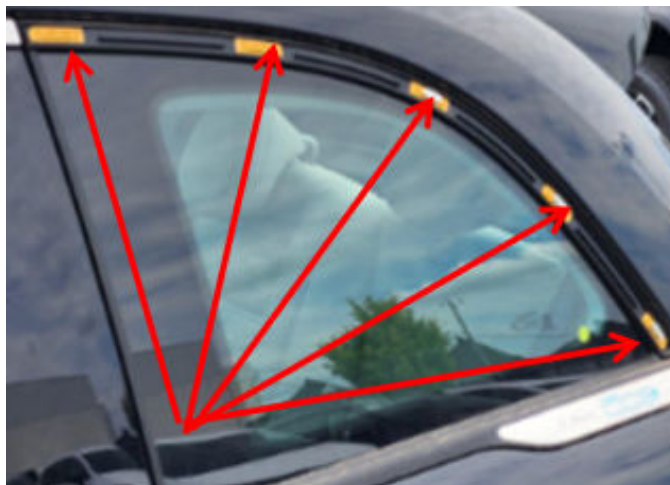
**Fig. 1**

Area On Trim Molding To Inspect

2. Using a feeler gauge with a measurement of 1.19 mm (3/64 in.) check the upper contact area of the molding with the rubber gasket gap at the clip points. The gap must be less than 1.19 mm (3/64 in.).

3. Does the gap exceed 1.19 mm (3/64 in.) or did the molding pull away from the mounting clips?
  - YES >>> Proceed to [Step 4](#).
  - NO >>> This bulletin does not apply. Use Inspection LOP (23-30-30-96). Perform further diagnostics.

1. Inspect for correct attachment of the molding by pushing on the clip position shown in [Fig. 1](#).

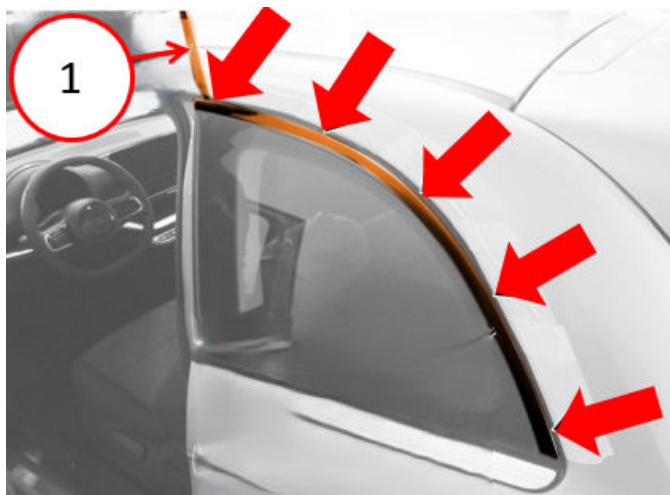
**Fig. 2**

Trim Stick Locations For Removal Of Trim

4. Open the front door.
5. Apply a double layer of paper tape to the body to protect the paint.
6. Using a trim stick, remove the trim from the seal clips and retaining clips then remove and discard the trim [Fig. 2](#).

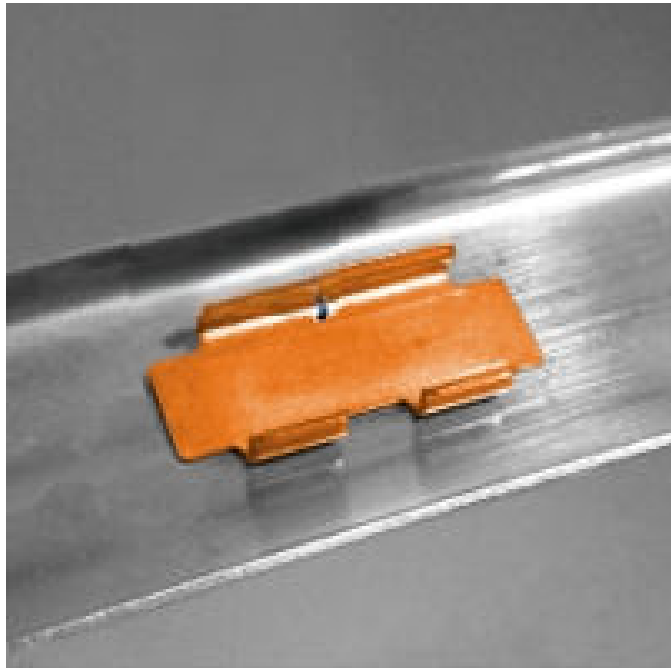
**Fig. 3**  
Retaining Clip

7. Check that the retaining clips and the seal clips are not damaged [Fig. 3](#) and [Fig. 4](#).

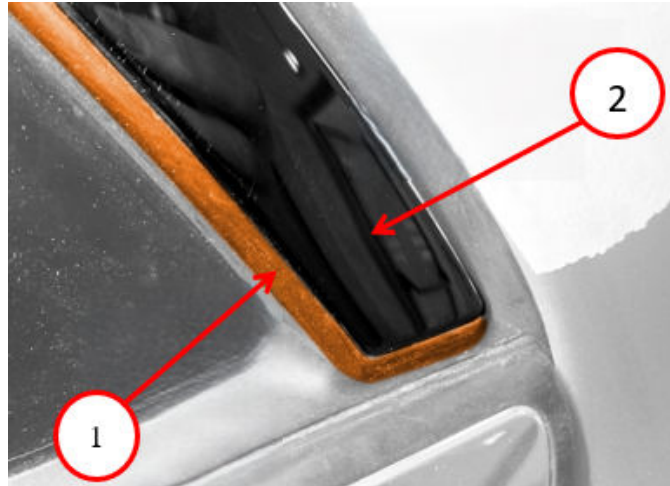
**Fig. 7**  
Trim Installed

1 - Lower Lip Of The Seal  
2 - Trim

**NOTE:** Ensure the lower lip of the seal has not been pinched by the trim and remains positioned outside the trim **Fig. 7**.
