| REFERENCE: | TSB: 18-011-25 REV. B GROUP: 18 - Vehicle Performance | Date: | August 1, 2025 | REVISION: | 18-011-25 REV. A |
| VEHICLES AFFECTED: | 2024 (JL) Jeep Wrangler This bulletin applies to vehicles equipped with a 2.0L I4 DOHC DI Turbo Engine W/ESS (Sales Code EC1). | | | MARKET APPLICABILITY: <input checked="" type="checkbox"/> NA <input checked="" type="checkbox"/> MEA <input checked="" type="checkbox"/> SA <input checked="" type="checkbox"/> IAP <input checked="" type="checkbox"/> **EE** <input type="checkbox"/> CH NOTE: This bulletin applies to the **Enlarged Europe** North America, South America, India & Asia Pacific, Middle East and Africa and China markets. | |
| CAUSE: | PCM software | | | | |

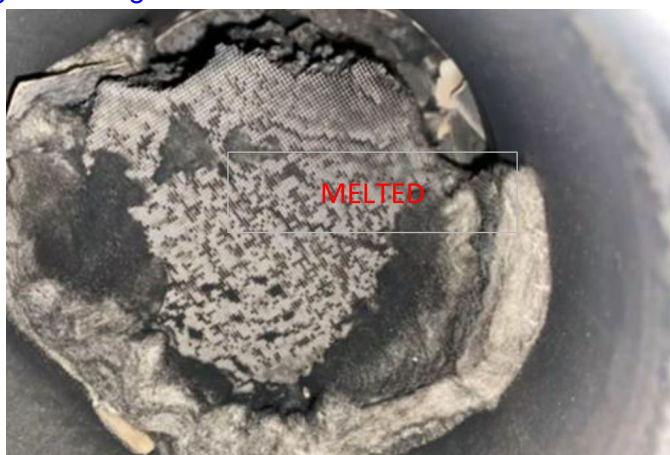
10. Remove the Upstream Oxygen Sensor and using a borescope, is the catalytic converter internally melted/ cracked or brain pattern [Fig. 3](#) and [Fig. 4](#) ?

Fig. 3
Melted Catalyst

- YES >>> Replace the catalytic converter. Refer to the detailed service procedures listed in DealerCONNECT>Service Library>Service Info>under: 11 - Exhaust System / Converter, Catalytic / Removal and Installation. Use LOP (11-50-01-91). Proceed to [Step 11](#).
- NO >>> Use Inspect LOP (11-50-01-90). Proceed to [Step 11](#).
