## STAR ONLINE PUBLICATION

**Case Number:** S2508000058

**Symptom/Vehicle Issue:** Red Turtle Lamp Warning Indicator On, Drive-by-Brake Limp-in-Mode, Propulsion System

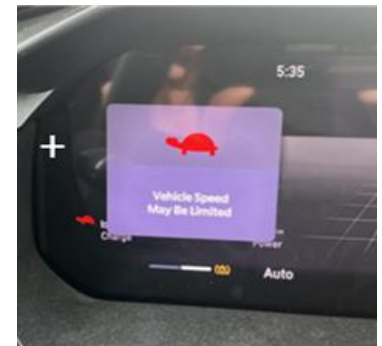
**Customer Complaint/Technician Observation:** The owner complains of a red turtle lamp warning indicator illuminated “Vehicle Speed May Be Limited” message on the cluster. The technician observed the vehicles Electric Vehicle Control Module (EVCU), and other modules may have set one or more of the following Diagnostic Trouble Codes (DTCs):

**Note:** If the vehicle entered the ‘Drive-by-Brake’ limp-home mode, a key cycle (especially a long key cycle that allows the modules to sleep) may allow the fault condition to reset and exit the limp-home mode.
