STAR ONLINE PUBLICATION

Case Number: S2508000048 Rev. A

Symptom/Vehicle Issue: Charging Status Lights Inoperable (No Illumination) at Charge Port, Vehicle Still Does Charge

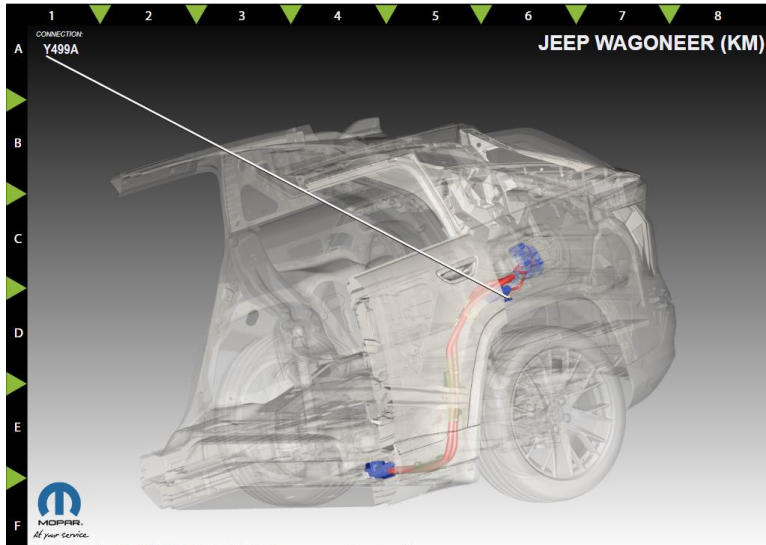
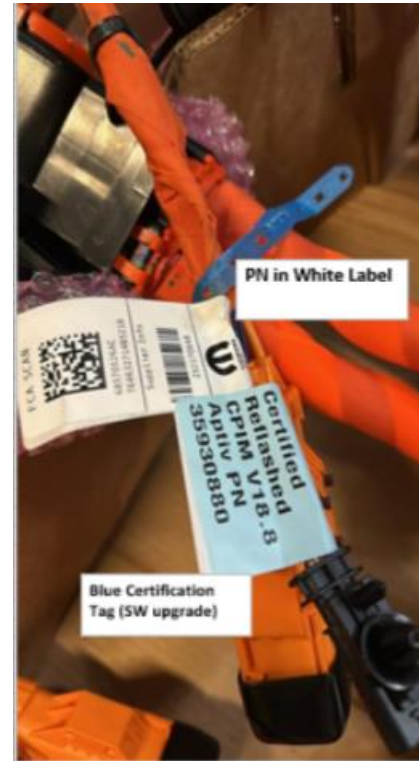
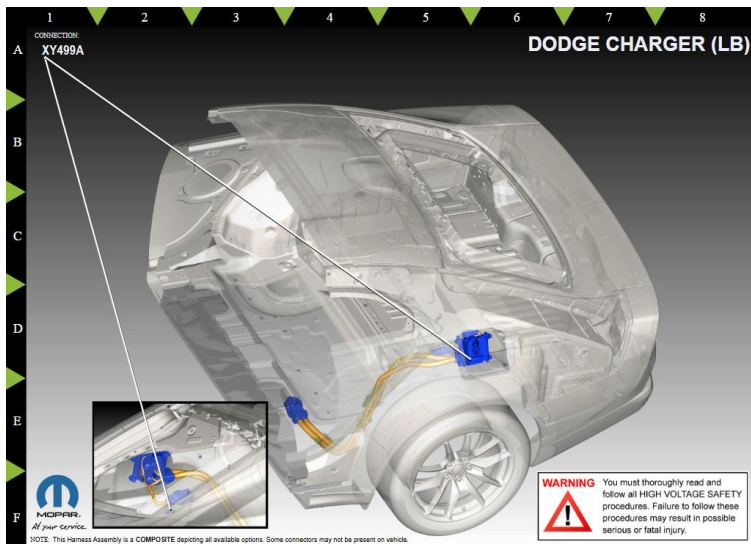
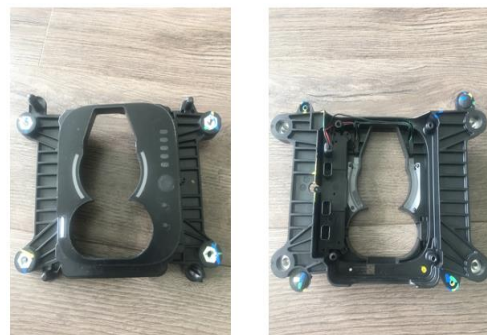
Pg 2

4. Follow High Voltage (HV) safety procedures when accessing Charge Port wiring branches.
5. Inspect for the label/labels see pg 2, attached to the Charge Port's wiring branch that contains the XY499A connection.

6. If the part number (PN) on white label is 68570526AD, the charge port has the upgraded Software (SW) version that contains a fix for the symptoms described on this publication, it is not required to replace the Charge Port if vehicle is charging successfully. Engineering is aware some software EVCU bugs that can create the same symptoms at the start or end of charge, ensure the vehicle has the latest EVCU SW/HW available.

7. If PN on the white label is 68570526AC AND the additional blue certification tag is present; the charge port has been upgraded with the SW version that contains a fix for the symptoms described on this publication, it is not required to replace the Charge Port if vehicle is charging successfully. Engineering is aware of some software EVCU bugs that can create the same symptoms at the start or end of charge, ensure the vehicle has the latest EVCU SW/HW available.

8. If part number on the white label is 68570526AC AND the additional blue certification tag is NOT present, the Charge Port interface is suspect of having an older SW version

creating the condition described. The Charge Status Indicator/Interface component PN 68752336AA with the software updates can be ordered as replacement Pg 3 - 7. There is no need to replace the Charge Port as an Assembly to fix this condition.

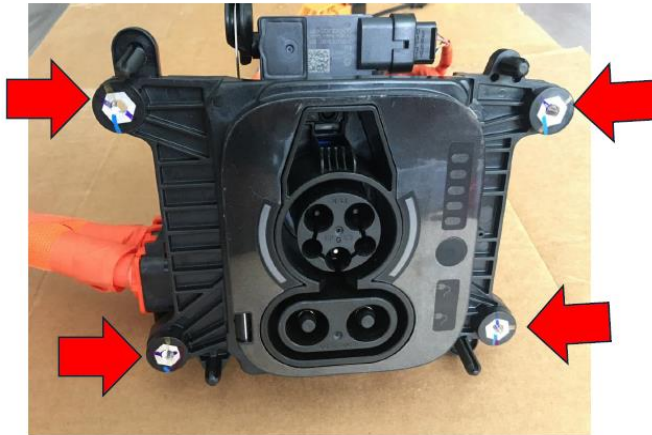
Step 1. Remove front fasteners and getting access to the back of the Charge Port (CPIM)

You will need access to the back of the Charge Port. Rear wheel, Wheel liner and Charge Port wiring attachment points to body structure will need to be removed as needed in order to get access to the back of the Charge Port. Or if required the Charge Port Assembly may be removed from vehicle in order to facilitate the HMI faceplate replacement.

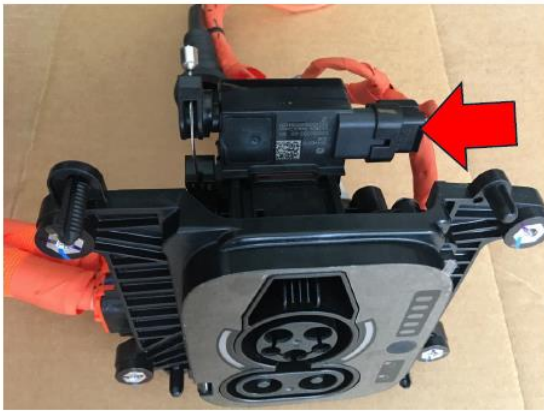
Remove Actuator connector

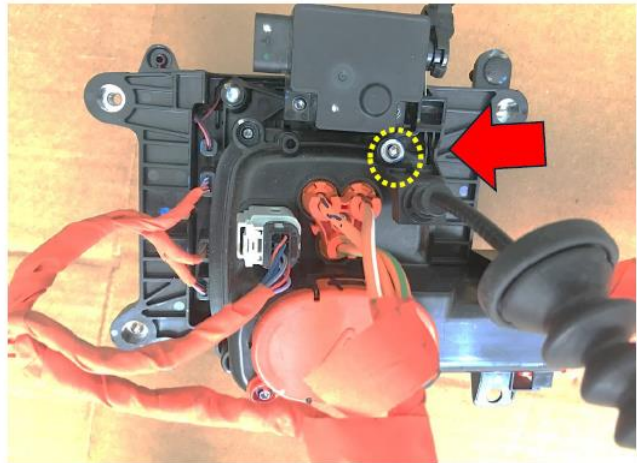
Remove Release Cable bracket in the rear of the Charge Port (1x using T20 bit)

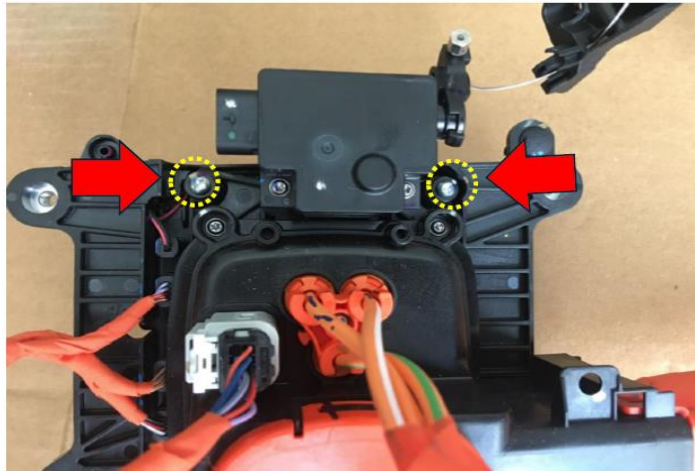
Step 3a. Removing HMI faceplate fasteners (2x top)

Using a T20 bit, remove the M4 screws securing the HMI faceplate to the Charge Port inlet housing.

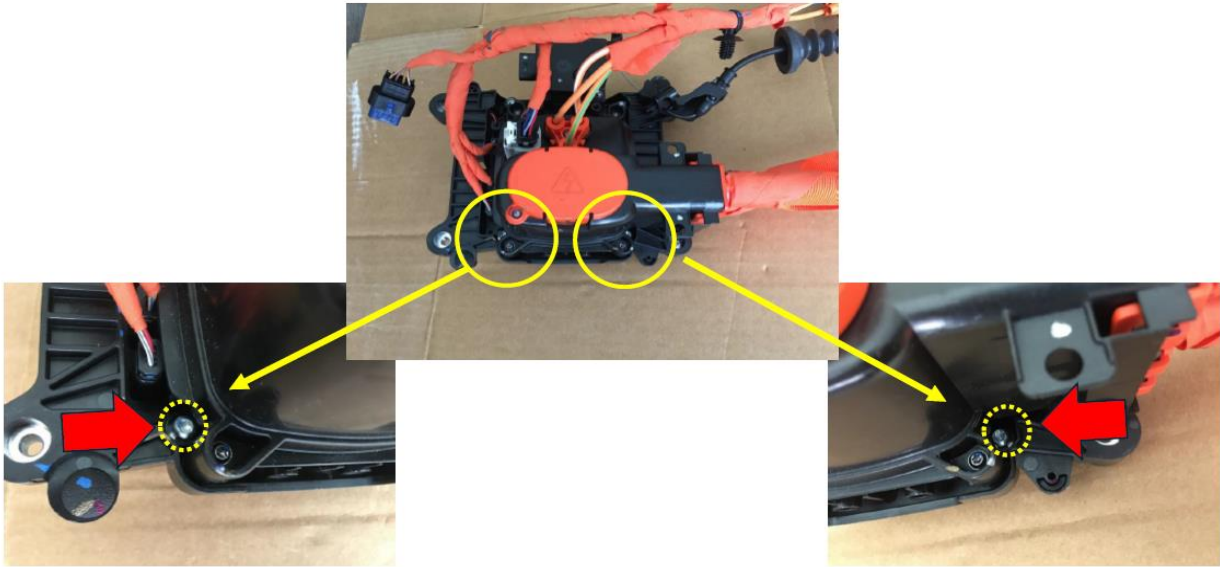
Step 3b. Removing HMI faceplate fasteners (2x bottom)

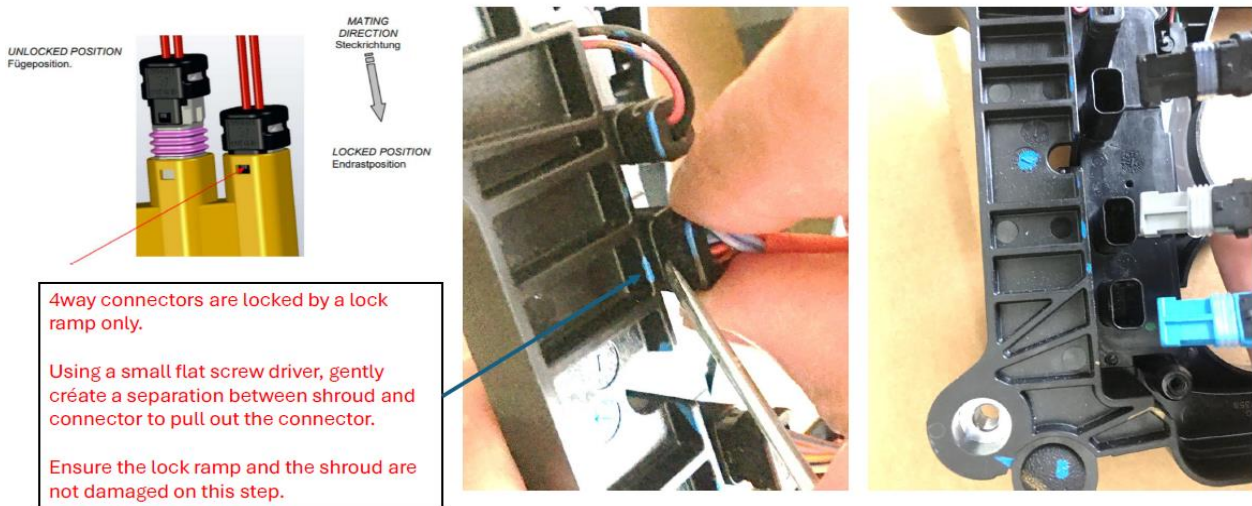
Step 4. Unplug 4way connectors (3x)

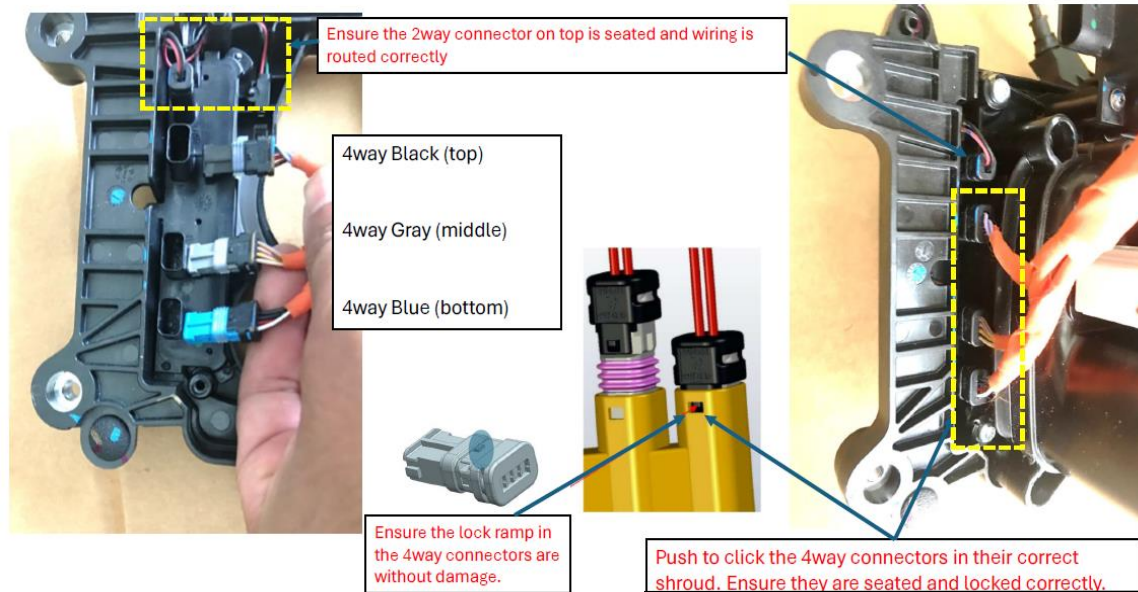
Step 5. Plug-in 4way connectors in the new HMI faceplate (3x)

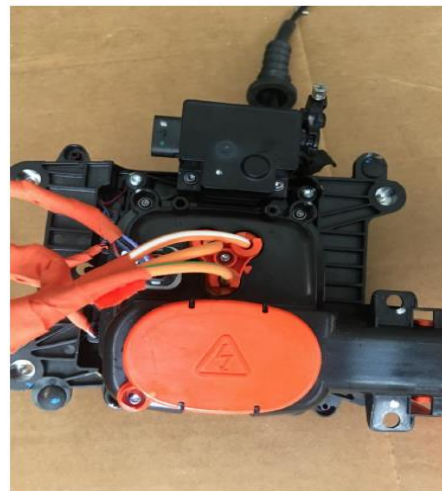
Step 6. Reinstall new HMI faceplate to Charge Port.

Carefully assemble the HMI faceplate back to the inlet housing – making sure no wires are being pinched.

Use the same M4 bolts to secure them together – a controlled torque method must be used to achieve 1.6 +/- 0.1 Nm

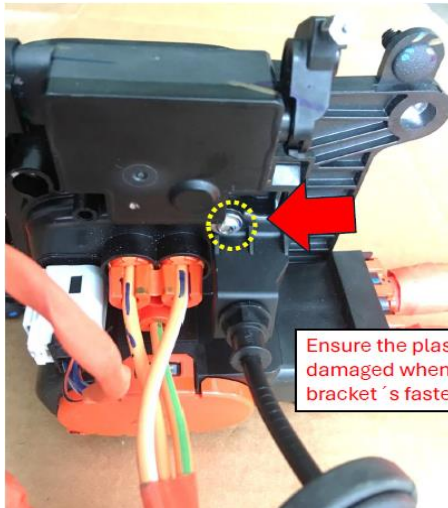
Step 7. Reinstall Release Cable bracket to Charge Port.

Ensure the plastic thread is not damaged when tightening the bracket's fastener.

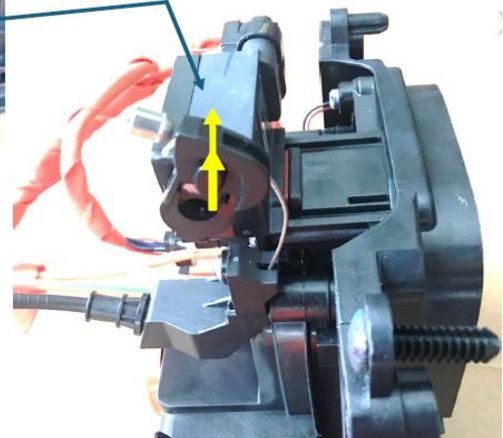
Ensure the release cable and actuator's lock arm remain at "home position" (12 o'clock) after assembly. There should be marks for "home position" alignment.

It is recommended to Charge vehicle with Level 3 to ensure actuator and release cable are in alignment. Level 3 charging will require actuator to lock charger and this ensures the cable and actuator arm are assembled correctly.
