Countries: CANADA, UNITED STATES Document ID: IK0700113  
Availability: ISIS, FleetSIS, NotSIR Revision: 4  
Major System: Exhaust / Aftertreatment Created: 5/20/2021  
Current Language: English Last Modified: 7/29/2025  
Other Languages: NONE Author: Jack Fossler  
Viewed: 1701

Title: HX Rattle and Squeak Service Instructions

Applies To: HX Series Trucks exhibiting complaints of a rattle or squeak from the vertical exhaust slider due to wear or too much pre load

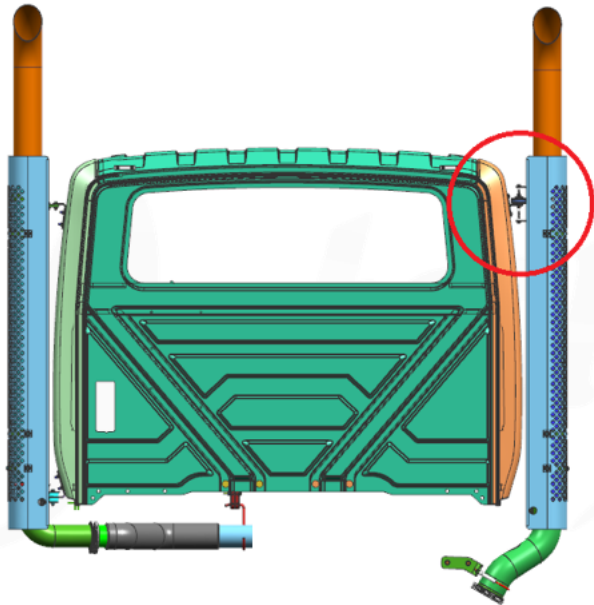
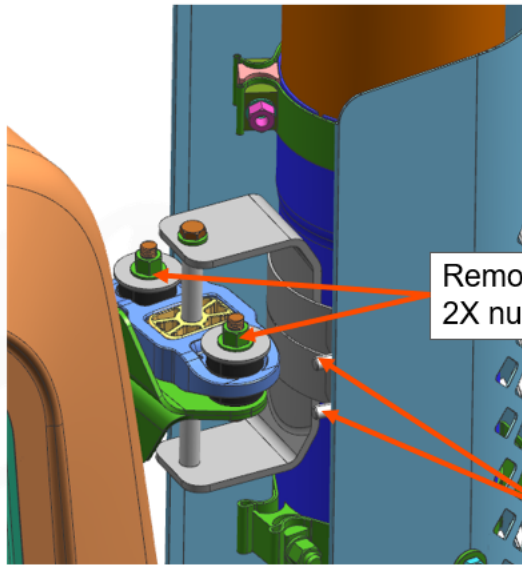
## REMOVE SLIDER FASTENERS

Remove isolator  
2X nuts & 2X washers

Reuse- 38-40  
on re-install

Do not loosen  
of clamps the  
C-Bracket to

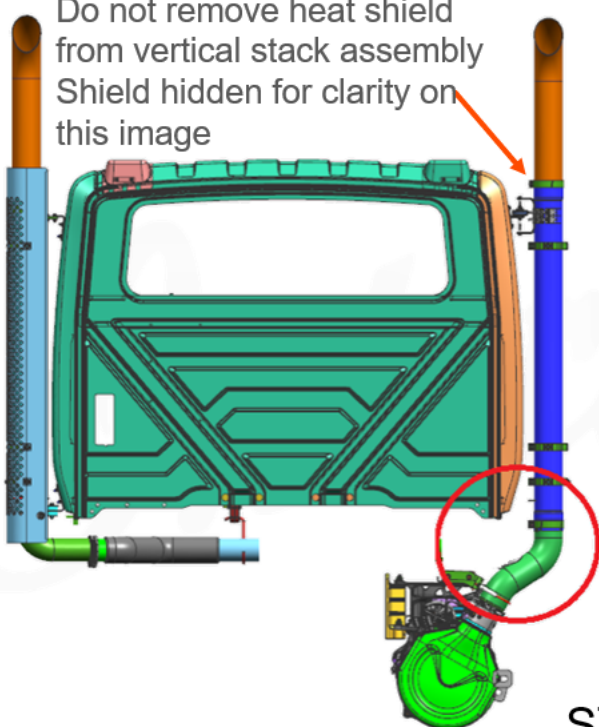
## STEP 1

Do not remove heat shield  
from vertical stack assembly  
Shield hidden for clarity on  
this image

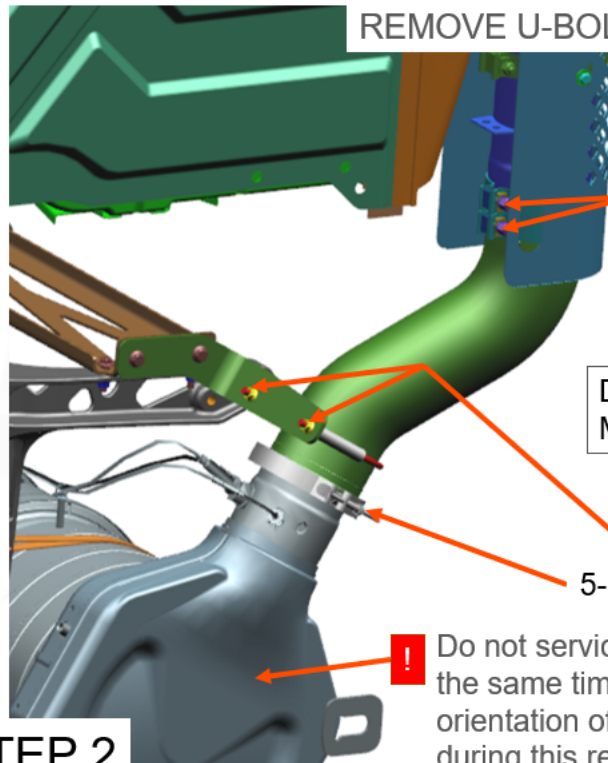
## REMOVE U-BOLT & ATD MAF

Do not loosen  
of clamps at  
stack to S-p

Disassemble U-  
Marmon Clamp

Reuse hardware  
30-38 Nm on  
5-10 Nm on ATD

Do not service ATD and verify  
the same time. Factory location  
orientation of ATD must be maintained  
during this rework. (ATD service)

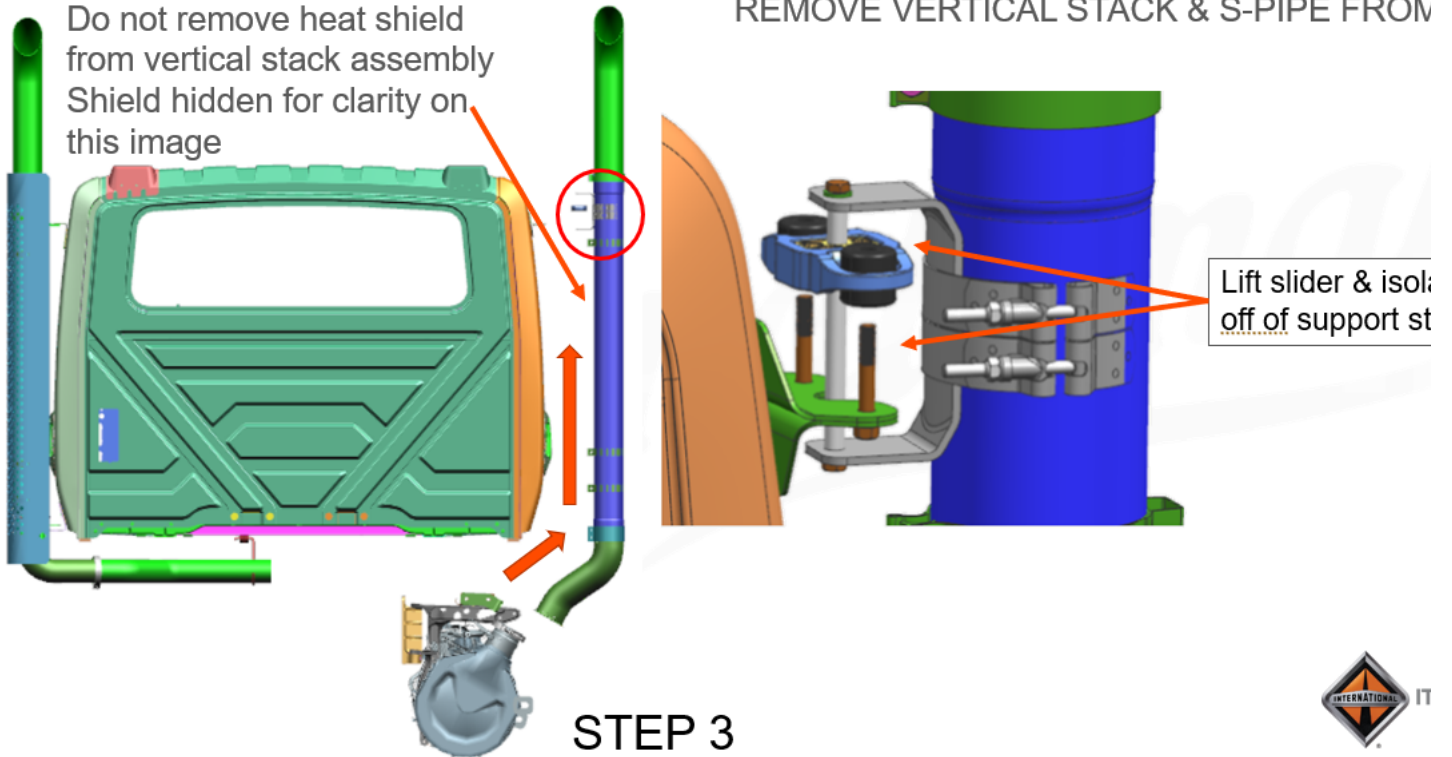
REMOVE VERTICAL STACK & S-PIPE FROM

Do not remove heat shield from vertical stack assembly  
Shield hidden for clarity on this image

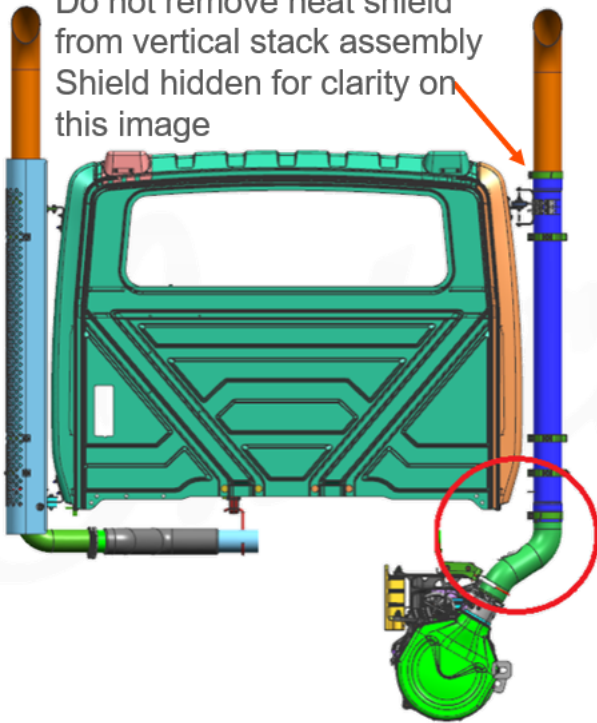
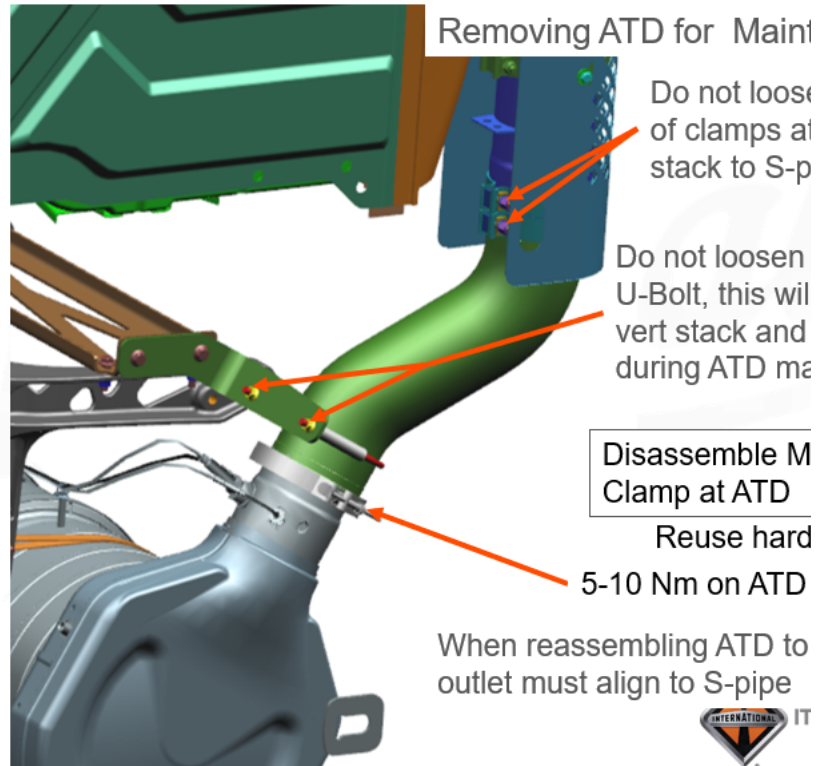
Do not remove heat shield from vertical stack assembly  
Shield hidden for clarity on this image
