Title: S13 Gear Housing Leak (By The Air Compressor)

Applies To: S13 Integrated Powertrain LT RH HX

The purpose of this document is to properly identify and repair a leak at the rear gear housing boss.

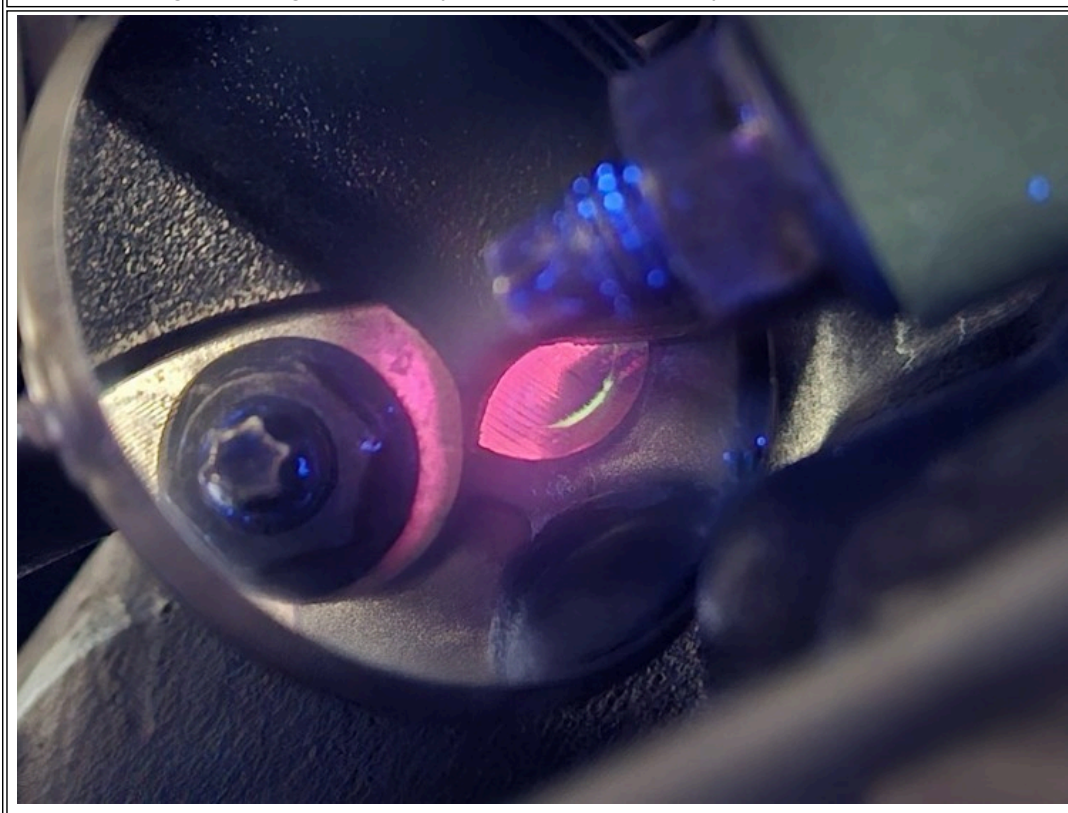
Figure 3 - Using a mirror to inspect between the lower compressor stud and block

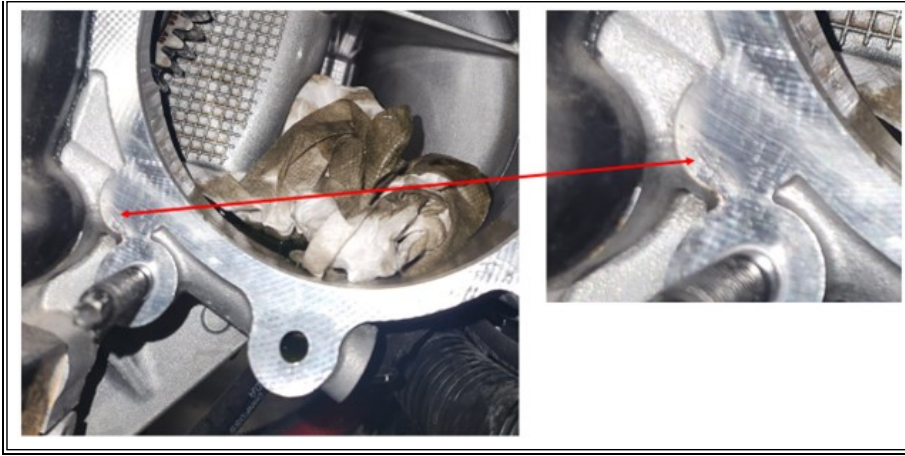
Figure 4

**\*NOTE\*** - Below Figure 4, the air compressor is removed to assist in showing the area in question; the compressor does not need to be removed to inspect for the boss leak
