# ASA6 - Check Air-Spring Strut on the Front Axle and Rework if Necessary (Stop Delivery/Recall Campaign)

Model Line: Taycan (Y1A/Y1B/Y1C)

Panamera (YAA/YAB)

Concerns: Air-spring strut front axle

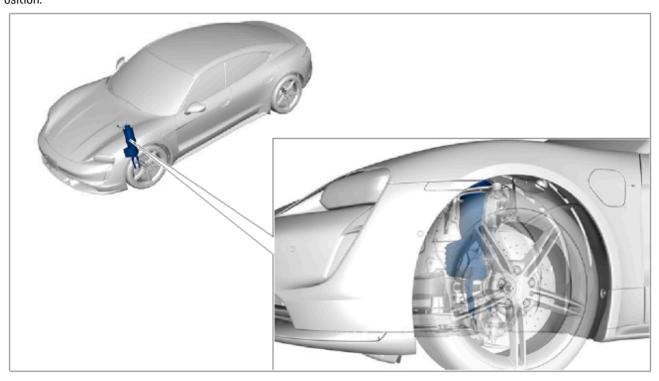
Installation position of air-spring strut
