TURBOCHARGER COOLANT FEED AND RETURN PIPE O-RING LEAK – 3.0L / P6

Range Rover

Defender

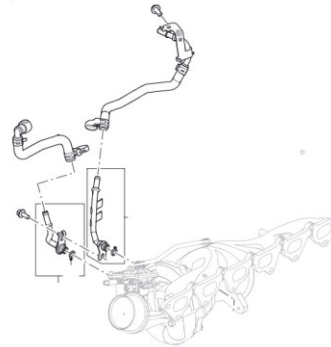
- The low coolant light may be illuminated/there may be a coolant leak from the engine area.
- TOPIx workflow must be run by selecting the relevant symptom dropdowns: *Powertrain > Engine > Fluid Leaks > Coolant leak*
- When running the workflow, a test plan titled “Turbocharger Coolant Pipe Leakage – Test” should be run.
- If fault is found during the test plan, approval will be granted to replace the O-ring seals – *refer to SSM 76268 (Jaguar) & SSM 76269 (Land Rover)*. **Normal warranty policies apply when replacing the O-ring seals. You do not need a FRED approval via workflow or manual submission.**
- If there is visible damage to the coolant pipes, please submit a manual FRED with photographic evidence attached.
