Technical Information

114/16 ENU 9415

Assessment of Extent of Fogging on Lighting Components (114/16)

Model Line: All model lines

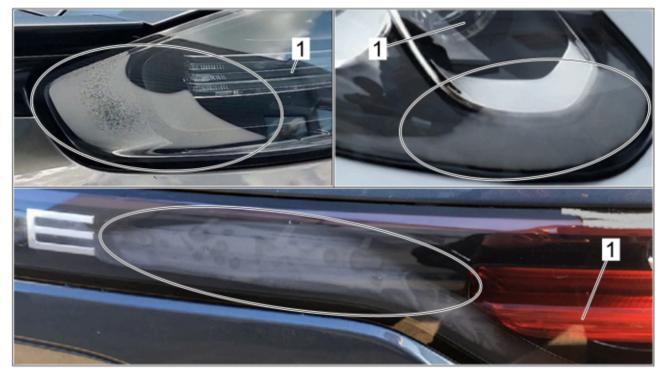
Work Procedure: 1 Perform a visual inspection of the lighting component ⇒ Step 1: Lighting component fogged up -1- and assess the situation.

2 If only the technical design area of the lighting component is fogged up ⇒ Step 1: Lighting component fogged up -Marking-, this will not affect the light output.

Replacing the lighting component ⇒ Step 1: Lighting component fogged up -1- will not correct the problem.

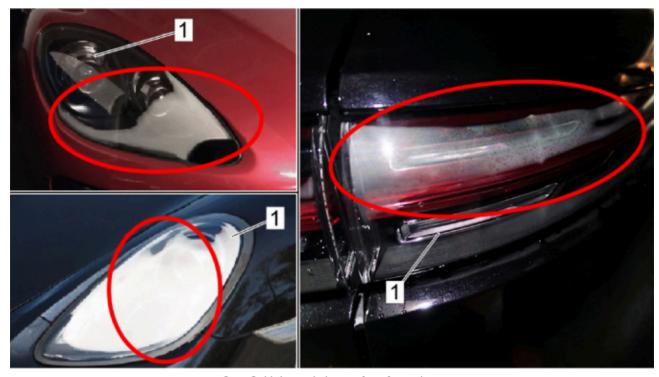
- Perform a visual inspection of the lighting component ⇒ Step 2: Light-emitting surface fogged up -1- and assess the situation.
- If the technical design area and the technical lighting area of the lighting component are fogged up \Rightarrow Step 2: Light-emitting surface fogged up -Marking-, the lighting component \Rightarrow Step 2: Light-emitting surface fogged up -1- must be checked.

- 2.1 Check gap dimensions and air gaps of the affected lighting component and correct them if necessary. ⇒ Workshop Manual '5X00IN Gap dimension'
- 2.2 If not already done, check the ventilation and aeration elements.

Test-drive the vehicle for at least 30 minutes at a consistent increased speed of 50 km/h (30 mph) (no Stop & Go) and dipped beam on and check whether the fogging clears.

- If the fogging clears, replacing the lighting component will **not** correct the problem.
- If the fogging does not clear, replace lighting components and complete the relevant documentation.

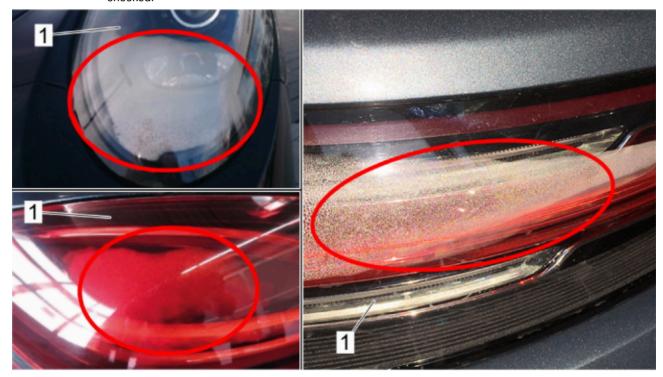
Work Procedure: 1 Perform a visual inspection of the lighting component ⇒ Step 3: Slight drops forming on lighting component -1- and assess the situation.

2 If the technical design area and the technical lighting area of the lighting component are fogged up and there are slight drops of moisture forming \Rightarrow Step 3: Slight drops forming on lighting component -Marking-, the lighting component \Rightarrow Step 3: Slight drops forming on lighting component -1- must be checked.

- 2.1 Check gap dimensions and air gaps of the affected lighting component and correct them if necessary. ⇒ Workshop Manual '5XOOIN Gap dimension'
- 2.2 If not already done, check the ventilation and aeration elements.

Test-drive the vehicle for at least 30 minutes at a consistent increased speed of 50 km/h (30 mph) (no Stop & Go) and dipped beam on and check whether the fogging clears.

- If the fogging clears and the amount of drops forming is reduced, replacing the lighting component will **not** correct the problem.
- If the fogging does **not** clear and the amount of drops forming is not reduced, replace the lighting component **and complete the relevant documentation**.

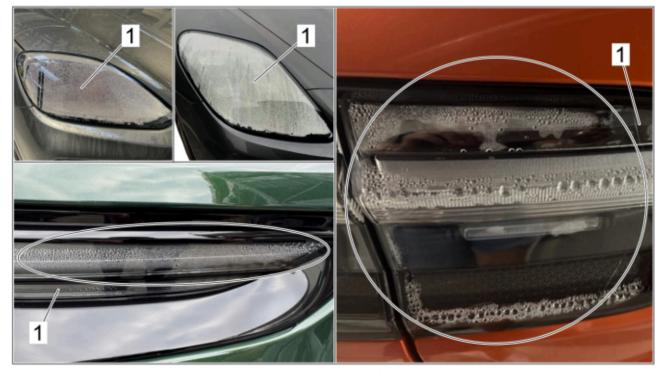
Work Procedure: 1 Perform a visual inspection of the lighting component \Rightarrow Step 4: Significant drops forming on lighting component -1- and assess the situation.

2 If the technical design area and the technical lighting area of the lighting component are fogged up and there are significant drops of moisture forming ⇒ Step 4: Significant drops forming on lighting component -Marking-, the lighting component ⇒ Step 4: Significant drops forming on lighting component -1- must be replaced.
