TURBOCHARGER COOLANT INLET/OUTLET PIPE LEAK - P6

SSM 76269

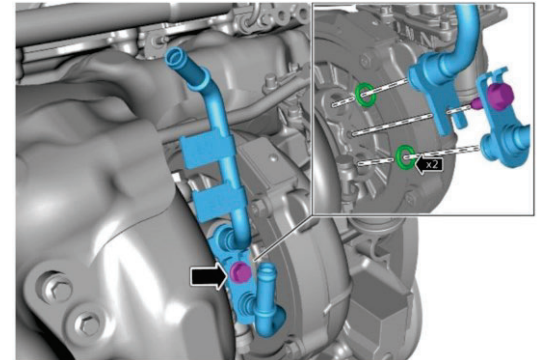
- Engineering investigations have identified instances where the turbocharger cooling inlet/or outlet pipe is leaking.
- Pinched, split or deformed O-ring on the cooling pipe(s).

- In TOPIx enter Fault and Breakdown and start a new Workflow
 - Enter the following symptoms:
 - Powertrain > Engine > Fluid Leaks > Coolant Leak
 - The following Test Plan will be offered:
 - Turbocharger Coolant Leakage – Test
 - Please raise an Electronic Product Quality Report (EPQR), which should include the following:
 - - Reference PTS_100, P397036, SSM 76269
 - - Photographs/video file attached as detailed/requested in step 7 of the service request.
 - - Confirmation the O-ring(s) are available for collection.
- NOTE: If pipes are found to be the cause, a FRED is required with photos attached to the FRED submission.
