WSE6 - Replace Dryer in Air-Conditioning System (Workshop Campaign)

Action:	Replace dryer in air-conditioning system.
Affected Vehicles:	Only vehicles assigned to the campaign (see also PCSS Vehicle Information).

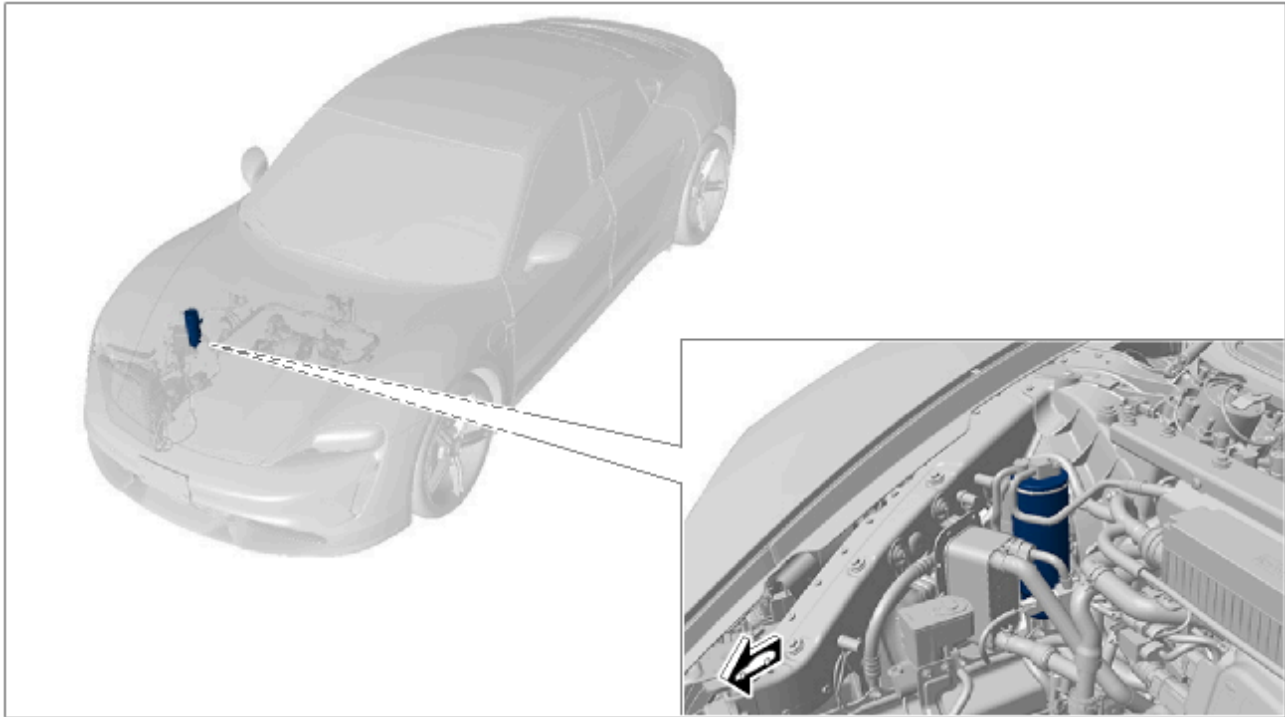
Installation
Position:

Installation position of dryer

- Work Procedure:
- 1 Replace dryer.
⇒ *Workshop Manual '875555A1 Replace dryer'*
 - 2 Enter the campaign in the Warranty and Maintenance Logbook.
