**ARB6 - Re-Programming High-Voltage Battery Control Unit (BMCe) (Recall Campaign)**

Model Line: **Taycan (Y1A / Y1B / Y1C)**

Concerns: **High-voltage battery control unit (BMCe)**

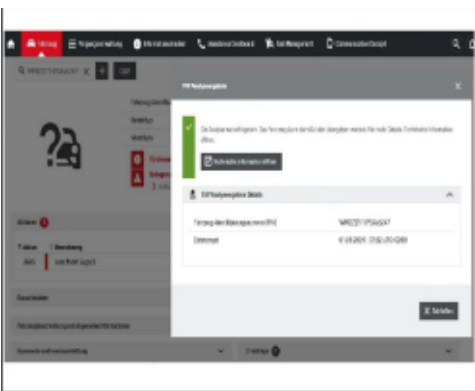
"Green" display result

- **Green display:** The test result is **"positive"**. Cell modules are OK, carry out the programming of the high-voltage battery control unit.

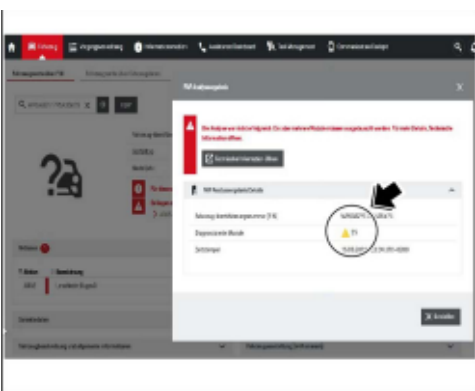
"Red" display result

- **Red display:** The test result is **"negative"**. One or more modules must be replaced **after** the control unit programming.

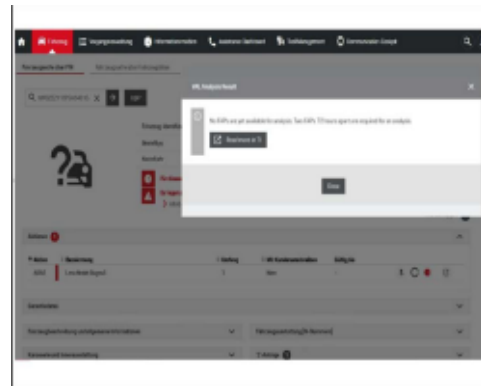
"Grey" display result

- **Grey display:** The vehicle analysis log (VAL) cannot be evaluated, but the high-voltage battery control unit is still programmed.
