Advanced Technical Information

Bulletin #: 2016.3

Troubleshooting AC Charging

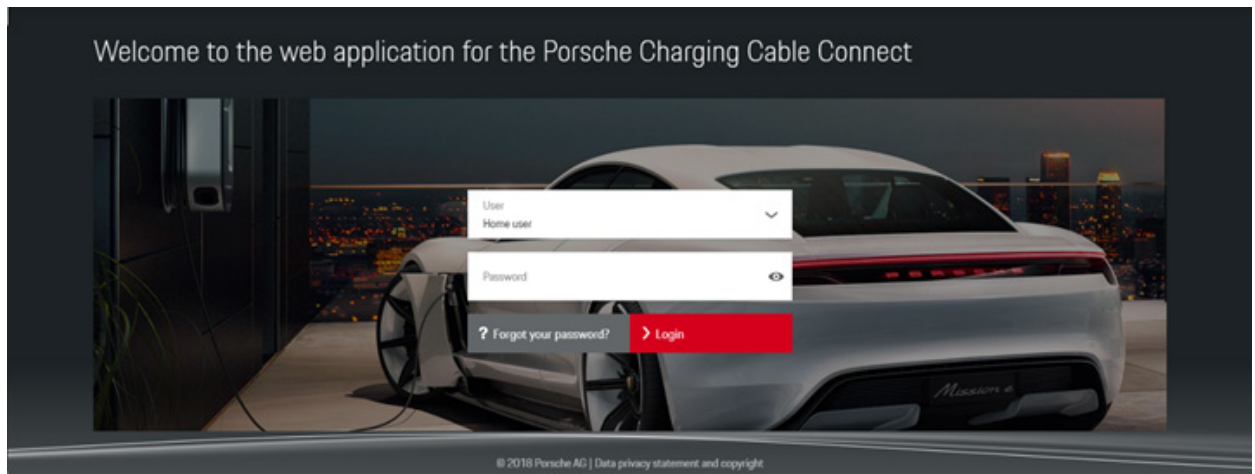
Figure 2

4. Open your internet browser (i.e. Chrome, Safari, Firefox) and go to 192.168.0.1
 - a. NOTE: When logging in via private or local IP address, a security warning may be shown on the browser. In the warning message in your browser, select Advanced then Add exception (or similar). The SSL certificate is confirmed and the browser opens the web application
 - b. Afterwards, the following site will open (see Figure 2)

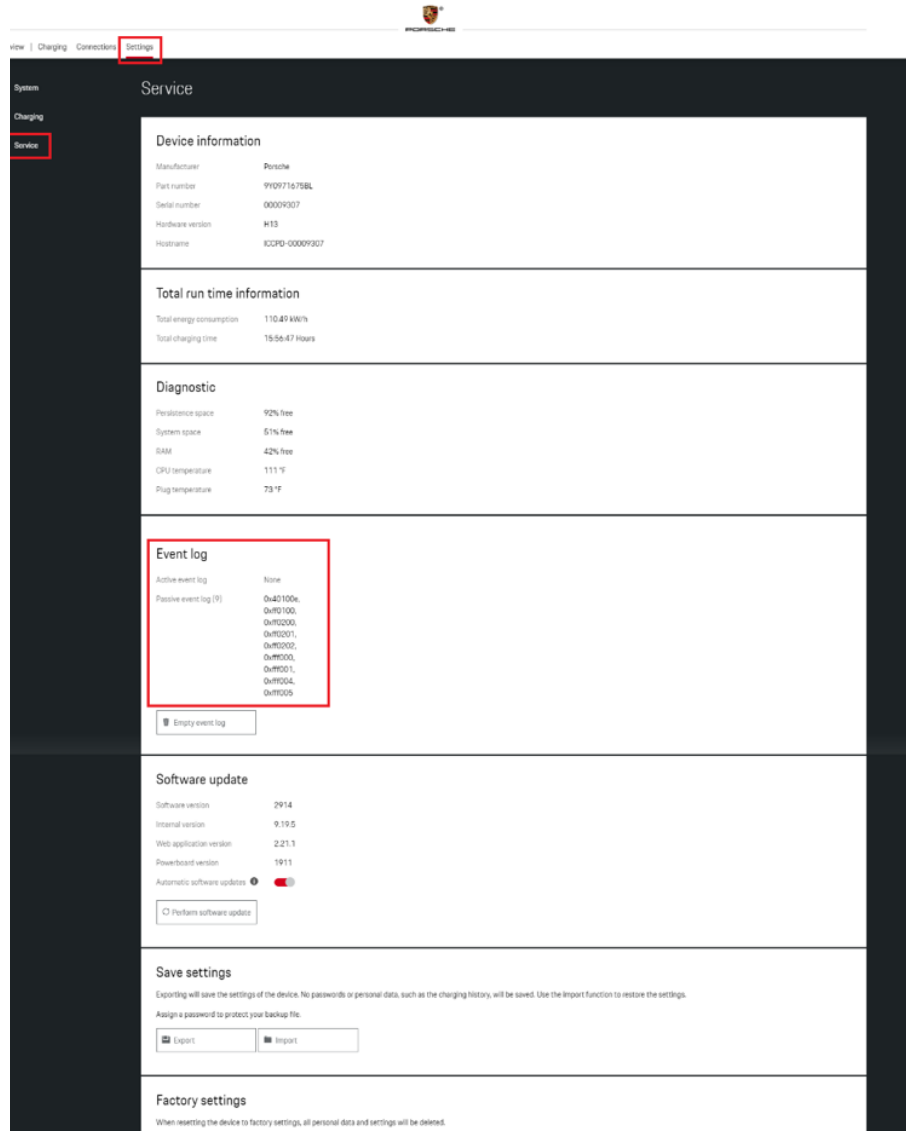
Figure 3

5. Log into the Web App as Customer Service (see "Logging into Web Application" section)
6. DTCs from the Web Application
 - a. Go to **Settings ->Service** and scroll down to **Event log** (see Figure 3)
 - b. Click the hyperlink for each DTC and save DTC data as needed (see Figure 4)
This data can also be copied & pasted into a notepad or document to be saved & shared (just be sure to capture all DTC information)

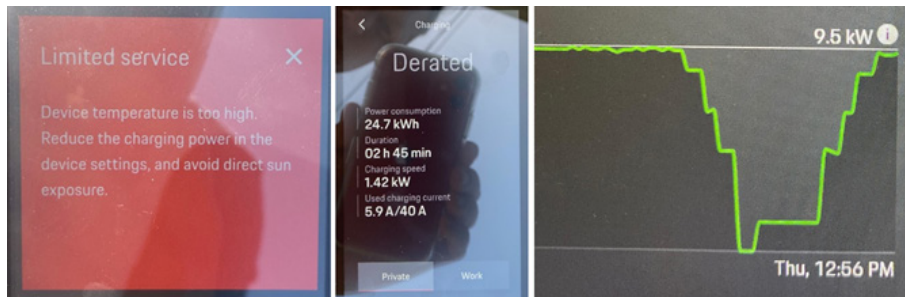
The ICCPD is equipped with various temperature sensors and function monitors. If the device detects overheating, for example, then charging current can be automatically reduced for a period of time.

The PMCC was left in direct sunlight while charging at 40A / 9.6 kW. The device automatically derated to 0.0 kW charge rate and displayed the red "Limited service" message shown here. 1 minute later, the device automatically increased charge rate to 6A / ca. 1.42 kW and presented as indicated in the "Derated" screen shown here. The device was then moved from direct sun to shade and proceeded to automatically increase charge rate until it returned to 40A / 9.6 kW. The total time period for the entire derating session was 13 minutes and is indicated by the graph in Figure 8 from the PMCC Web App.

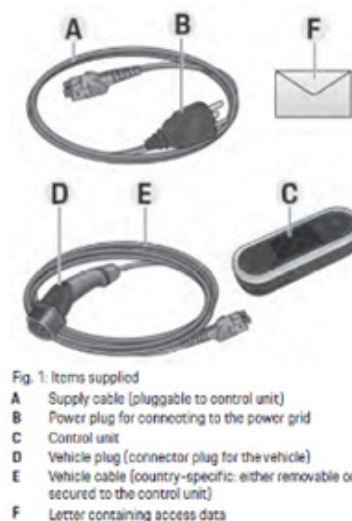
Figure 10

1. Printed on the "Letter containing access data" (F in Figure 10) included with new vehicle purchase -or- provided with a PMCC purchased via Porsche Parts
2. Via the SoliD portal, accessible by certain Technical Support and Call Center personnel
3. Via PCSS --> Vehicle --> Charging Products
