TECHNICAL SERVICE BULLETIN

Oil Consumption And Blue Smoke From Tailpipe

25-2361

Ford 2024-2025 Transit	Engine: 3.5L Duratec
2024-2025 Explorer	Engine: 3.3L Duratec Engine: 3.3L Hybrid

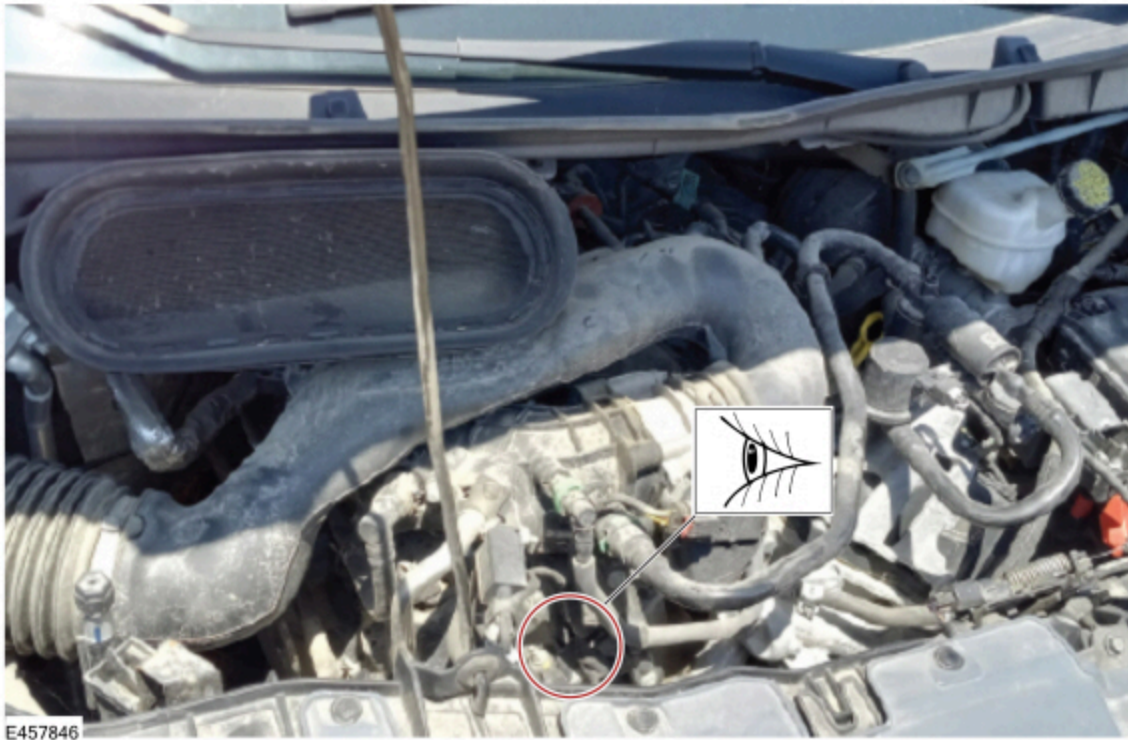
1. Verify the production build date of the valve cover RH. Refer to Figures 1 and 2 for 3.5L engines and Figures 3 and 4 for 3.3L engines.

Figure 1 - Showing the zoomed-out location of the date on the 3.5L valve cover.

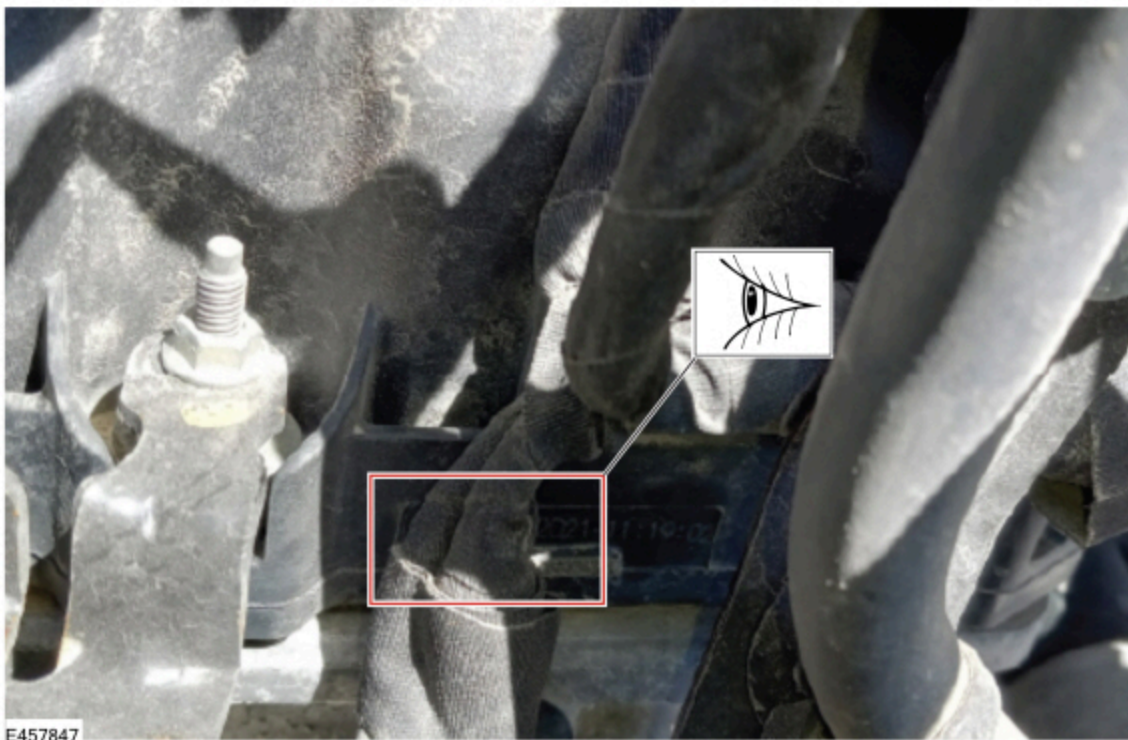
NOTE: The harness shown in Figure 2 needs to be slightly pushed aside to view the entire date.

NOTE: Date displayed on valve cover will show as: 12/09/2024 or 12/10/2024.

Figure 2 - Showing the zoomed-in location of the date on the 3.5L valve cover. Date is shown on the valve cover as Month/Day/Year.
