SIB 32 01 23

2025-08-08

CRACKING/CREAKING NOISE FROM FRONT AXLE/STEERING SYSTEM

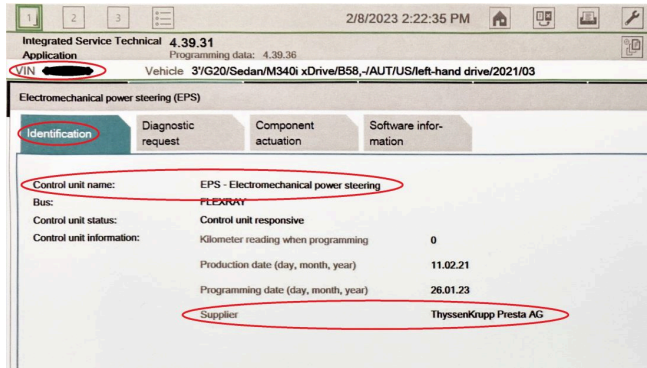
1. Verify a TKPS EPS is installed via ISTA control unit functions (G20, G22, G23, G26 and G42 only).
