## Vehicle does not start, plug X292x1/X296x1 not engaged correctly

| Topic number | LI54.18-P-079535 |
| Function group | 54.18 - Cable harnesses |

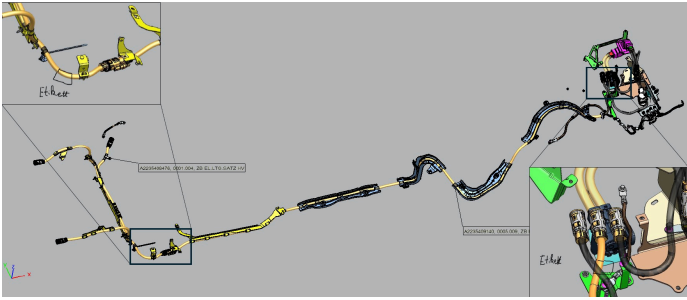
| Attachments | |
|--|---|
| <a href="#">Position Label_Etikett.jpg</a> | Position of label |

If this check confirms that the outer housing can be shifted forward despite the disconnected plug X292x1 / X296x1, the plug X292x1 / X296x1 including wiring harness is not OK (please attach video) and must be replaced. Please attach a photo of the label to the TIPS case, see Annex "Position of label"

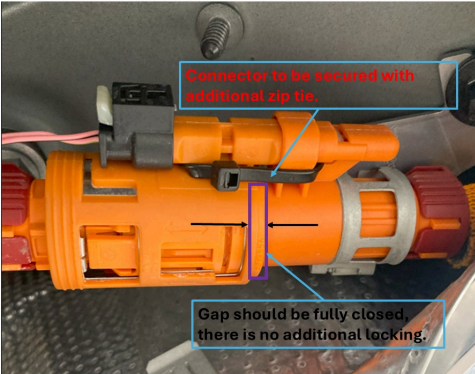
| Attachments | |
|--|---|
| <a href="#">Stecker X292x1_296x1_english connector.jpg</a> | Gap / cable zip tie position |

There is no additional engaging for the outer housing. In addition, the plug X292x1 / X296x1 must be fixed in place with a cable tie, see "Gap / cable tie note" picture in the Annex.

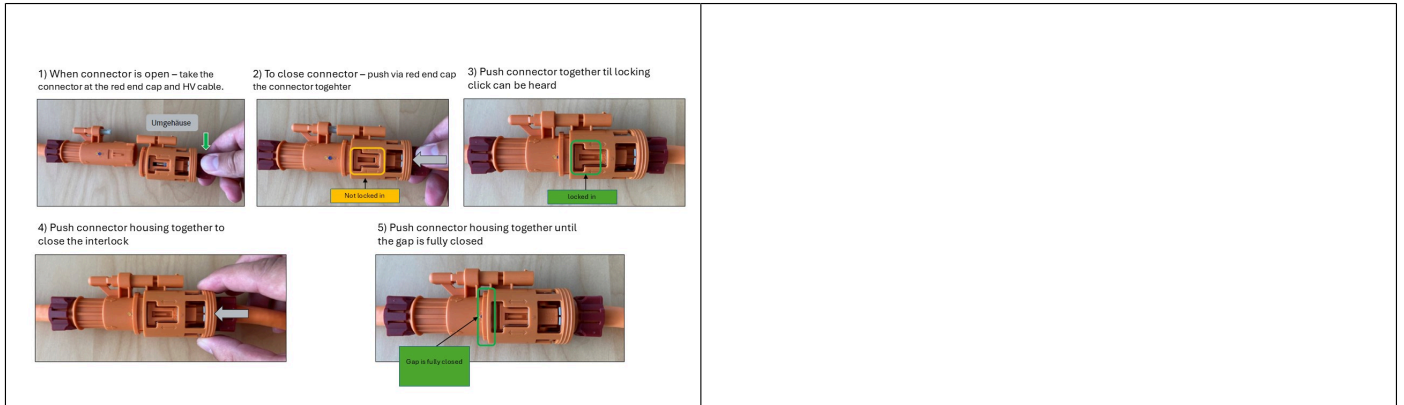
| Attachments | |
|--|---|
| <a href="#">Stecker X292x1_296x1_english connector closing.jpg</a> | Plug assembly instructions |

If the outer housing cannot be shifted forward after the check above, then the plug X292x1 / X296x1 can be installed properly as per the "Plug assembly" instructions, see Annex.

If the plug was installed correctly, no gap between the outer housing and plug housing must be visible, see picture 5 from "Plug assembly" instructions Annex.
