Technical Service Bulletin (TSB)
Partial Rear Window Molding Detachment

REFERENCE:	TSB: 23-024-25 REV. B GROUP: 23 - Body	Date:	August 9, 2025	REVISION:	23-024-25 REV. A
VEHICLES AFFECTED:	2024 (FG) FIAT 500e This bulletin applies to vehicles built on or after January 15, 2024 (MDH 0115XX) and on or before September 03, 2024 (MDH 0903XX).			MARKET APPLICABILITY: <input checked="" type="checkbox"/> NA <input checked="" type="checkbox"/> MEA <input checked="" type="checkbox"/> SA <input type="checkbox"/> IAP <input checked="" type="checkbox"/> EE <input type="checkbox"/> CH NOTE: This bulletin applies to the North America, South America, Middle East and Africa and Enlarged Europe markets.	
CUSTOMER SYMPTOM:	Customers may experience the following: <ul style="list-style-type: none"> Noise/vibration from rear side window while driving. 				
CAUSE:	Rear window trim not fully sealed to the body at assembly

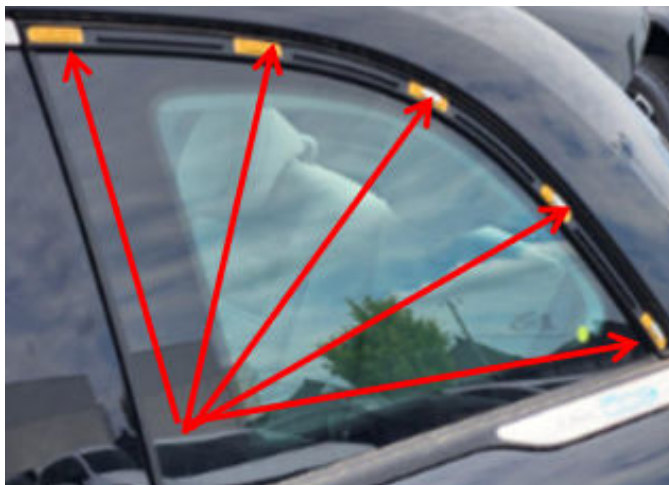
Fig. 1

Area On Trim Molding To Inspect

1. Inspect for correct attachment of the molding by pushing on the clip position shown in [Fig. 1](#).

2. Using a feeler gauge with a measurement of 1.19 mm (3/64 in.) check the upper contact area of the molding with the rubber gasket gap at the clip points. The gap must be less than 1.19 mm (3/64 in.).

3. Does the gap exceed 1.19 mm (3/64 in.) or did the molding pull away from the mounting clips?
 - YES >>> Proceed to [Step 4](#).
 - NO >>> This bulletin does not apply. Use Inspection LOP (23-30-30-96). Perform further diagnostics.

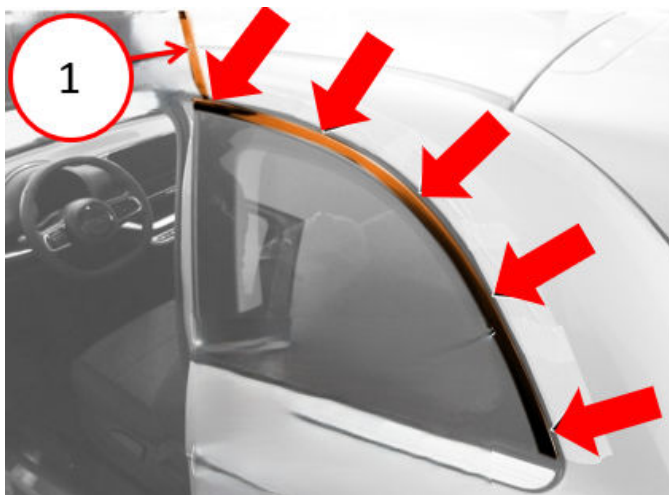
Fig. 2

Trim Stick Locations For Removal Of Trim

4. Open the front door.
5. Apply a double layer of paper tape to the body to protect the paint.
6. Using a trim stick, remove the trim from the seal clips and retaining clips then remove and discard the trim [Fig. 2](#).
