STAR ONLINE PUBLICATION

Case Number: S2408000079 Rev.A

Symptom/Vehicle Issue: Liftgate Lock Button Inoperative, Cluster Message “Service Keyless System”

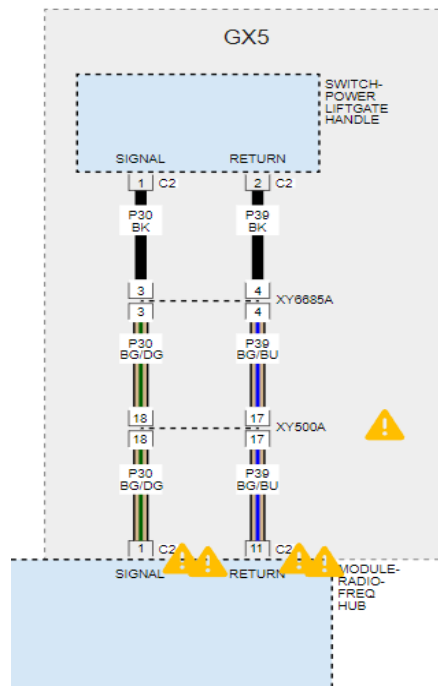
PN# 68303988AA

Customer Complaint/Technician Observation: The owner complains the liftgate power lock button is not operating and that the cluster displays an occasional message to “Service Keyless System”. The technician observed the Radio Frequency Hub (RFHUB) set Diagnostic Trouble Code (DTC) B259E-11 Trunk/Liftgate Door Handle Sense Circuit Short to Ground as active.

Repair Procedure: Inspect the common areas highlighted by the yellow triangles for any circuit related issues. The switch signal circuit is 12volt/battery voltage from the Radio Frequency Hub (RFHUB) and grounds through the switch. Test the switch for open and closed actuation values and document on repair prior to replacement of the switch.
