<b>REFERENCE:</b>	<b>TSB:</b> 08-239-25 <b>GROUP:</b> 08 - Electrical	<b>Date:</b>	August 6, 2025	<b>REVISION:</b>	-
<b>VEHICLES AFFECTED:</b>	<b>2021 - 2025 (B1) Jeep Renegade</b> This bulletin applies to vehicles built on or after January 01, 2021 (MDH 0101XX) and on or before May 30, 2025 (MDH 0530XX) and equipped with Parkview Rear Back-Up Camera (Sales Code XAC).			<b>MARKET APPLICABILITY:</b> <input type="checkbox"/> NA <input type="checkbox"/> MEA <input checked="" type="checkbox"/> SA <input type="checkbox"/> IAP <input type="checkbox"/> EE <input type="checkbox"/> CH <b>NOTE:</b> This bulletin applies to the South America market.	
<b>CUSTOMER SYMPTOM:</b>	<b>Customers may experience the following:</b> <ul style="list-style-type: none"> <li>Rearview camera is inoperable, or shows a blue screen.</li> </ul>				
<b>CAUSE:</b>	<b>Manufacturing issue</b>

This bulletin involves replacing the rearview camera main harness.

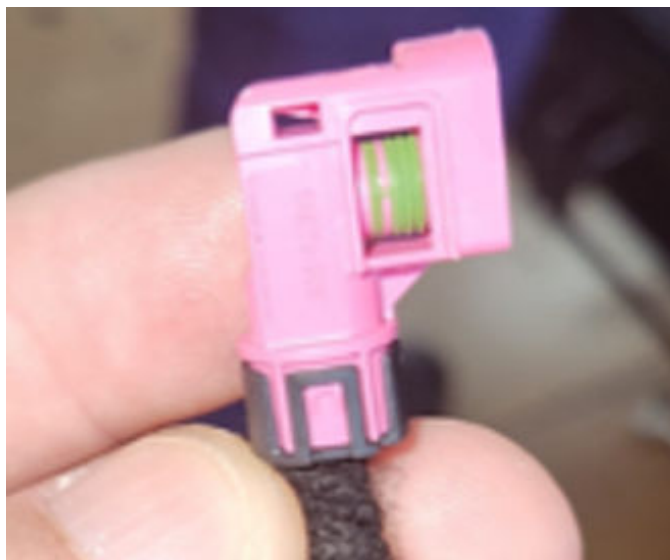
**Fig. 1**

1. Remove the rear view camera. Refer to the detailed service procedures available in DealerCONNECT> Service Library under: Service Info> 5580H60 - Telecamera Traseira para Verificação de Obstáculos em Estacionamento - Remoção/Recolocação.
2. Check if the rear view camera connector [Fig. 1](#) (side main harness) is cracked or broken.

Rear View Camera Connector

3. Was the rear view camera connector [Fig. 1](#) cracked or broken?
  - YES >>> Proceed to [Step 4](#).
  - NO >>> This bulletin has been completed. Use LOP (08-90-75-9C) to close the bulletin.

4. Replace the rear camera main harness. Refer to the detailed service procedures available in DealerCONNECT> Service Library under: Service Info> 5505C41 Chicote integrado no vao passageiros - Remocao/Recolocacao.
