GROUP	MODEL
ELE	2025MY K4 (CL4)
NUMBER	DATE
385	August 2025

TECHNICAL SERVICE BULLETIN

SUBJECT: **BODY DOMAIN CONTROLLER (BDC) REPLACEMENT (CA2507)**

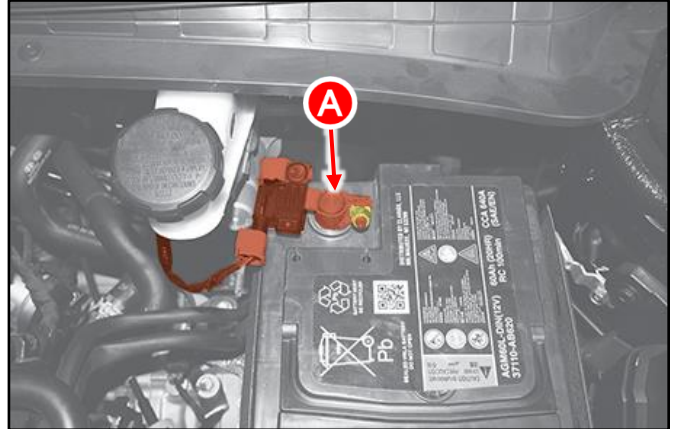
1. Disconnect the negative (-) battery terminal (A).

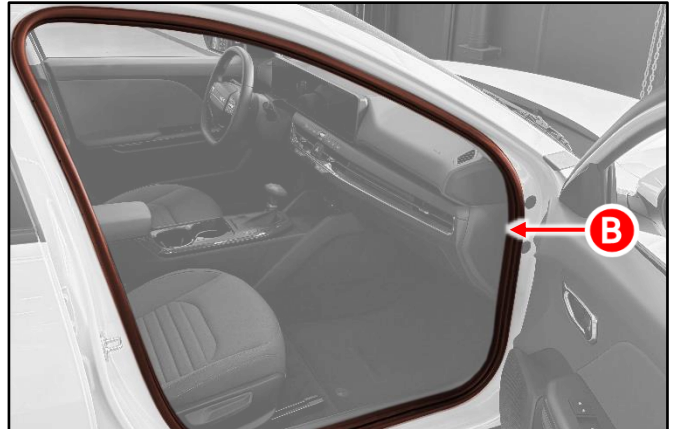
2. Remove the front weather strip (B) from the right front door opening.

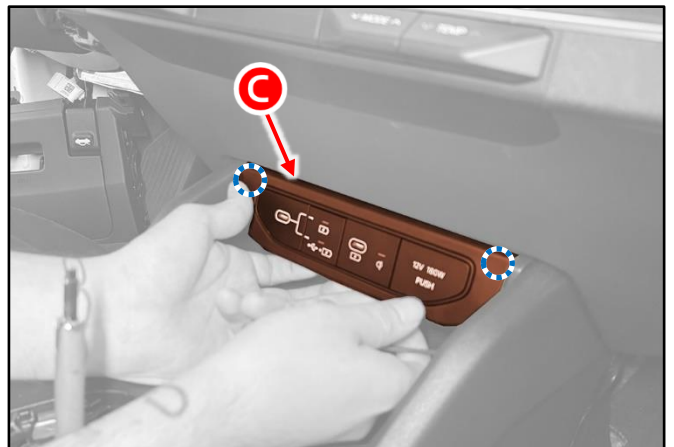
3. Remove the floor console button panel (C).

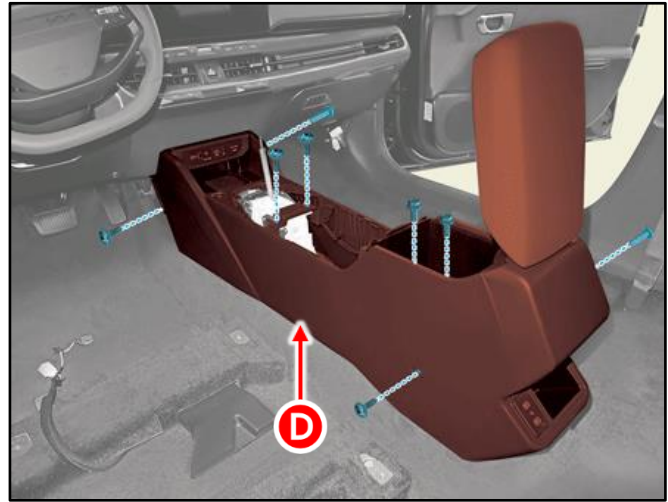
4. Remove the floor console assembly (D) by referring to "Body (Interior / Exterior / Electrical) → Floor Console → Floor Console Assembly → Removal and Installation" in the applicable Shop Manual on KGIS.

Note: Front seats removed for illustration purposes only.

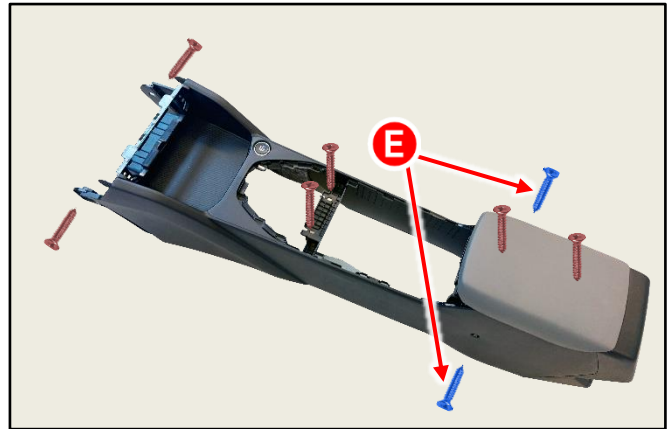
Note: It is not necessary to remove the two (2) console screws (E).

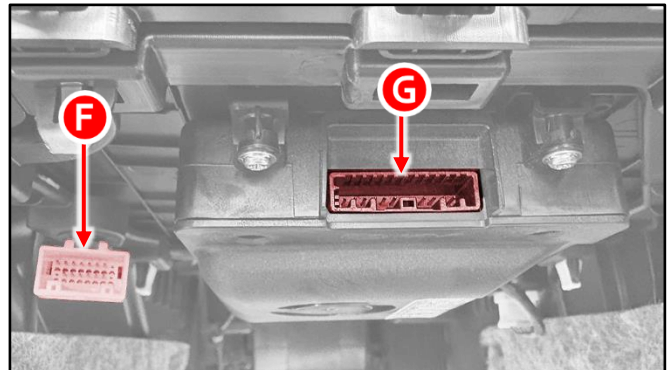
- 5a. Disconnect the floor console extension connector (F).
- 5b. **If equipped**, disconnect the wireless power charger (WPC) connector (G).

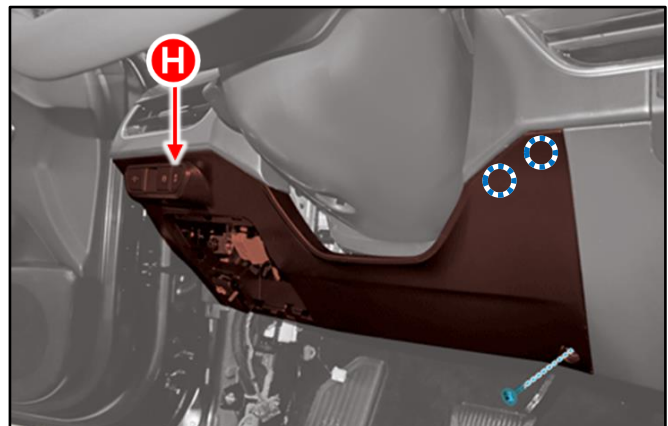
6. Remove the screw and detach the two (2) retaining clips at the top right corner of the crash pad lower panel (H).

Note: The crash pad lower panel (H) does NOT need to be removed.

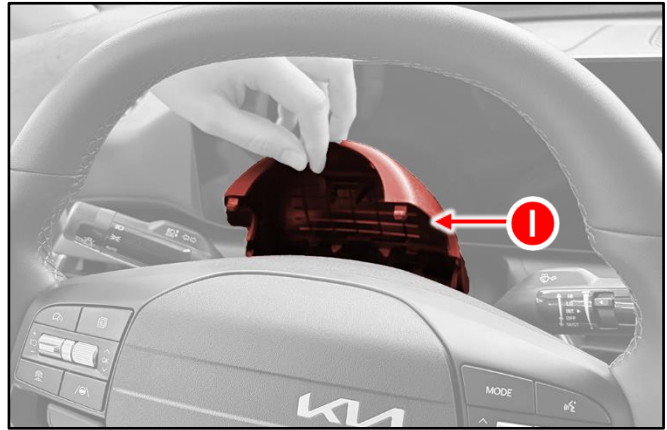
- 7. Remove the upper steering column cover (I).

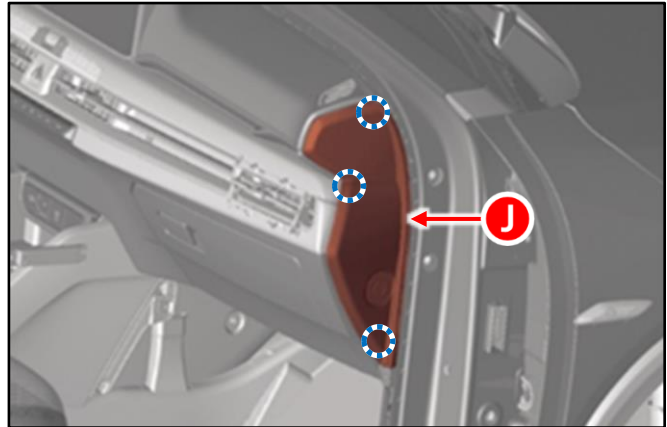
- 8. Remove the right side crash pad side cover (J).

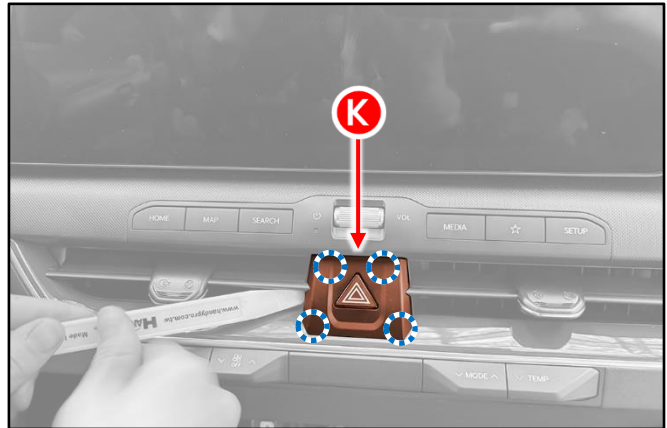
- 9a. Disengage the four (4) retaining clips to remove the hazard switch cover (K).

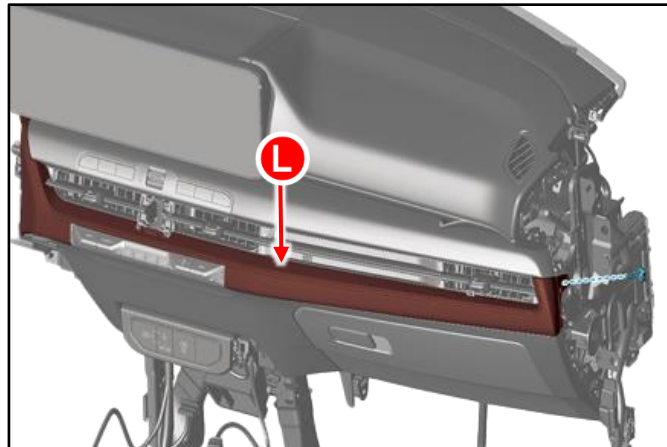
- 9b. Loosen the screw to remove the crash pad lower garnish (L).

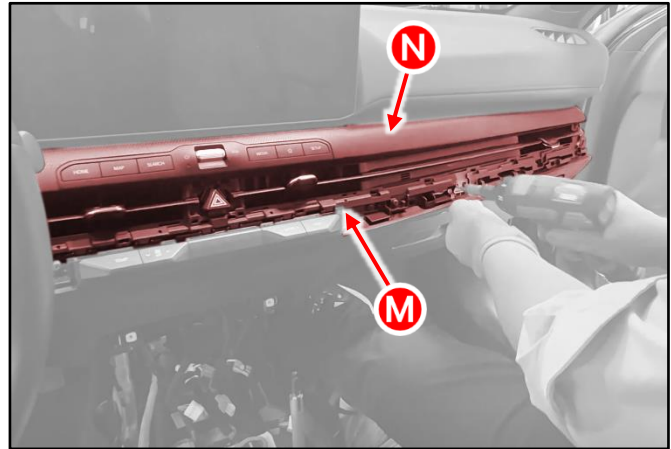
10. Loosen the five (5) screws to remove the crash pad air vent (M).

The crash pad upper garnish (N) does NOT need to be separated from the crash pad air vent (M).

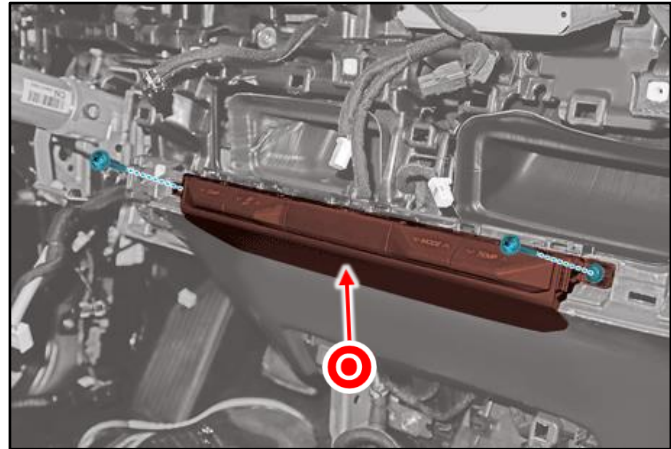
11. Loosen the two (2) screws to remove the heater and air conditioning controller (O).

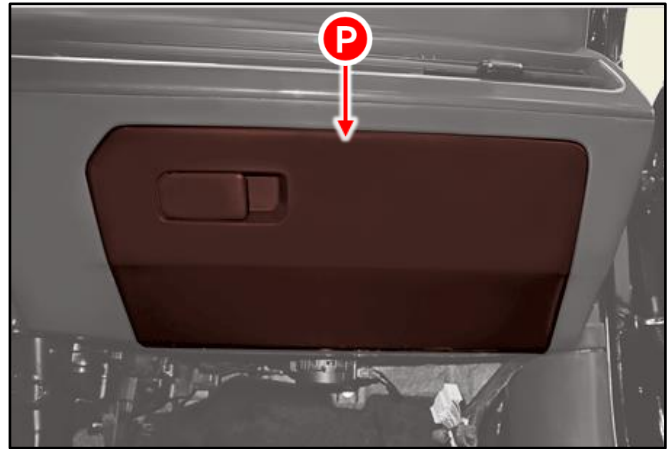
12. Remove the glove box (P) by referring to "Body (Interior / Exterior / Electrical) → Crash Pad → Glove Box → Removal and Installation" in the applicable Shop Manual on KGIS.

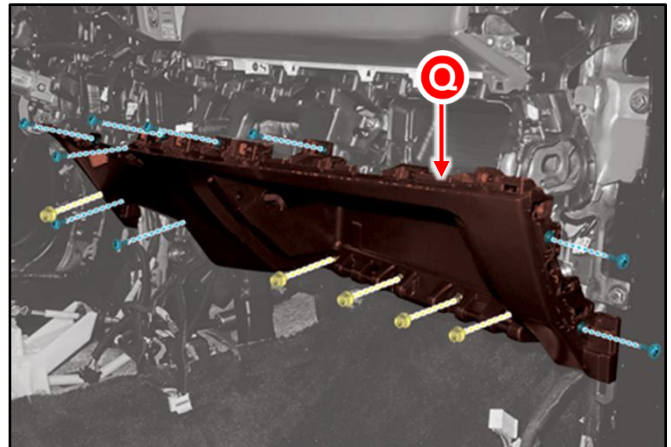
13. Loosen the five (5) nuts and nine (9) screws to remove the crash pad center panel (Q).

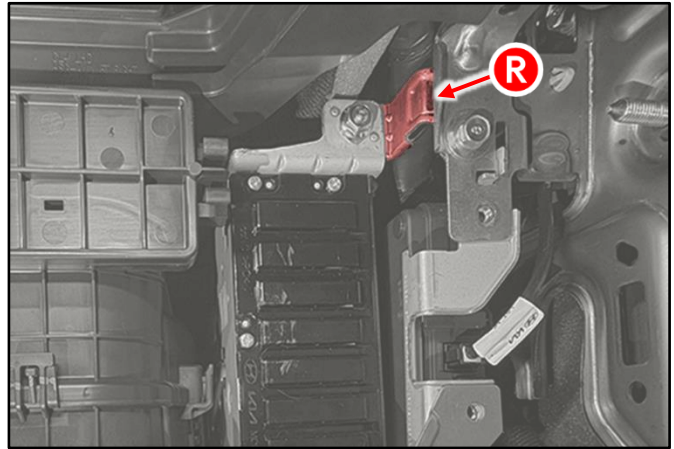
- 14a. Remove the bracket (R) connecting the ccNC unit to the BDC unit.

Tightening torque for nut/bolt:
4.8 - 7.3 lb.ft (6.6 - 9.9 N.m)

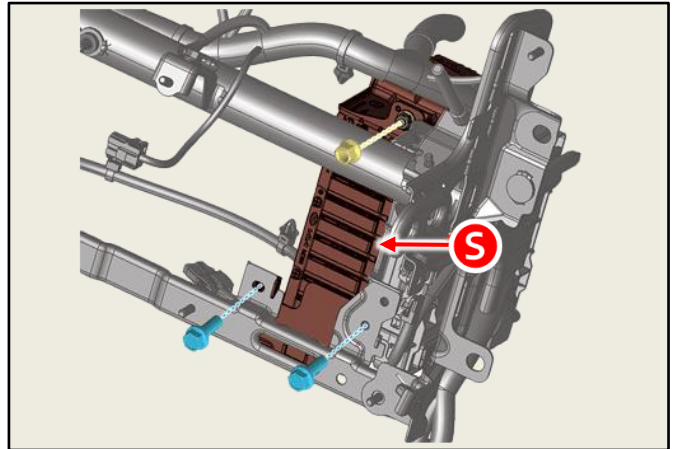
- 14b. Loosen the two (2) bolts and nut to remove the connected car navigation cockpit unit 'ccNC' (S).

Tightening torque for nut/bolt:
5.1 - 8.0 lb.ft (6.9 - 10.8 N.m)

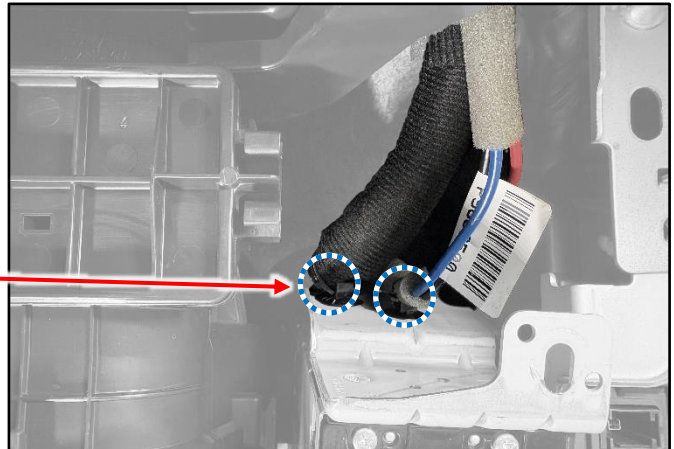
- 14c. Release the wiring harness clips at the top ccNC unit bracket to allow for additional slack.

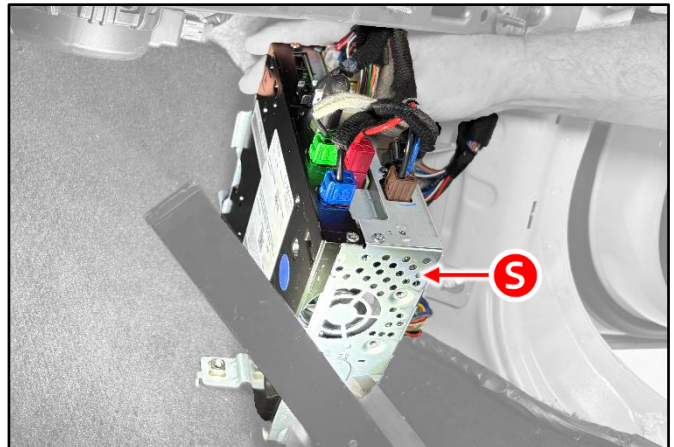
- 14d. Lower the ccNC unit (S) and then disconnect the connectors.

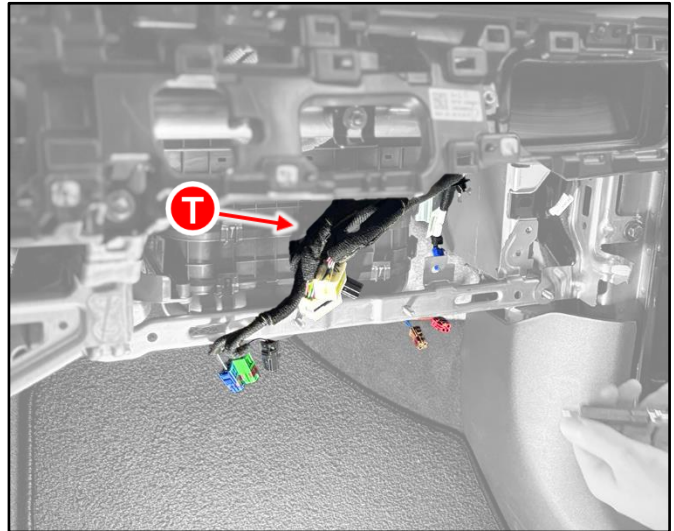
- 14e. Route the wiring harness (T) through the cowl cross bar assembly as shown.

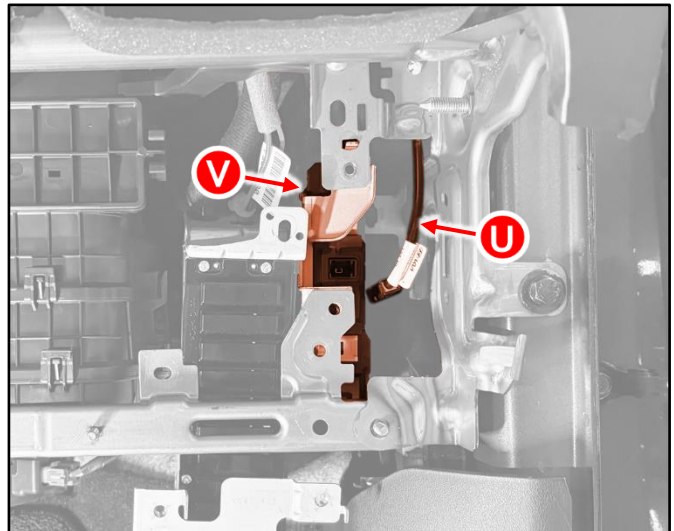
15. Disconnect the antenna (U) and related connectors from the BDC (V).

The antenna does **NOT** need to be removed from the vehicle.

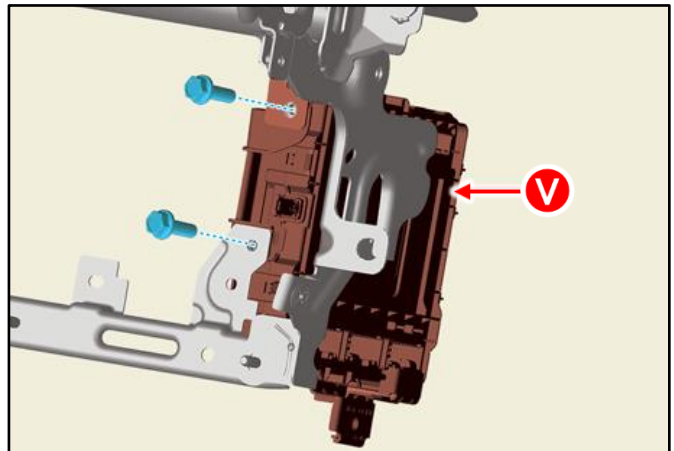
This bulletin provides information regarding the Body Domain Control unit (BDC) on certain 2025MY K4 (CL4) vehicles manufactured from June 1, 2024 through May 1, 2025. Due to a communication issue between the key fob and the BDC, the affected vehicles may exhibit a NO START condition when the ignition 'START' button is pressed accompanied by the inability to move the shifter out of the Park (P) position; however, all other Key Fob functions such as the Lock/Unlock, Trunk Release, Alarm and Remote Start continue to operate normally. Follow the procedure outlined in this publication to replace the Body Domain Control unit 'BDC'. Before conducting the procedure, verify that the vehicle is included in the list of affected VINs.

16. Loosen the two (2) BDC (V) retaining bolts and replace the BDC with a new part.

Remove the BDC by lowering underneath the cowl cross bar assembly.

Tightening torque for nut/bolt:
4.8 - 7.3 lb.ft (6.6 - 9.9 N.m)

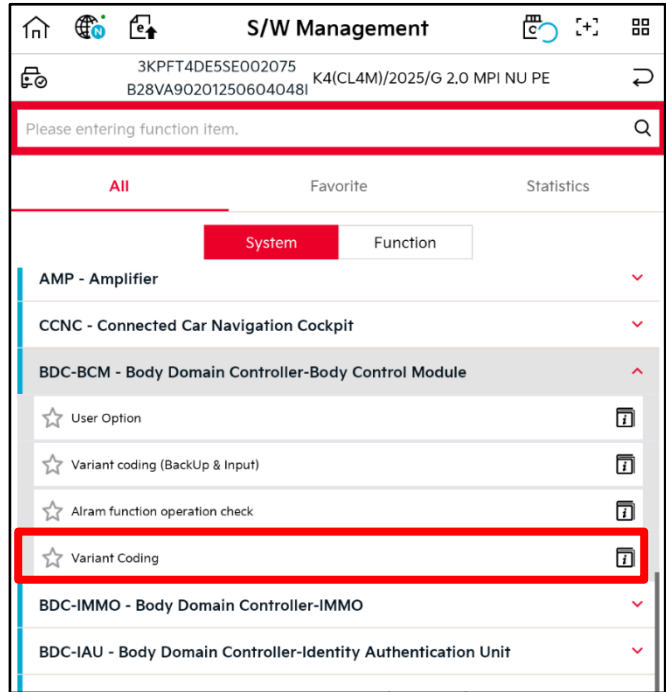
- 18. Using the KDS 2.0, perform the **Variant Coding** by referring to “Expert Diagnosis → S/W Management → BDC-BCM - Body Domain Controller-Body Control Module → Variant Coding”.

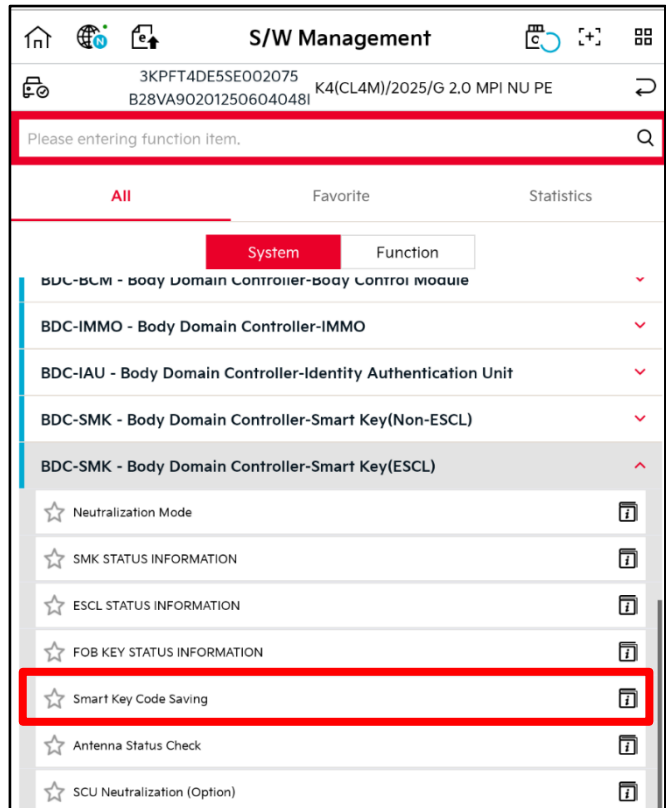
- 19a. Using the KDS 2.0, perform the **Smart Key Code Saving** by referring to “Expert Diagnosis → S/W Management → BDC-SMK - Body Domain Controller-Smart Key (ESCL) → Smart Key Code Saving”.

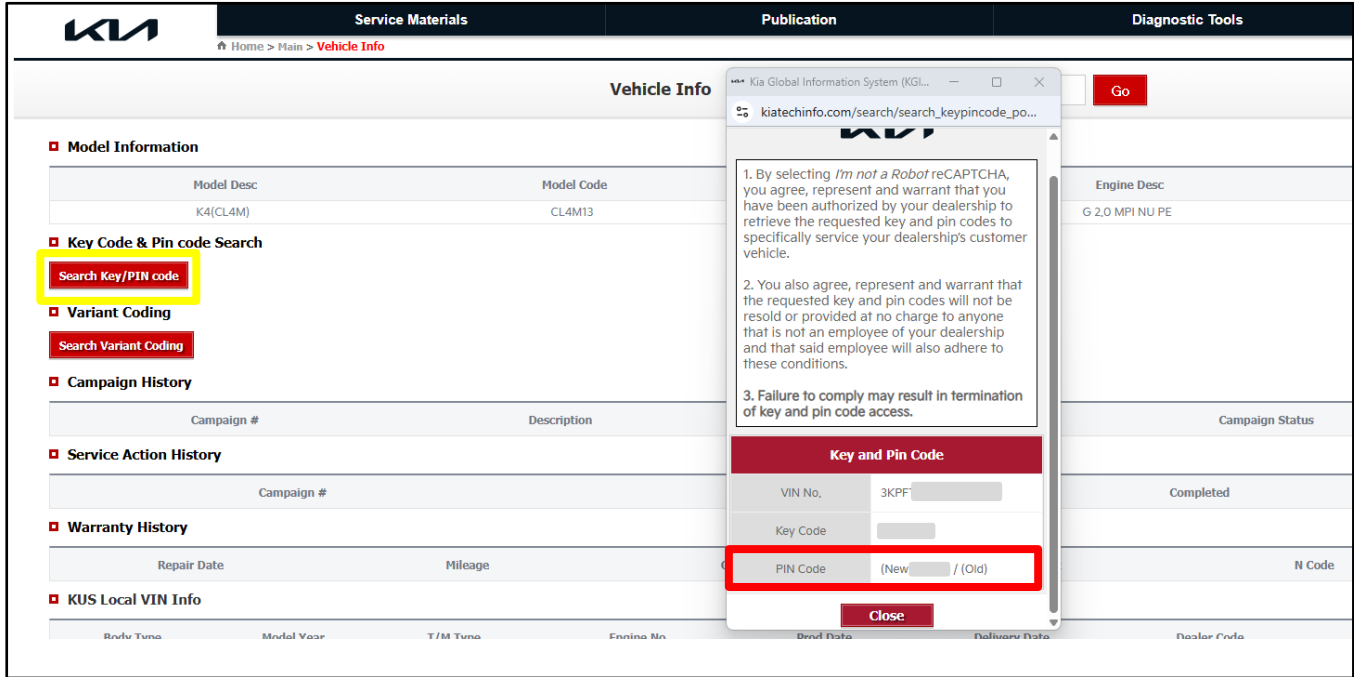
- 19b. Retrieve the **PIN Code** by referring to “KDealer+ → Vehicle Info → Search Key/PIN Code”.

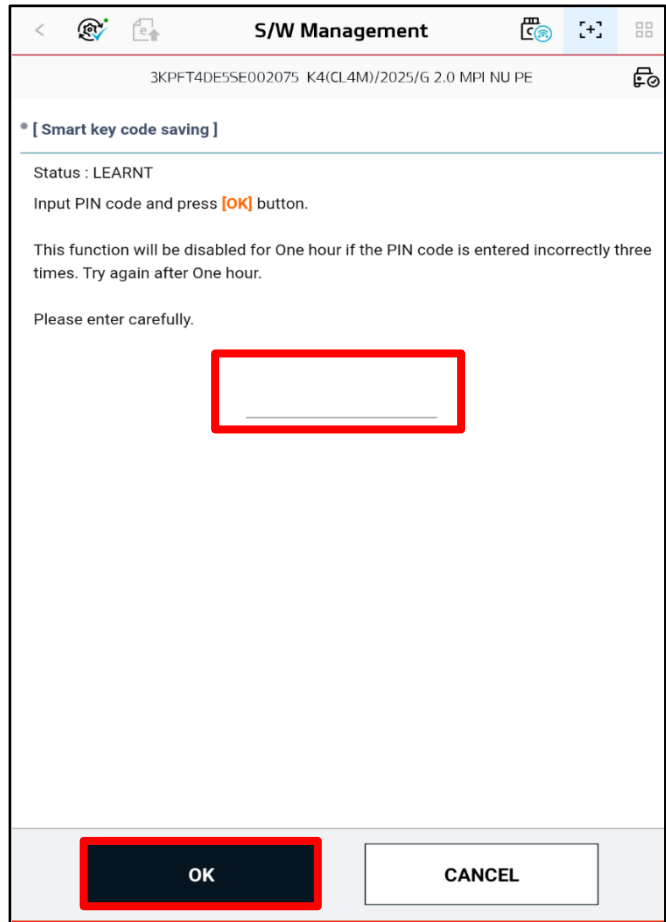
- 19c. Input PIN code and select 'OK'.

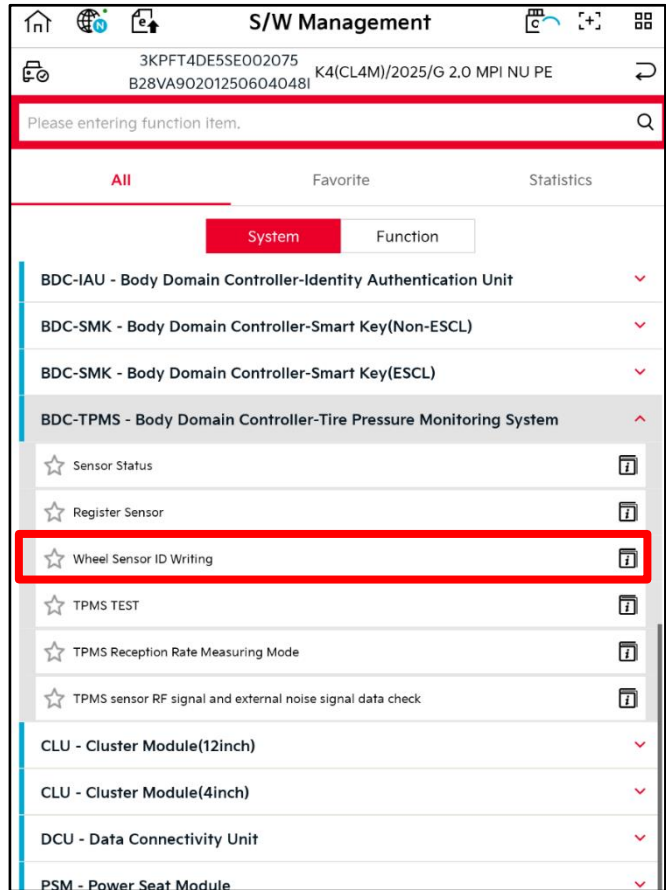
- 20. Using the KDS 2.0 and TPMS Communication Interface (SST# GITGOTKNMK01 or GITOTKDNN200), perform the **TPMS ID Writing** by referring to "Expert Diagnosis → S/W Management → BDC-TPMS - Body Domain Controller-Tire Pressure Monitoring System → Wheel Sensor ID Writing".

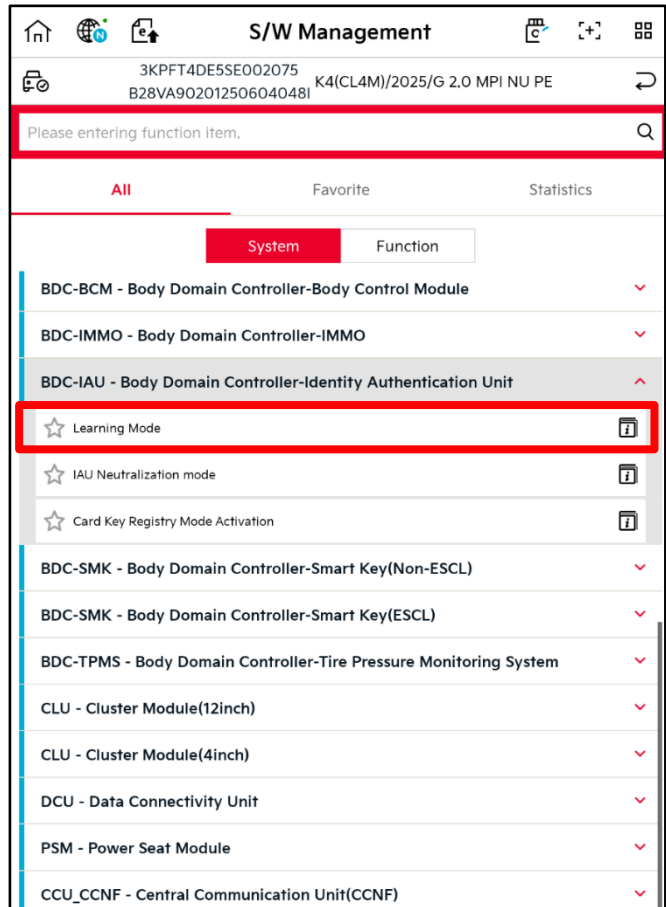
- 21. Using the KDS 2.0, performing the **Learning Mode** by referring to "Expert Diagnosis → S/W Management → BDC-IAU - Body Domain Controller-Identity Authentication Unit → Learning Mode".
