HYUNDAI

Technical Service Bulletin

GROUP CAMPAIGN	NUMBER 25-01-044H
DATE AUGUST 2025	MODEL(S) KONA ELECTRIC (SX2 EV)

SUBJECT: BDC SOFTWARE UPDATE (SERVICE CAMPAIGN TCWA)

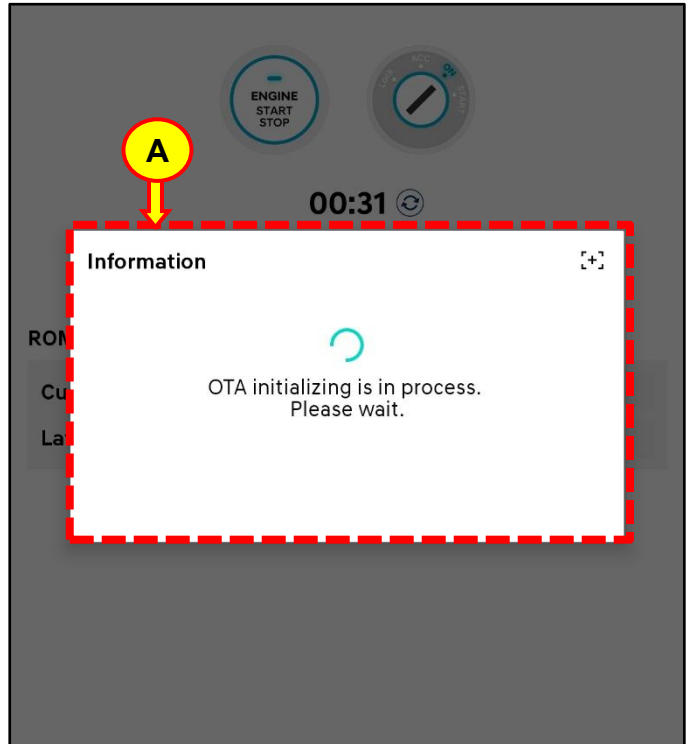
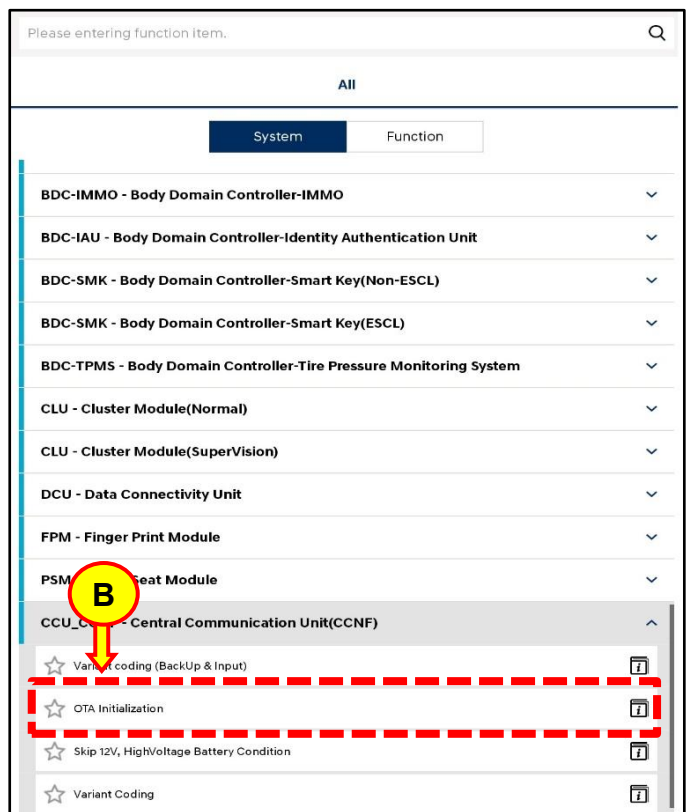
5. OTA initialization (A) should perform automatically:
 - If OTA initialization performs automatically, then proceed with the service procedure.
 - If the OTA initialization process fails, complete it manually under:
S/W Management > CCU_CCNF - Central Communication Unit (CCNF) > OTA Initialization (B).
 Follow the instructions on the screen.

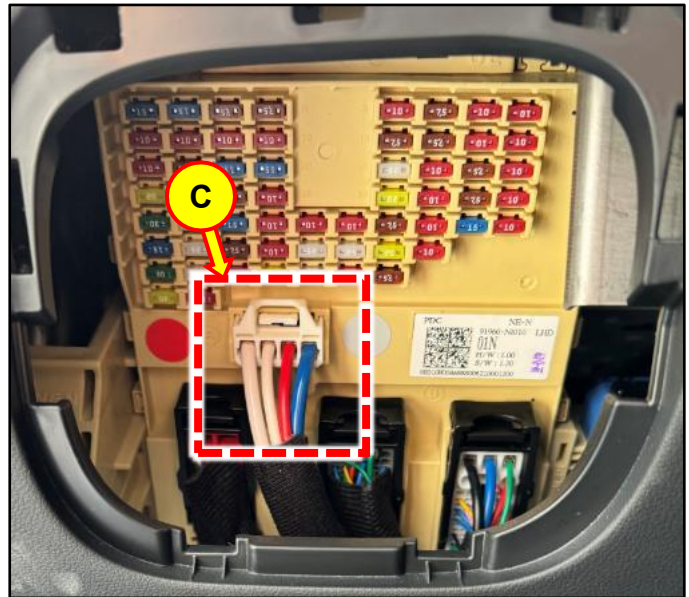
7. Disconnect the power connector (C) of the in-cabin fuse box, wait at least **5 seconds**, then reconnect it.
