GENERAL MOTORS  
DCS 7293  
URGENT - DISTRIBUTE IMMEDIATELY

Subject: N252510321 - Service Update  
ECM Software Update

## N252510321 ECM Software Update

<b>Condition</b>	Certain vehicles listed above will receive a software update to add to the existing Check Engine Light a Driver Information Center (DIC) warning message if DTC P0016 sets.
<b>Correction</b>	Dealers will reprogram the Engine Control Module (ECM). Owners who have accepted applicable terms and conditions will have the opportunity to accept these software changes using wireless over-the-air (OTA) technology without having to bring their vehicle to a dealership. Alternatively, owners may have their vehicle serviced at a GM dealer to receive these software updates.

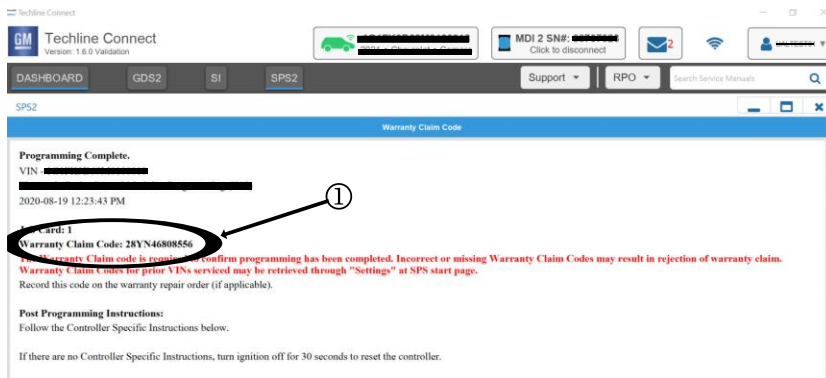
5644478

**Important:** To avoid warranty transaction rejections, you **MUST** record the warranty claim code provided on the Warranty Claim Code (WCC) screen shown above on the job card. Refer to callout 1 above for the location of the WCC on the screen.

1. Reprogram the Engine Control Module. Refer to *K20 Engine Control Module: Programming and Setup* in SI.

2. Record SPS Warranty Claim Code on job card for warranty transaction submission.
