MAS004847 RU 25-23

Rapid Update 802 GranTurismo – Cooling Fan Terminal Inspection

VEHICLES INVOLVED: GranTurismo (M189), GranCabrio (M190) MY24 MY25

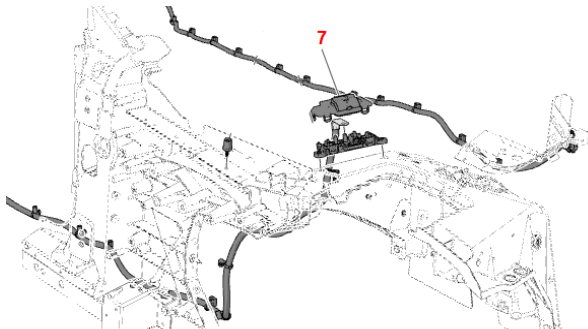
Figure 1: Position of the junction node box in the vehicle.

1. Always check ModisCS+ to see if the vehicle is involved in this action and if it has not been previously performed.
2. **Access the Junction Node Box**
 - Open the engine hood.
 - Locate the junction node box mounted on the **right front shock tower (RHT dome)**.

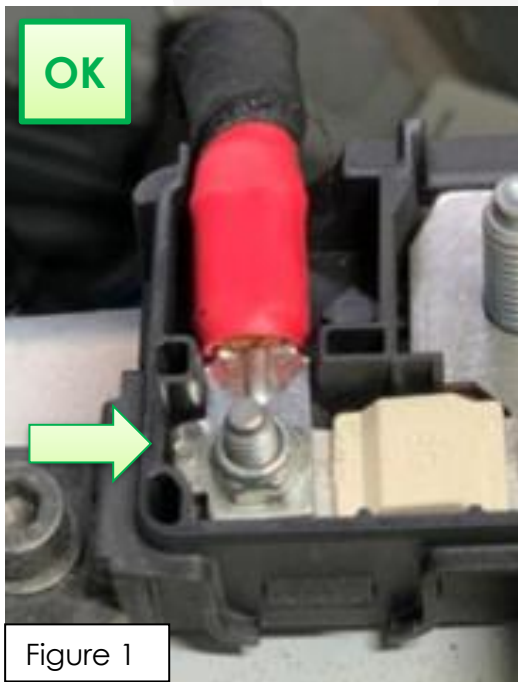
- **Correct Configuration:** Terminal wiring is routed cleanly, seated properly, and clear of adjacent components. No further action is needed. Release the vehicle (**Figure 1**).
- **Adjustment Needed:** Terminal appears to be flipped (**Figure 2**) or in contact with surrounding components.
