DCDC Sensor fault codes due to faulty wake-up behavior

Topic number	LI54.10-P-079533
Version	1
Function group	54.10 - Battery, power supply, voltage converter
Date	8/4/25
Validity	The DC/DC converter type that is installed in model series 243 and 465 can be affected.
Reason for change

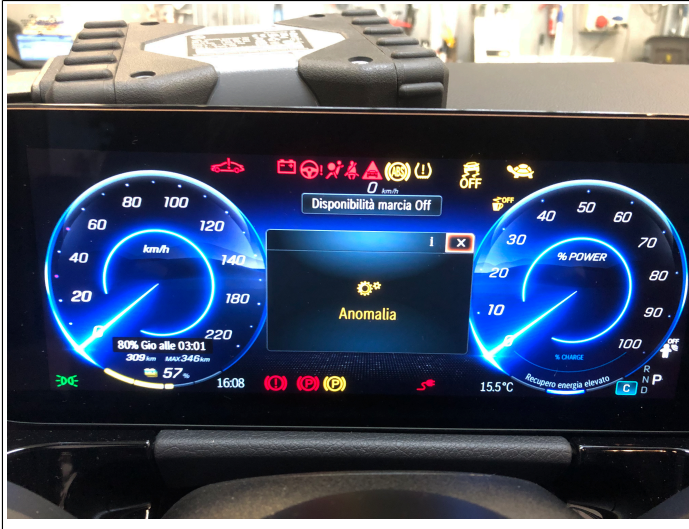
243: As a consequence, on vehicles with BMS30EB02, the DTC for the auxiliary assembly fuse P0E2F00 can be set in this.

This triggers the yellow HV drive system warning message.

Attachments	
File	Description
DCDC223 243 Sensor issue gelbe Hybrid Antriebssystem WEM.jpg	243 yellow HV drive system warning message - can only be deleted via XENTRY

Since the BMS on 243 uses the HV voltage value to check the auxiliary assembly fuse, the auxiliary assembly DTC can (with BMS30EB02) be stored as a consequence and the second (yellow) HV drive system warning message can be displayed in the IC.

Clear the fault memory, since the DTC for the auxiliary assembly fuse and the yellow hybrid drive system warning message can only be reset in this way.
