GROUP	MODEL
ELE	2025MY EV9 (MV1a)
NUMBER	DATE
392	August 2025

TECHNICAL SERVICE BULLETIN

BSA REPLACEMENT GUIDANCE

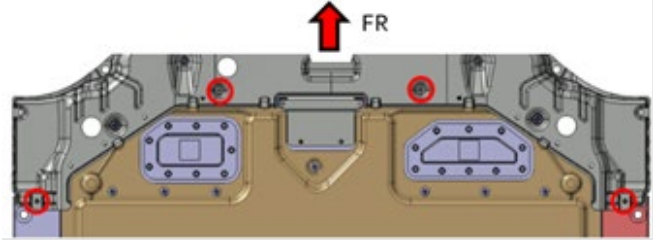
MV1a	MV1
13271-06007K (Nut)	11254-06206B (Bolt)

- The 'Front Under Cover Assy' is a similar design on both MV1 and MV1a. However **the fixing nuts on the front under cover were changed to fixing bolts.**

Note: Use Bolt 11254 06206B when replacing the BSA with part numbers 37501 DO050 or 37501 DO150.

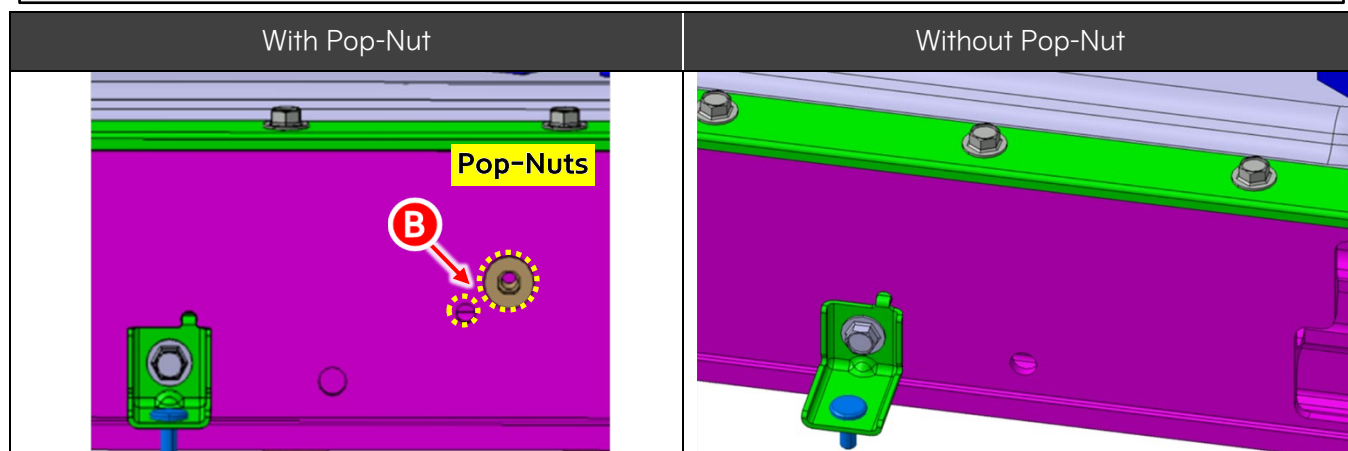
Some Battery System Assemblies (BSA) may feature pop-nuts (B) on the case; however, the presence of pop-nuts does not necessarily indicate that a ground (GND) cable should be installed.
