GROUP	MODEL
ELE	2025MY EV9 (MV1a)
NUMBER	DATE
393	August 2025

TECHNICAL SERVICE BULLETIN

SUBJECT: SERVICE ACTION: FRONT MOTOR AND REDUCTION GEAR (GDU) ASSEMBLY REPLACEMENT (SA622)

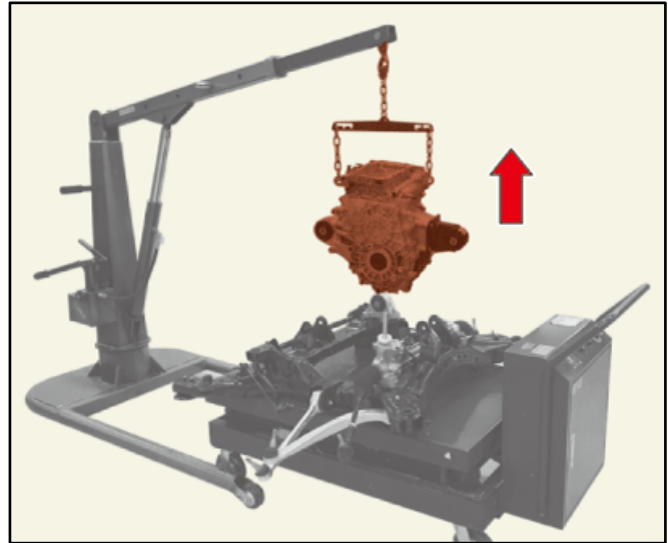
This bulletin provides information to replace the Front Motor Reduction Gear Assembly (GDU) on certain 2025MY EV9 (MV1a) vehicles produced from November 25, 2024 through December 06, 2025 that were assembled at the Kia assembly plant in the US. The affected vehicles may experience abnormal noise coming from the front GDU which is caused by a missing wave washer from the motor inside the front GDU. Follow the procedure outlined in this publication to replace the front GDU on the applicable vehicle. Before conducting the procedure, verify that the vehicle is included in the list of affected VINs.

1. **Replace** the Front Motor and Reduction Gear Assembly (A) by referring to “Motor and Reduction Gear System → Front Motor and Reduction Gear Assembly → Removal → Installation” in the applicable Shop Manual on KGIS.
