August 13, 2025

Rear Camera Displays Black and White Image

APPLIES TO

| Year | Model | Trim Level | VIN Range |
|---|---|---|---|
| 2023–25 | Integra | Base, A-Spec Base | ALL |

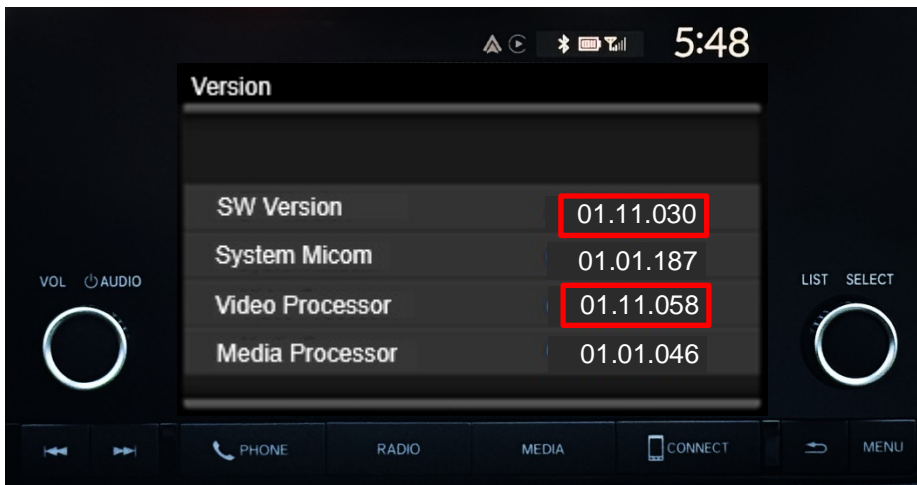
Is the **SW Version** and **Video Processor** equal to or greater than 01.11.030 and 01.11.058?

- **Yes** - The update has been applied, continue normal troubleshooting.
- **No** - Update the SW Version and Video Processor to the following:
 - Software Version 01.11.**030**
 - Video Processor 01.11.**058**

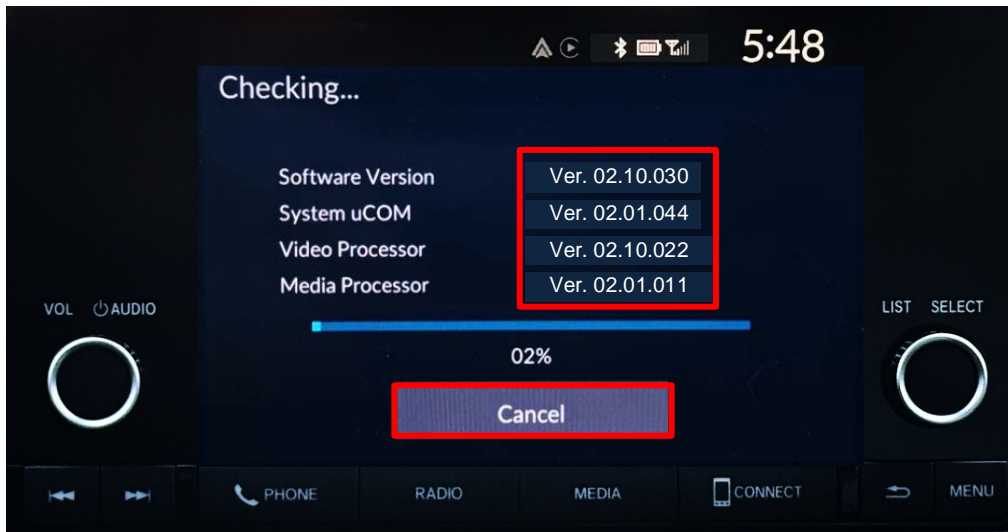
EXAMPLE: Incorrect Software

1. During the software “Checking” stage, it is important to confirm the software information on the screen matches the software table.
2. If the information does not match the table below, immediately press **CANCEL**. The update file on the USB flash drive **does not** apply to this vehicle. Confirm that you have downloaded the correct file for the vehicle model/trim you are working on.

Updating with the incorrect software will damage the audio unit and will require unit replacement.
