Service Bulletin

Bulletin No.: 25-NA-113

Subject: Oil Leak from the Front of Engine

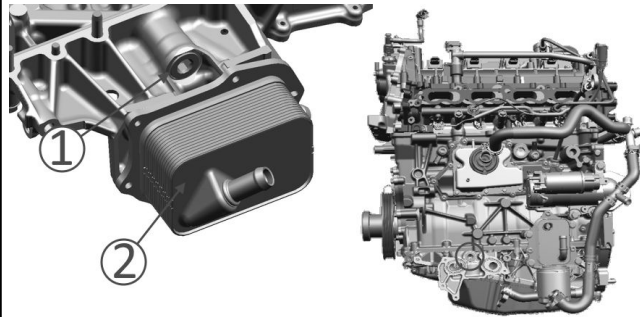
6929329

| Condition | Some customers may comment on an oil leak from the front of engine. Some technicians may comment on seeing an oil leak near the oil cooler area. |
| Cause | This condition may be caused by an oil cooler plug located behind the oil cooler, not installed properly. |

Inspect the plug (1) behind the cooler (2) for oil seepage:

- Remove the oil cooler for access. Refer to *Engine Oil Cooler Replacement*.
- The area may need to be cleaned for confirmation.
- If the leak has been verified, replace the oil galley plug.
