# Service Bulletin

Bulletin No.: PIT6396A

Date: August, 2025

**Subject: SES MIL with DTC P2535 / P12A6 / P10DA / C111B / P157A After Fuel Pump Driver Module Replacement 13565642**

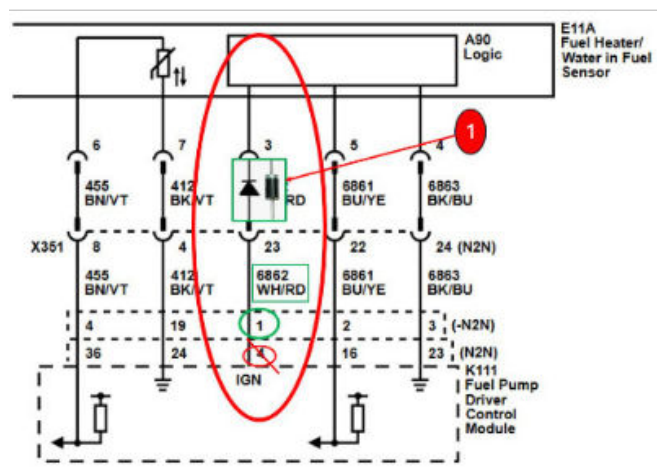
6954816

| <b>Cause</b> | <p>The cause of this concern is the K111 Fuel pump driver module has changed P/N from 13558813, 13540026 and 13531869 to one new P/N of 13565642. The new P/N could cause a voltage feed back of approximately 2 volts on the Ignition 1 circuit 439 after the ignition is turned off. The voltage is back feeding through the water-in-fuel sensor circuit 6862 terminals 1 of the K111 Fuel pump driver module.</p> <p><b>Note:</b> If circuit 6862 does not go to terminal 1 of the K111 Fuel pump driver module then disregard this PI as it does not apply.</p> |

Engineering is working on design improvements for a new fuel pump driver module. In the meantime, a diode can be installed in line with the water-in-fuel sensor circuit 6862, shown below (1), to correct the issue.
