Service Bulletin

Bulletin No.: PIC6511B

Subject: Diagnostic Tip - Unwanted Park Assist Indication

Brand:	Model:	Model Year:		VIN:		Engine:	Transmission:
		from	to	from	to		
Cadillac	Lyriq	2023 - 2025		All	All	All	All
Chevrolet	Traverse (All New)	2024 - 2025		All	All	LK0	All
GMC	Acadia	2024 - 2025		All	All	LK0	All

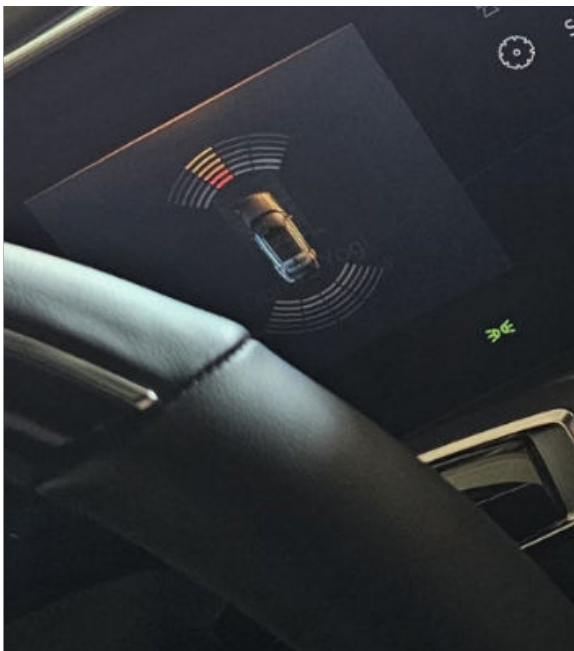
6383071

Involved Region or Country	North America
Condition	A customer may comment that the Park Assist will indicate an object detected intermittently from either the left or right front middle sensors.
Cause	Possible interference from front License Plate Frame.

Example of Park Assist indicator.
