Service Bulletin

Bulletin No.: PIC6616

Subject: Squeak Noise From Rear of Vehicle

Brand:	Model:	Model Year:		VIN:		Engine:	Transmission:
		from	to	from	to		
Cadillac	OPTIQ	2025		All	All	All	All

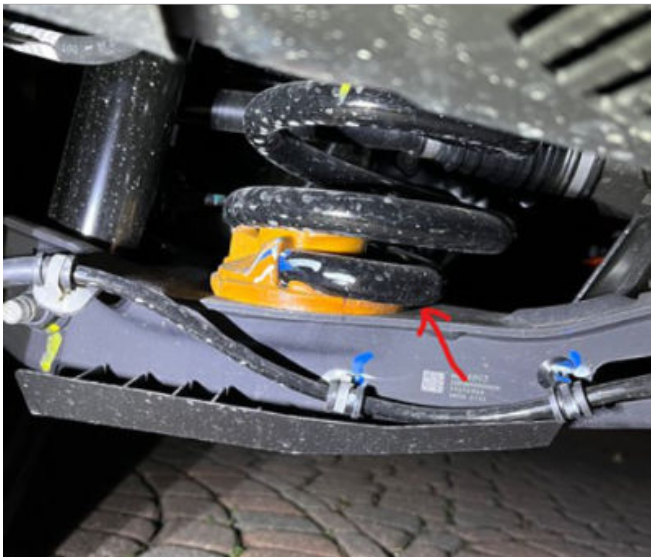
6991335

Involved Region or Country	North America
Condition	Customers may comment on a squeak noise coming from the rear of the vehicle when going over bumps.
Cause	Possible rear coil spring not seated properly on the rear spring isolator.

Images below show rear spring not properly seated on isolator.

If the technician finds the rear spring not properly installed, they will need to follow the repair instructions as outline in Service Information to properly install spring.

Note: inspect the spring isolator for damage and replace as needed.

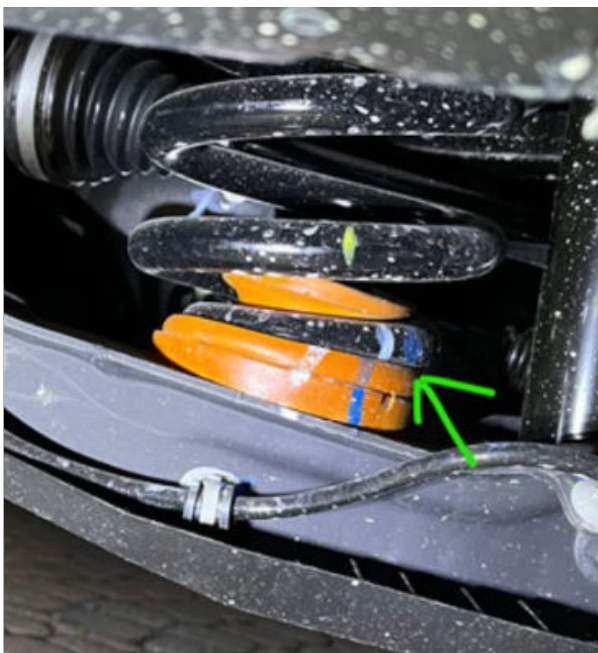
6991336

The following images show the rear spring properly mounted on the isolator.
