E-Series	Model Description	Production Date
G20	3 Series Sedan	August 1, 2019 – December 12, 2024
G22	4 Series Coupe	
G23	4 Series Convertible	
G26	4 Series Gran Coupe	
G42	2 Series Coupe	
G80	M3 Sedan	
G82	M4 Coupe	
G87	M2 Coupe

SITUATION

While driving on a smooth and/or uneven road, a “cracking” sound is heard from the rear wheel arch area (**highlighted in orange**) on either the right or left side.

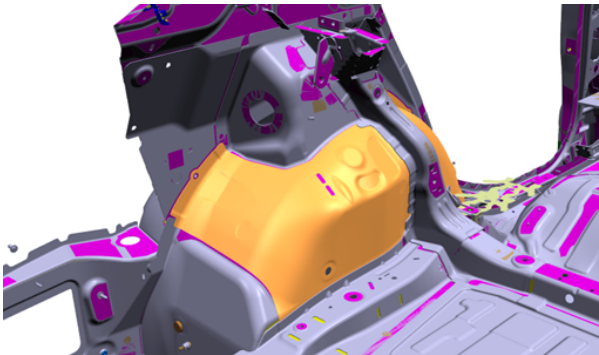
Red arrow is pointing to the area of where the sound is occurring (**with the wheel arch panel installed** (highlighted in orange; driver’s side shown)).

The wheel arch support panel may slightly overlap the side frame connection under certain circumstances. Tensile and compressive loads can cause movement between the panels resulting in a “cracking” sound.

Rework the rear upper section of the left and/or right-side wheel arch panel.

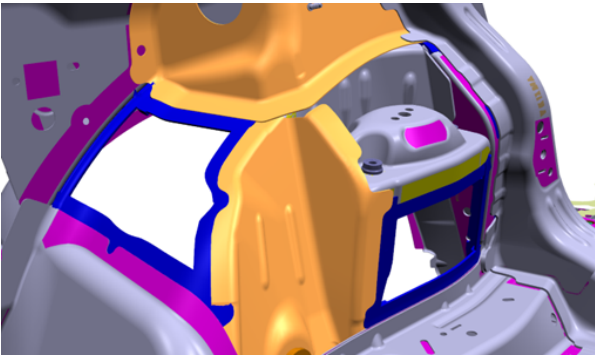
Red circle indicates the area of where the sound is occurring (**without the wheel arch panel installed** (highlighted in orange)).
