SIB 41 12 25  
GROANING SOUND FROM THE TAILGATE

2025-08-20

E-Series	Model Description
U10	X2 Sport Activity Coupe

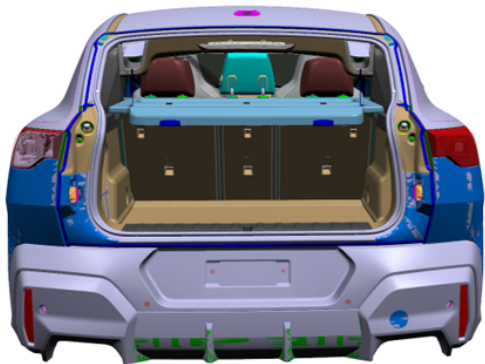
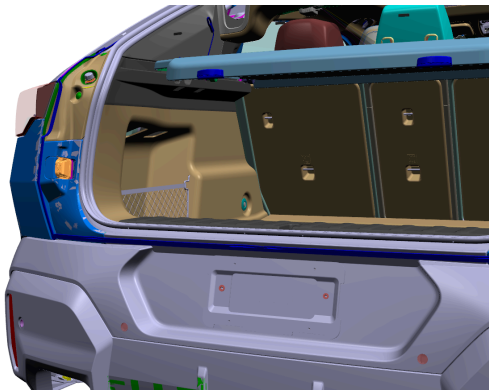
A “groaning” noise is heard from the tailgate when driving on rough roads.

Frictional vibration of the tailgate wedging elements (**highlighted in orange at arrows**).\_

Adjust the tailgate.

1. Verify the customer's concern.
2. Adjust the tailgate following repair instructions listed in ISTA/AIR 41 62 014.
3. Reassemble the vehicle and verify the repair.
