SIB 51 04 24

BUZZING SOUND FROM THE UPPER TAILGATE INTERIOR TRIM PANEL

E-Series	Model Description
F95	X5 M Sports Activity Vehicle
G05	X5 Sports Activity Vehicle
G07	X7 Sports Activity Vehicle

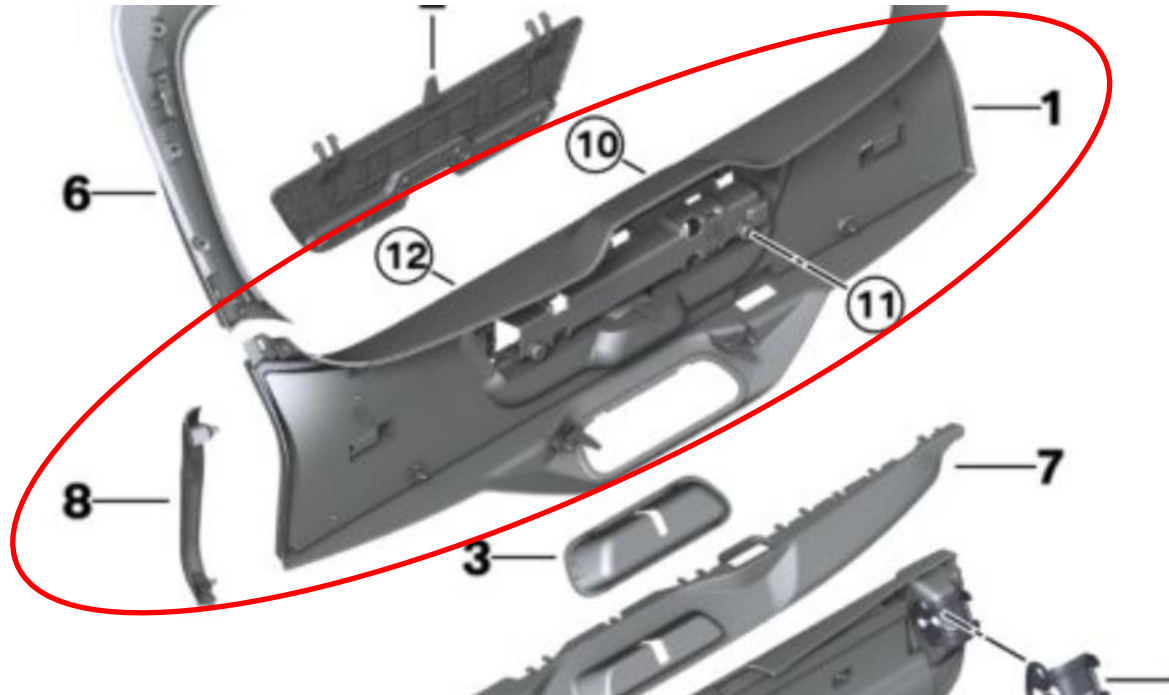
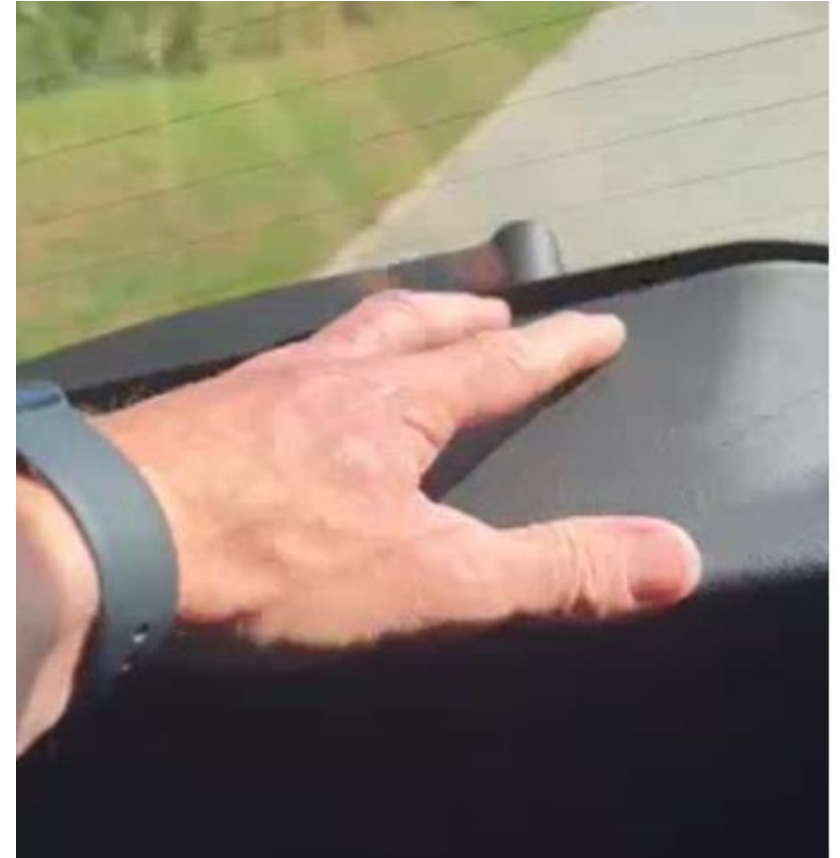
1

A welding burr on the upper tailgate trim panel is contacting the sheet metal.

1. Verify that the customer's vehicle issue is the one described in this Service Information Bulletin.
2. Remove the upper tailgate trim panel following the repair instructions listed in ISTA/AIR 51 49 000.
3. Remove the protruding welding burr using a file or sandpaper (see attachment).
4. Install the tailgate trim back on the vehicle and verify the repair.
